Hackensack Meadowlands Tide Gates Inspection Report

**The New Jersey Meadowlands Commission
One DeKorte Park Plaza
Lyndhurst, New Jersey**

March 27, 2006

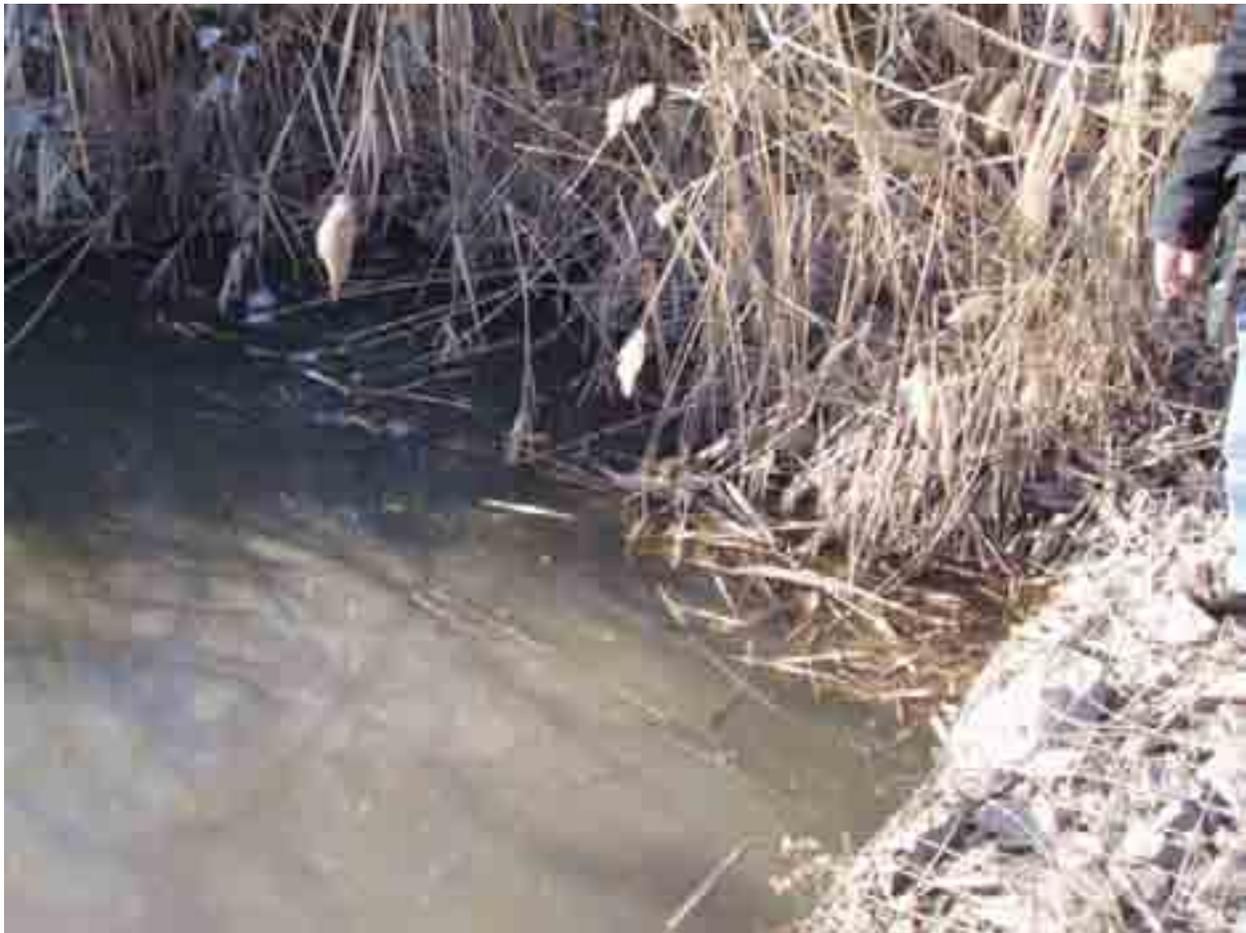
* During low tide condition, the system was found to be non-functional. Please see attached low tide condition report.

The gate appears to be working during high tide conditions. The storm sewer in the area need to be maintained regularly due to the build up of sedimentation.

Photo 1 Description: Location of steel flap gate

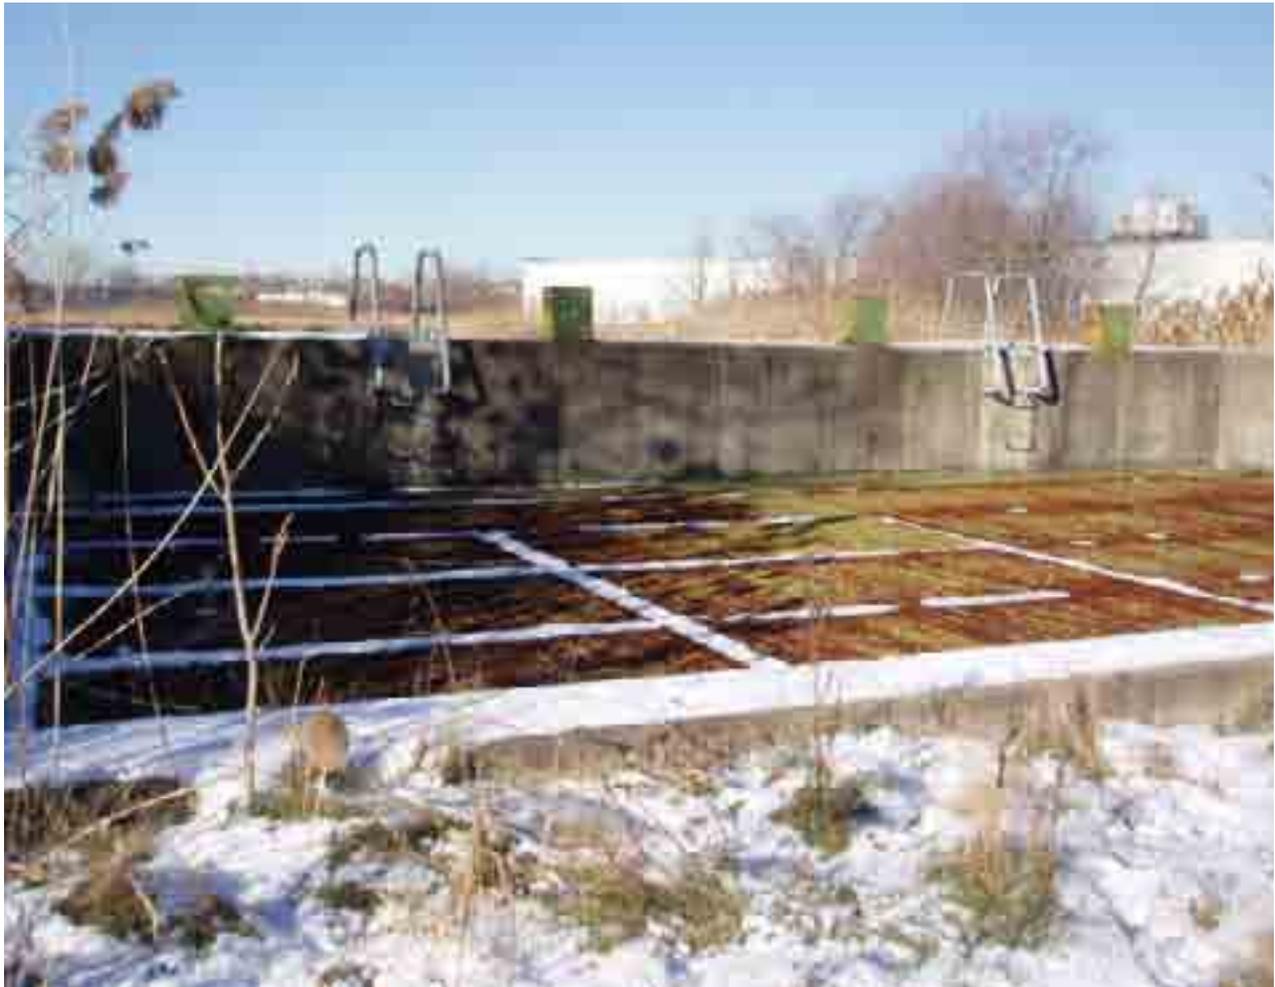
The trash rack needs immediate repair and cleaning. Debris has collected and blocks the flow of water through the gates. The roadway is also in need of repair due to settling above the tide gates.

Photo 1 Description: Tide gate structure

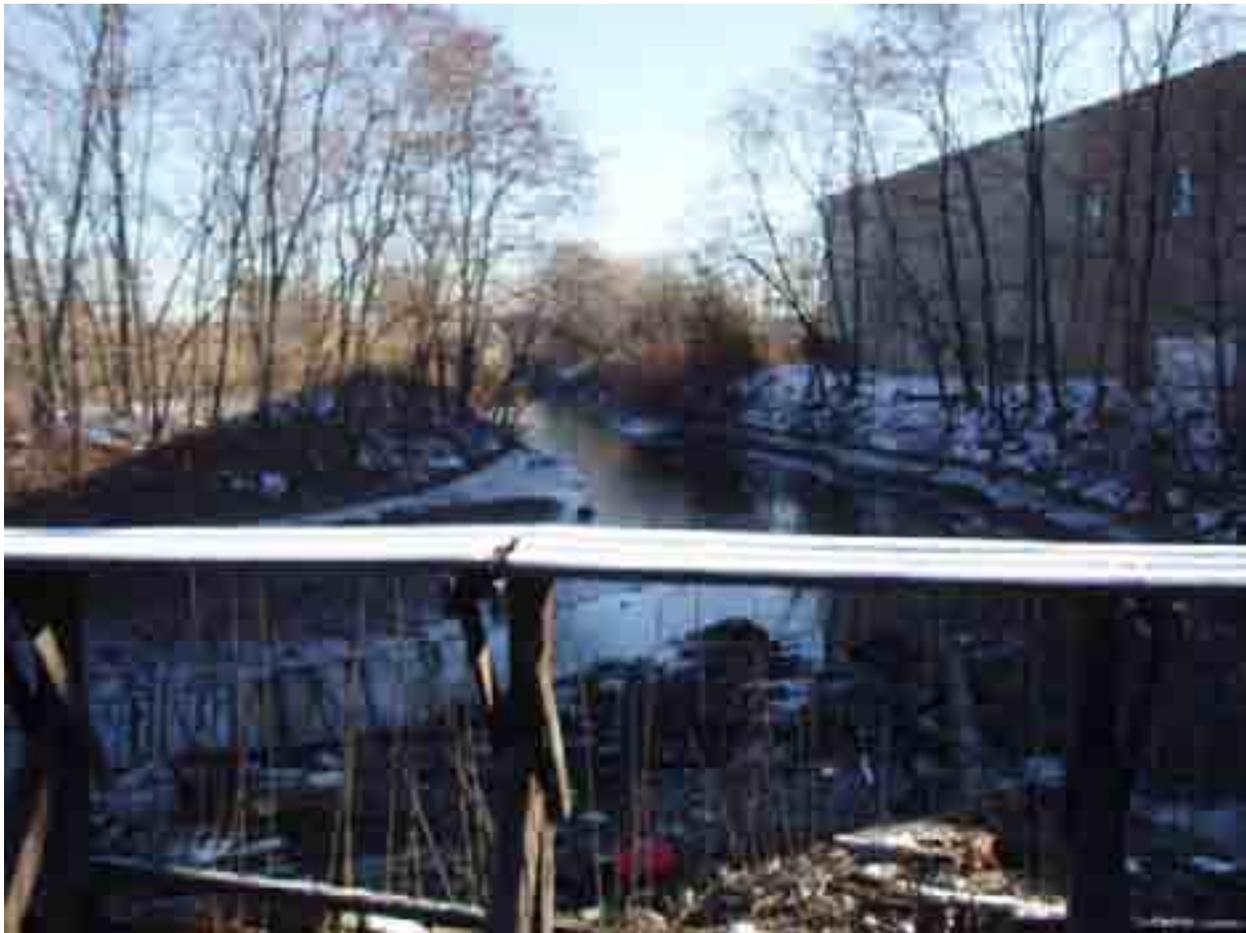
Photo 3 Description: Upstream view from tide gates and view of the trash rack system

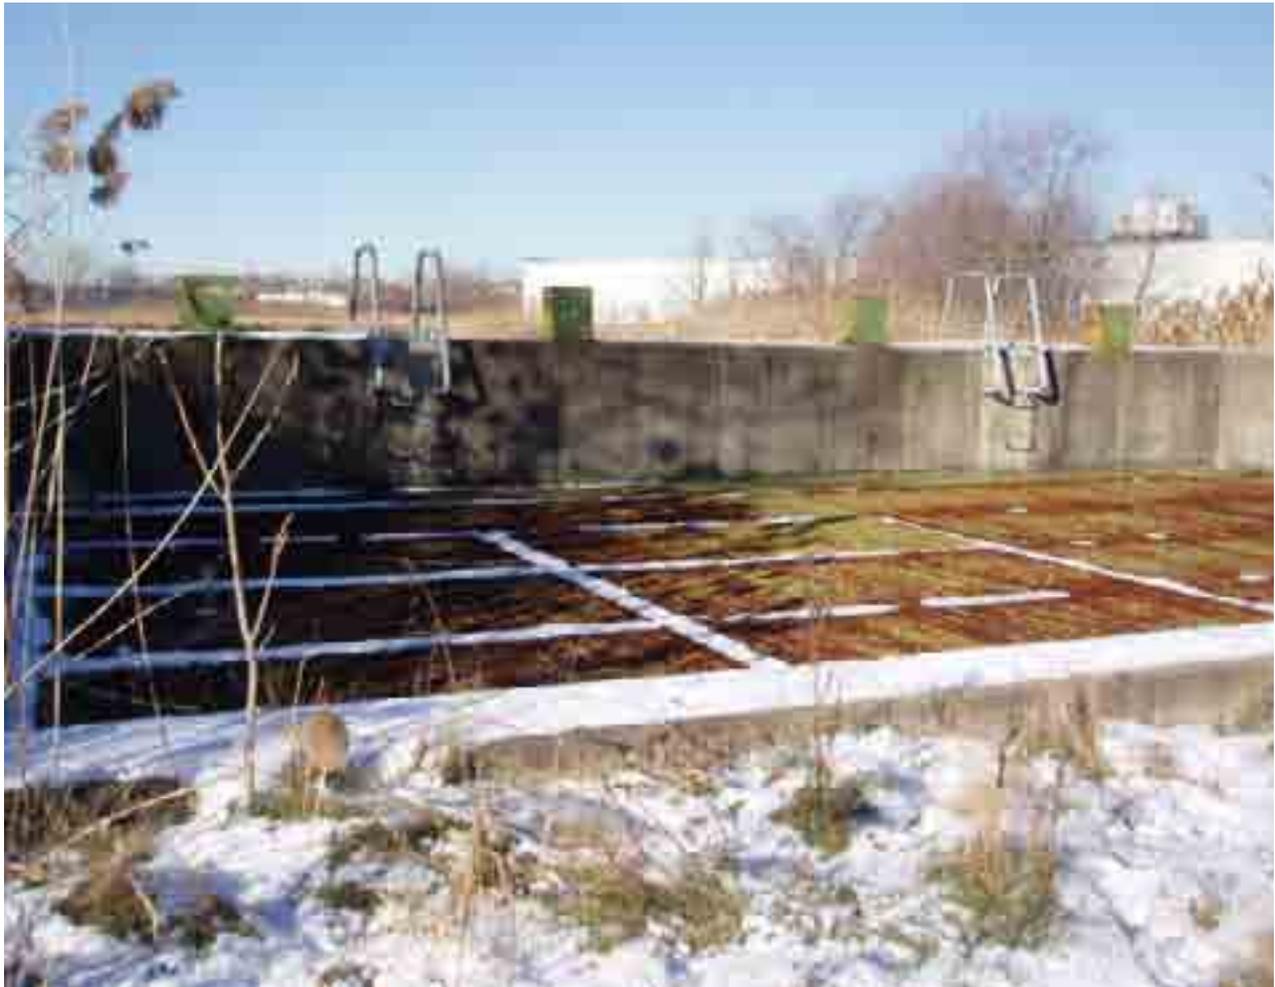
The tide gates are malfunctioning and not seating properly, specifically tide gates two and four. The water is entering through the gates and entering the upstream system during high tide conditions.

Photo 1 Description: Tide gate structure

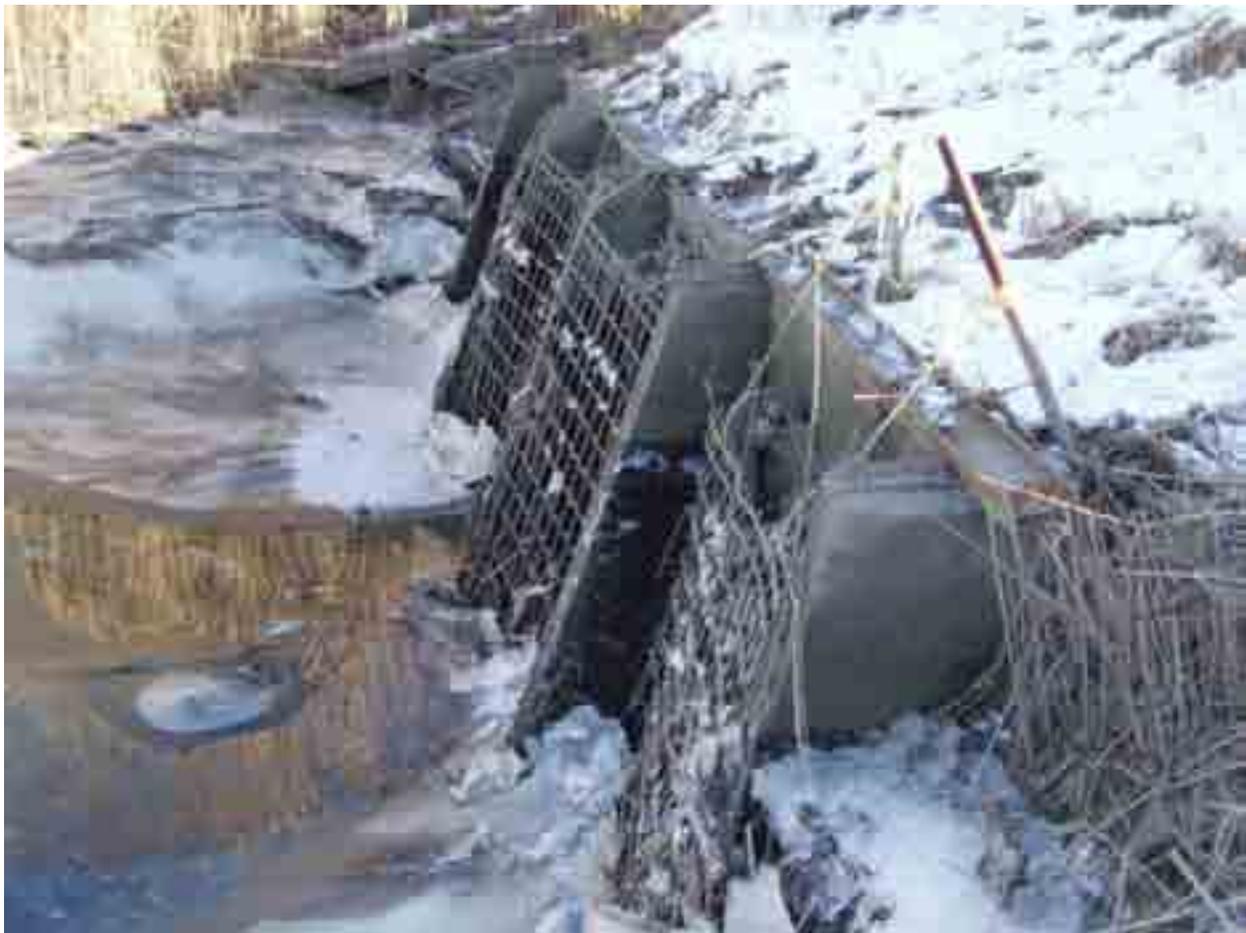
Photo 1 Description: 4 metal flap gates
