# Hackensack Meadowlands Tide Gates Inspection Report

**The National Flood Insurance Program  
Community Rating System**

**The New Jersey Meadowlands Commission  
One DeKorte Park Plaza  
Lyndhurst, New Jersey**

**March 27, 2006**

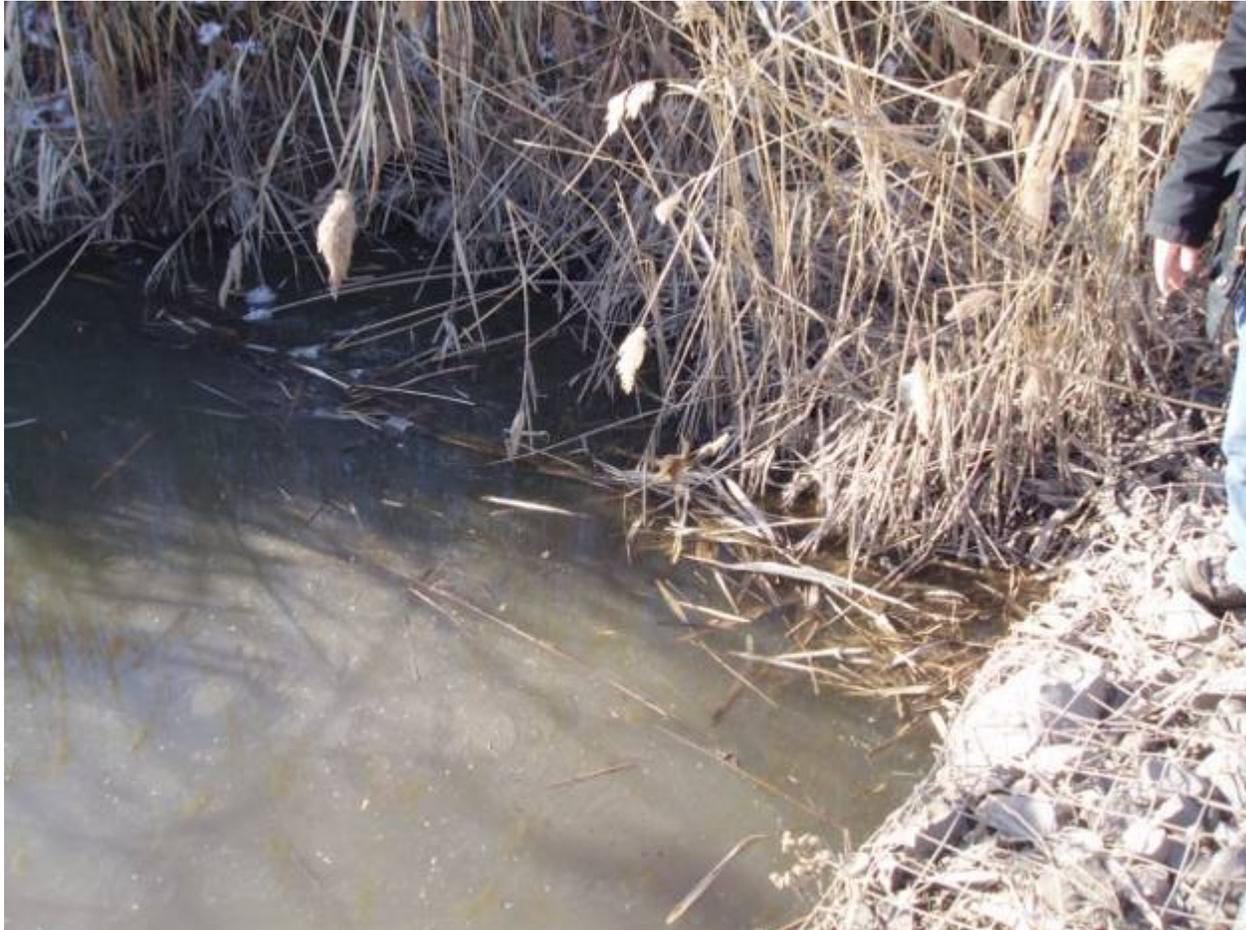
The gate appears to be working during high tide conditions. The storm sewer in the area need to be maintained regularly due to the build up of sedimentation.

**Photo 1 Description: Location of steel flap gate**

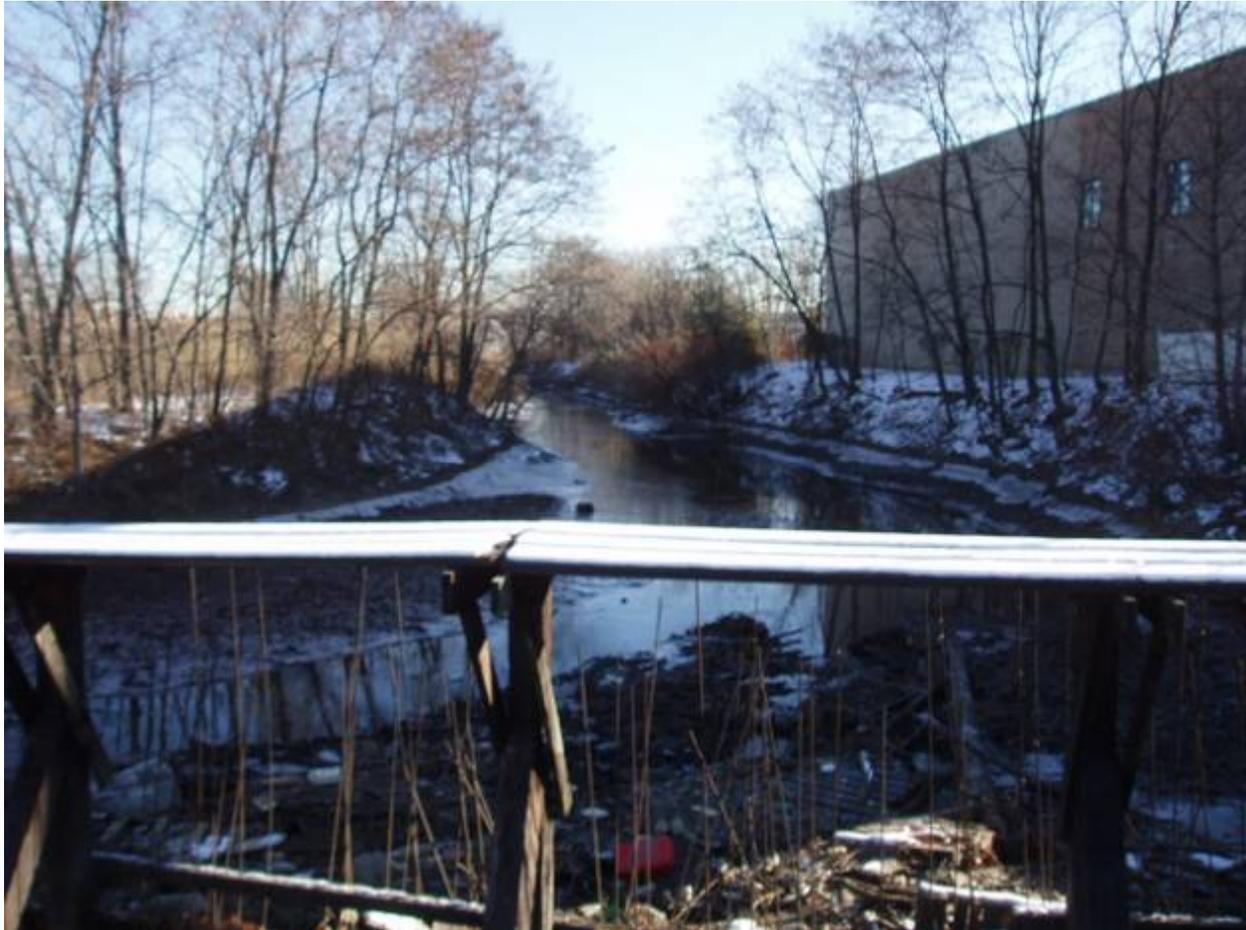
The trash rack needs immediate repair and cleaning. Debris has collected and blocks the flow of water through the gates. The roadway is also in need of repair due to settling above the tide gates.

**Photo 3 Description:** Upstream view from tide gates and view of the trash rack system

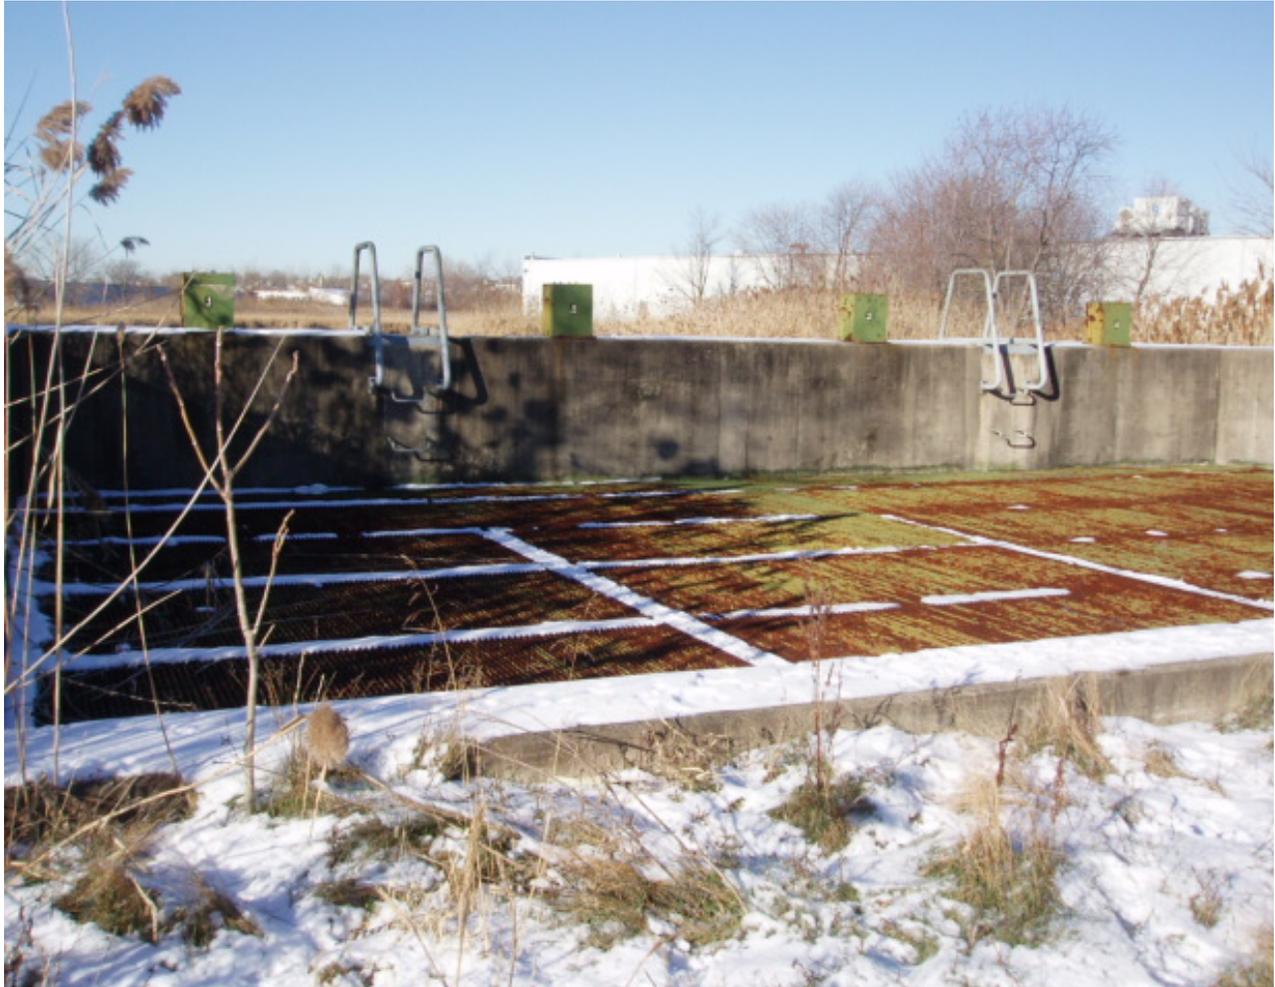
The tide gates are malfunctioning and not seating properly, specifically tide gates two and four. The water is entering through the gates and entering the upstream system during high tide conditions.

**Photo 1 Description: Tide gate structure**

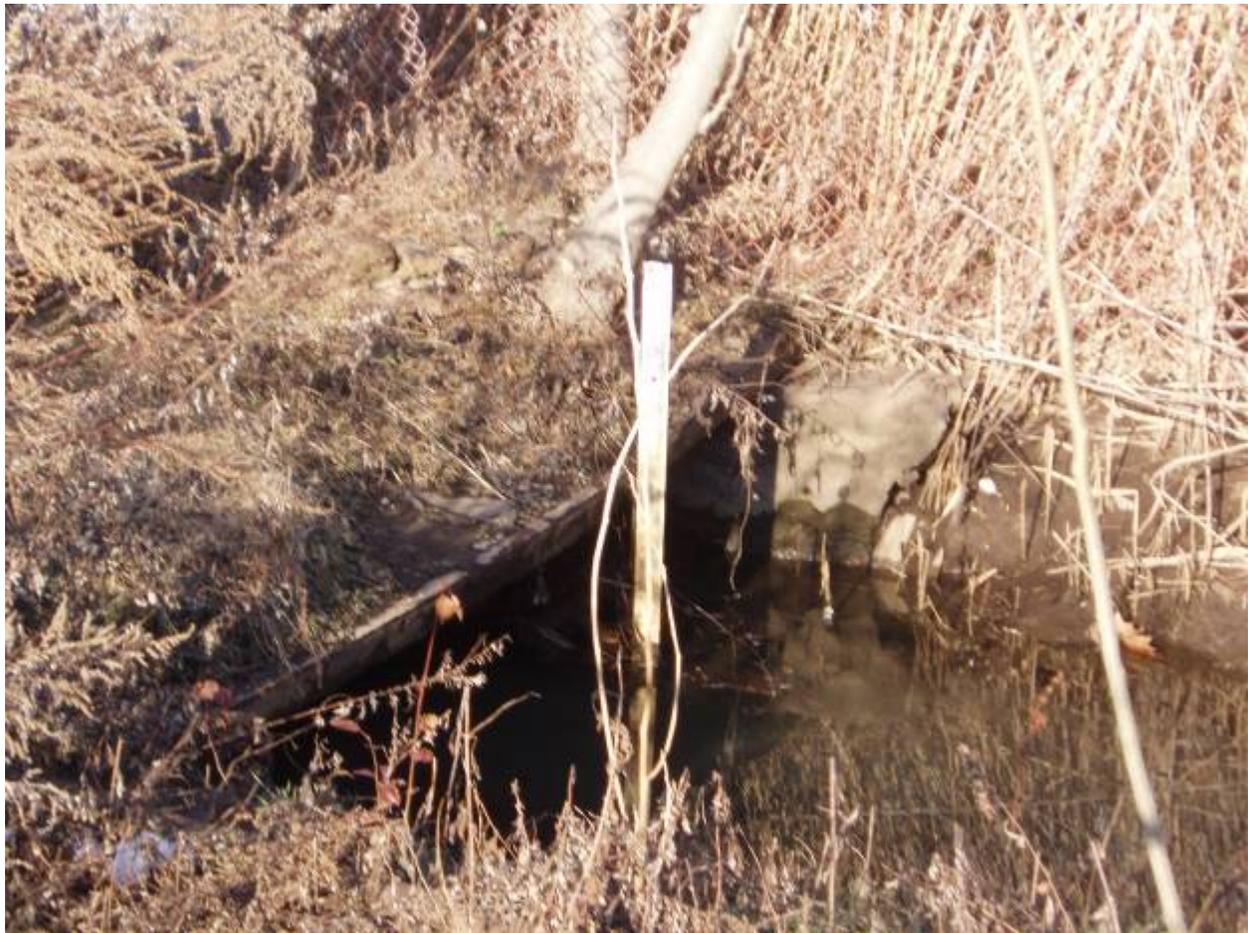
The tide gate located in the intersection of 13<sup>th</sup> Street and Division Street in Carlstadt was inspected on December 19, 2005 during low and high tide conditions. The water elevation in the vicinity of the tide gate did not change regardless of the tidal conditions. The tide gate is constantly submerged and cannot be inspected. After a detailed analysis of the topographic data and aerial mapping, NJMC has determined tidal water cannot reach the tide gate, and therefore, it is recommended that the J.P. Smith Tide Gate no longer be inspected.

**Photo 1 Description: Remains of existing tide gate structure**

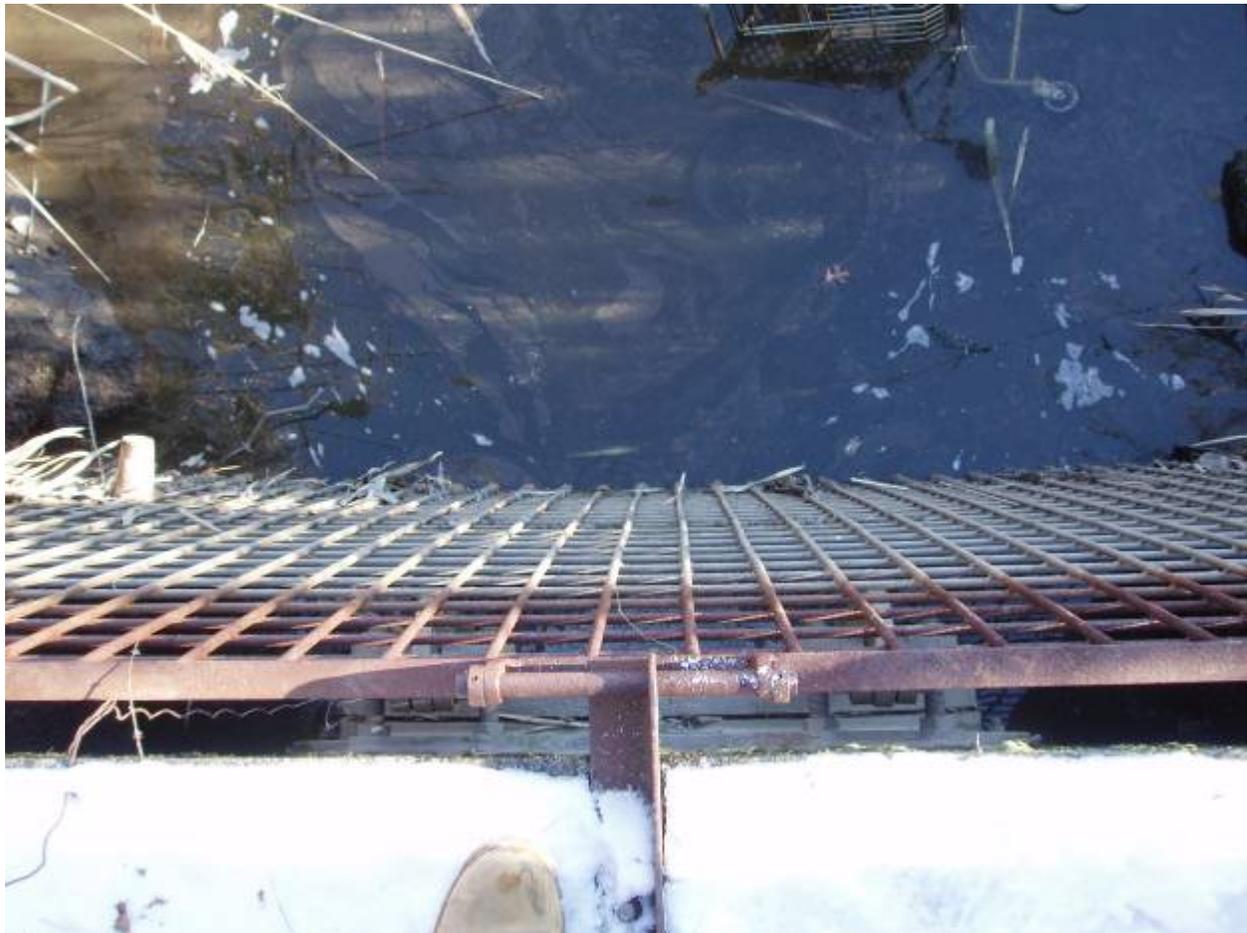
**Photo 1 Description: Metal flap gate with a trash rack**

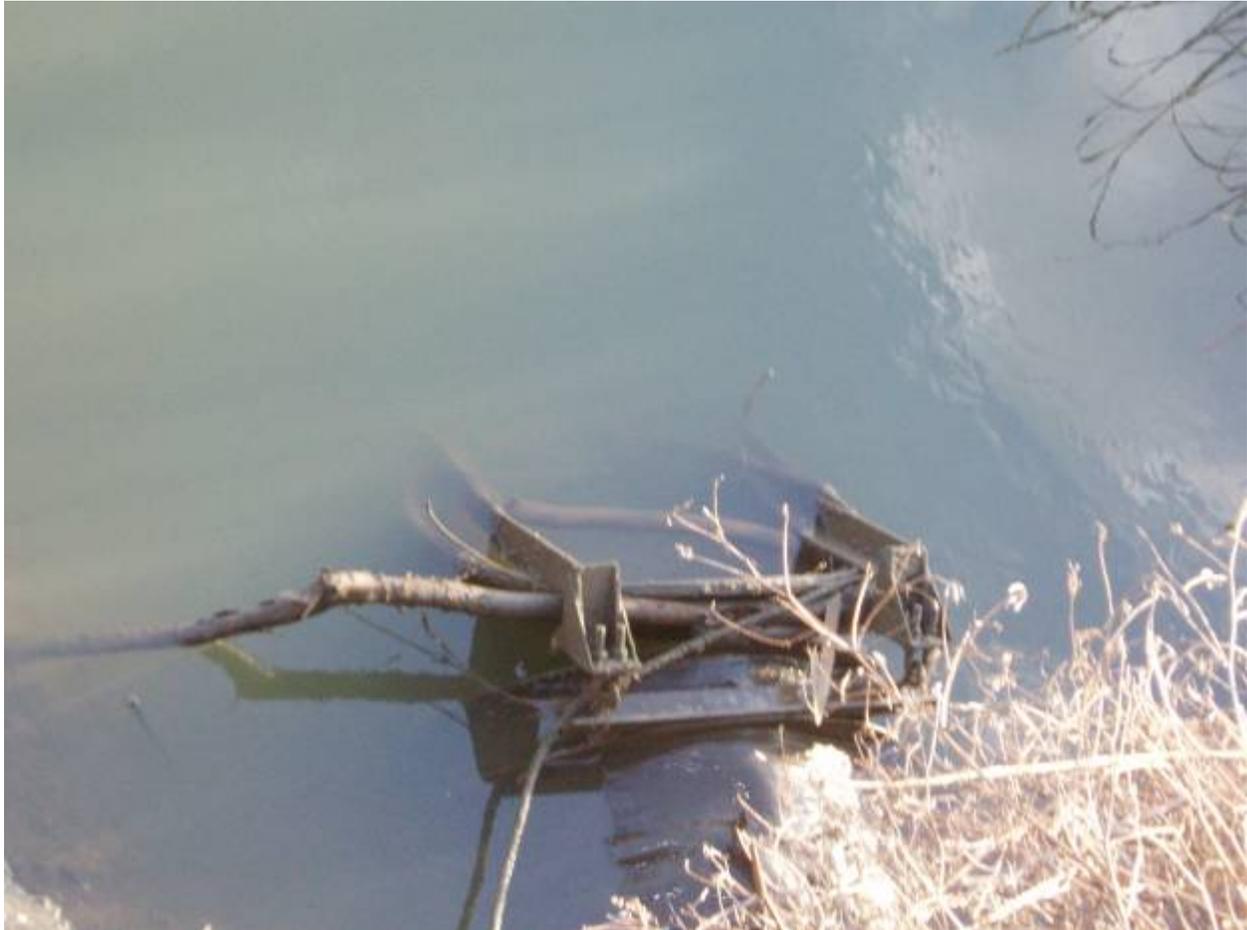
**Photo 1 Description:** Tide gate shown with debris keeping it from closing properly

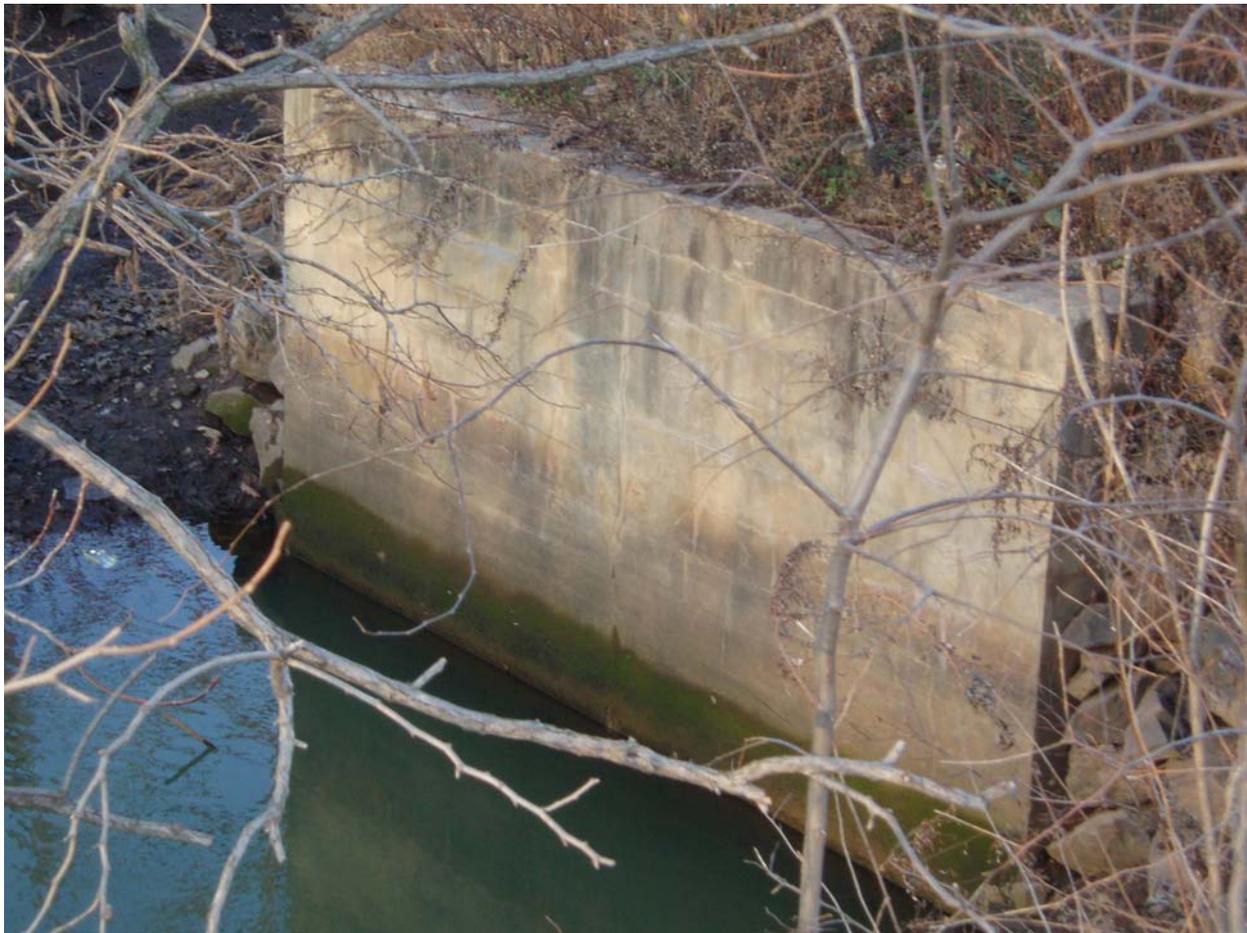
**Photo 1 Description: Location of removed tide gates**
