Hackensack Meadowlands Tide Gates Inspection Report

**The New Jersey Meadowlands Commission
One DeKorte Park Plaza
Lyndhurst, New Jersey**

March 27, 2006

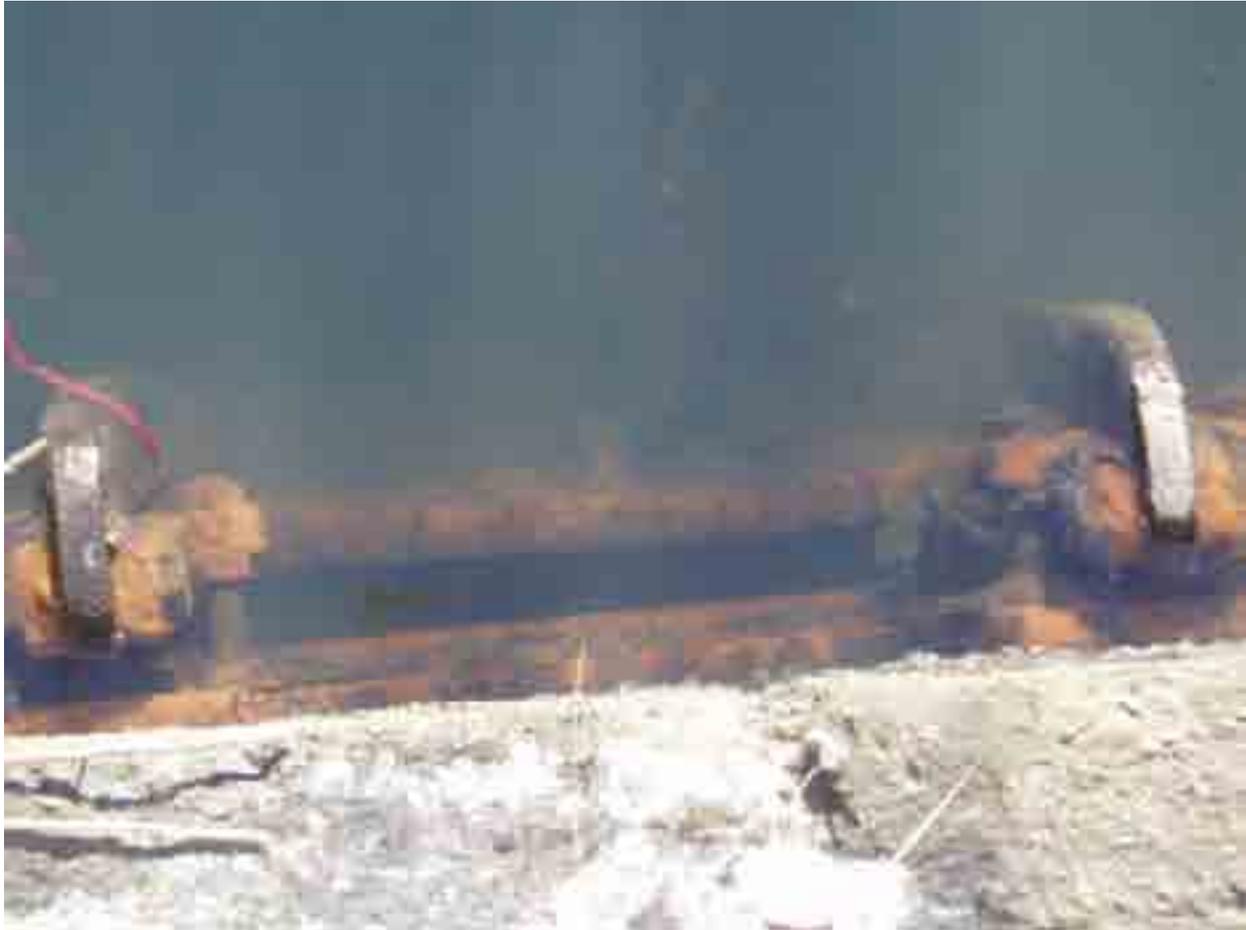
Photo 1 Description: 1 steel flap gate

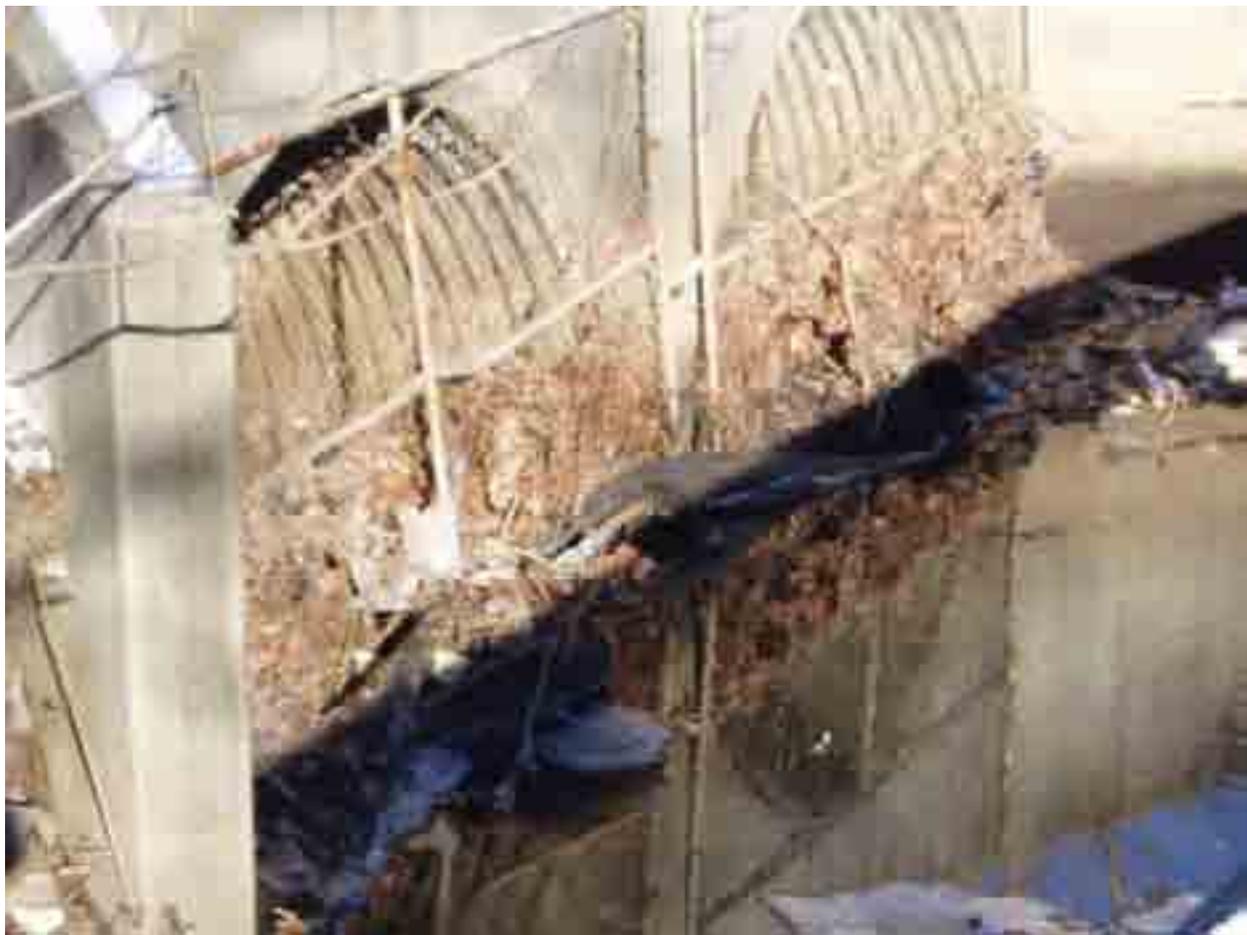
Photo 2 Description: Upstream end of the tide gates

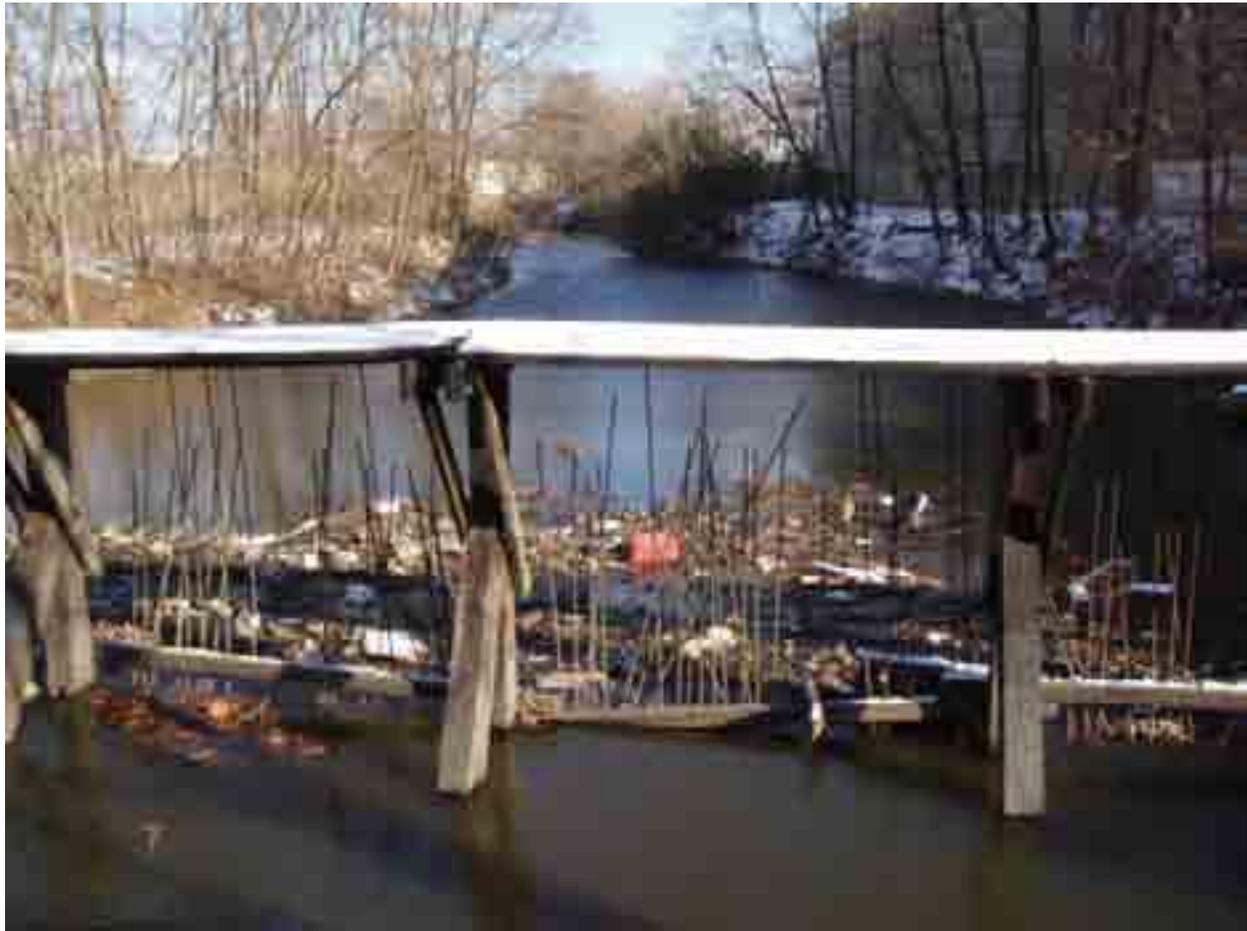
Photo 2 Description: Upstream view from tide gates and view of the trash rack system

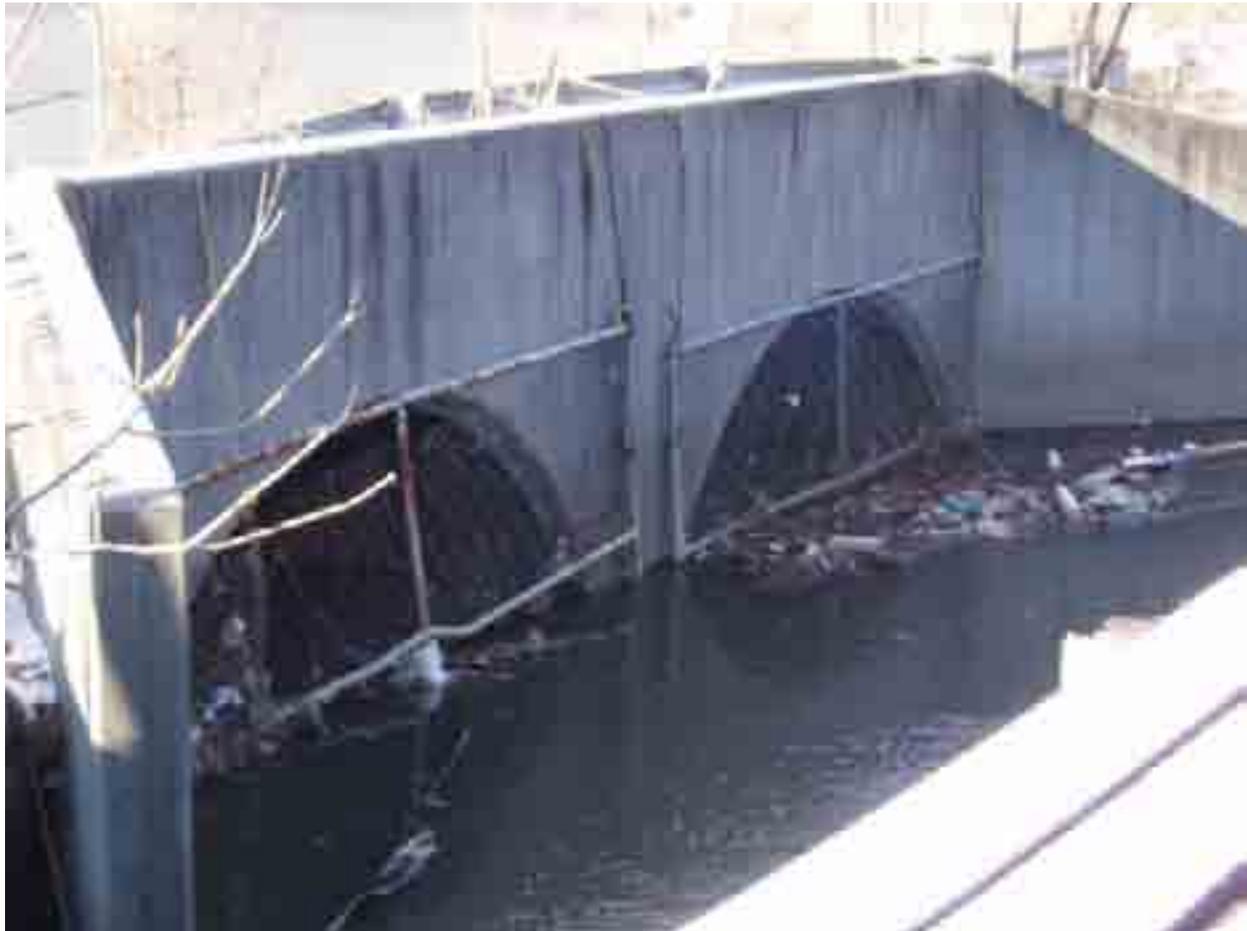
Photo 4 Description: Upstream end of the tide gates

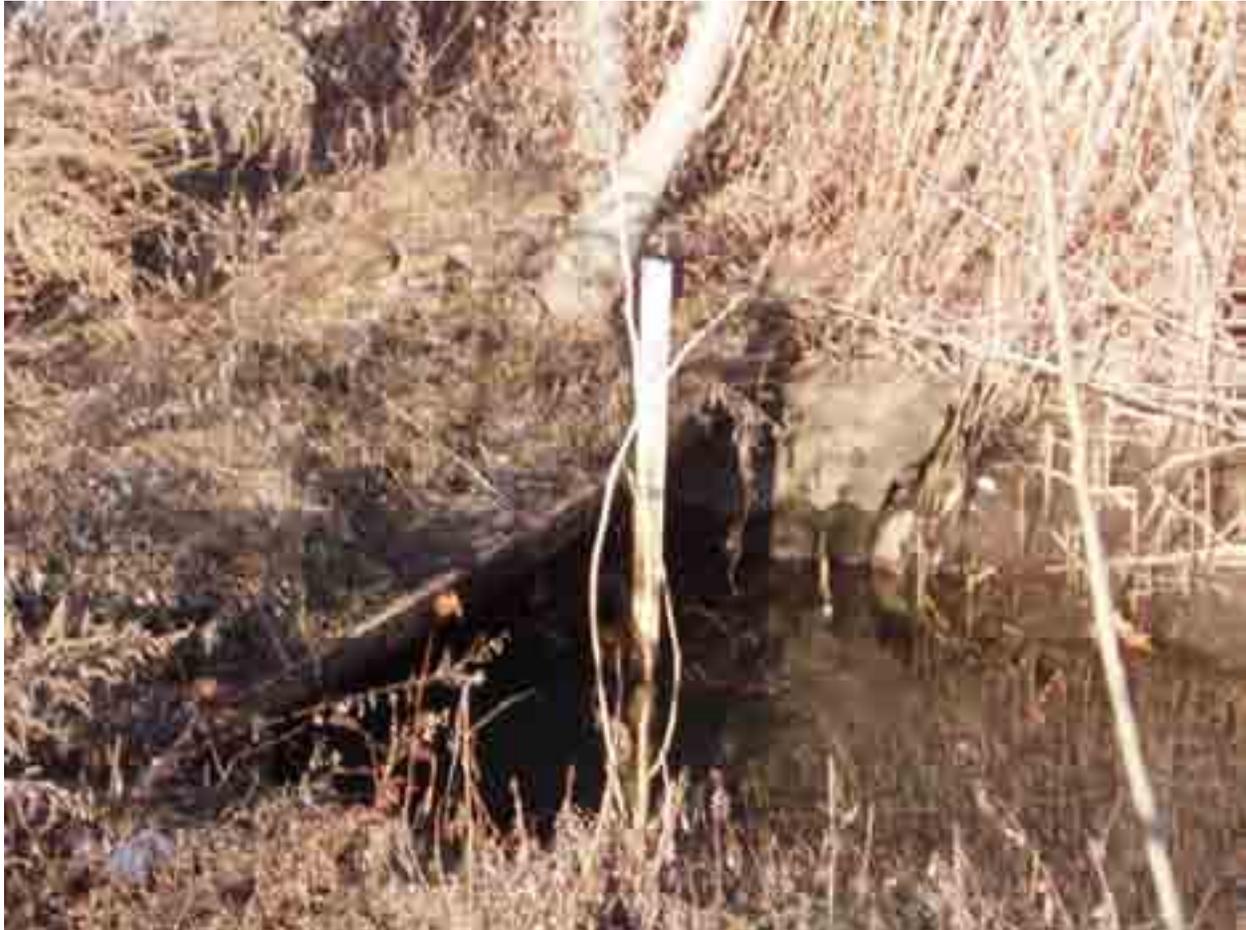
The tide gate located in the intersection of 13th Street and Division Street in Carlstadt was inspected on December 19, 2005 during low and high tide conditions. The water elevation in the vicinity of the tide gate did not change regardless of the tidal conditions. The tide gate is constantly submerged and cannot be inspected. After a detailed analysis of the topographic data and aerial mapping, NJMC has determined tidal water cannot reach the tide gate, and therefore, it is recommended that the J.P. Smith Tide Gate no longer be inspected.

Photo 1 Description: Remains of existing tide gate structure

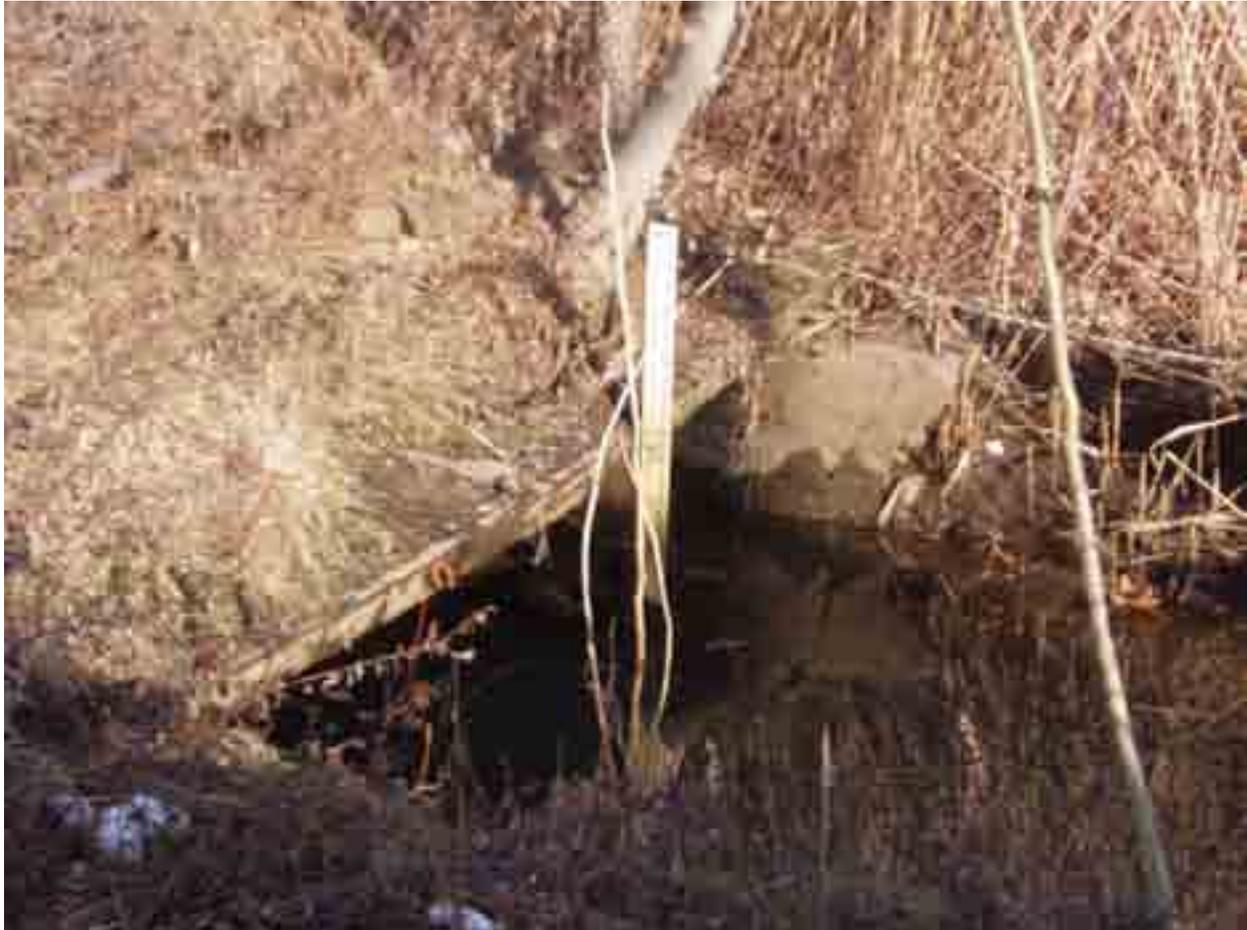
Photo 1 Description: Existing tide gate structure shown

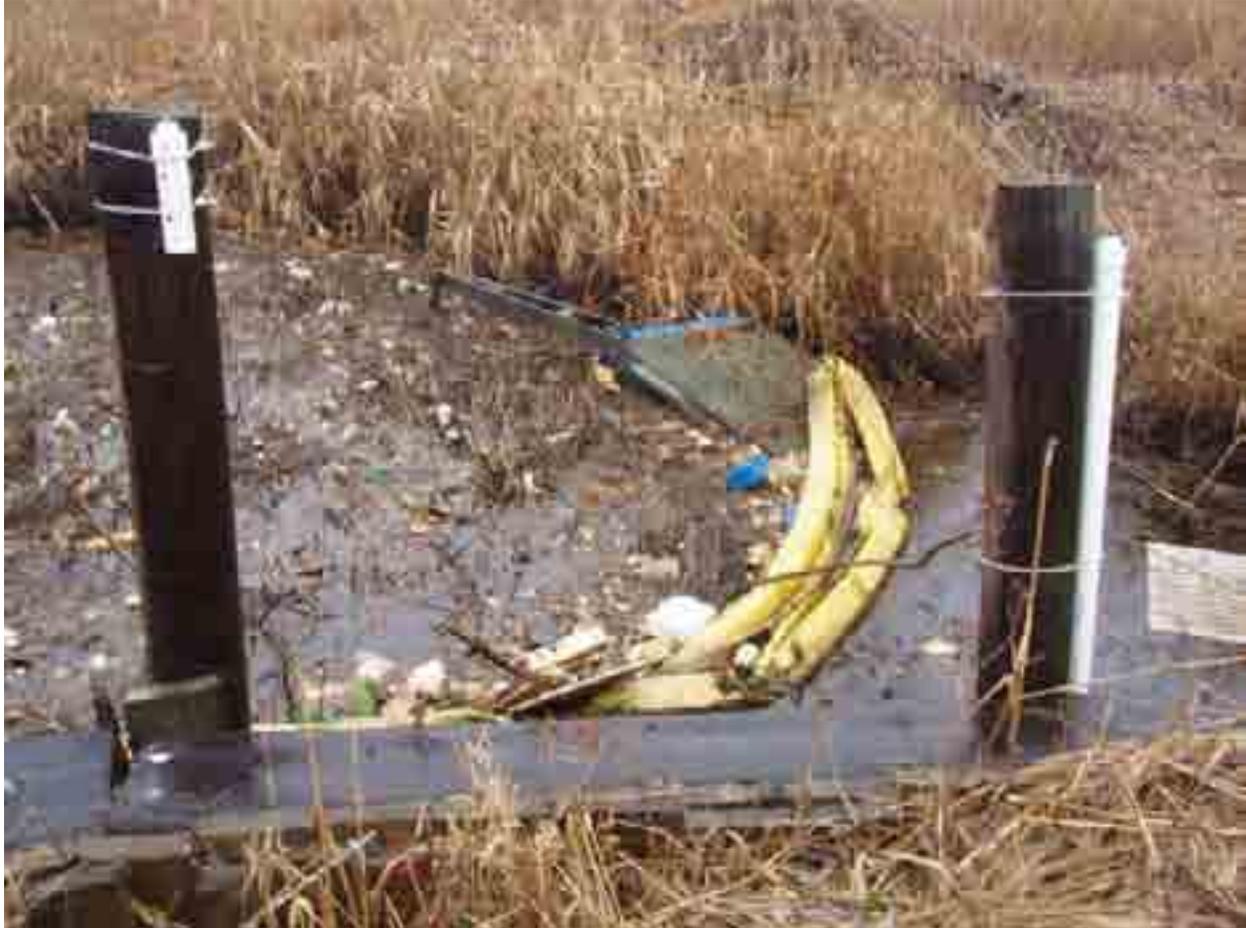
Photo 2 Description: View of trash rack on upstream side of the tide gate

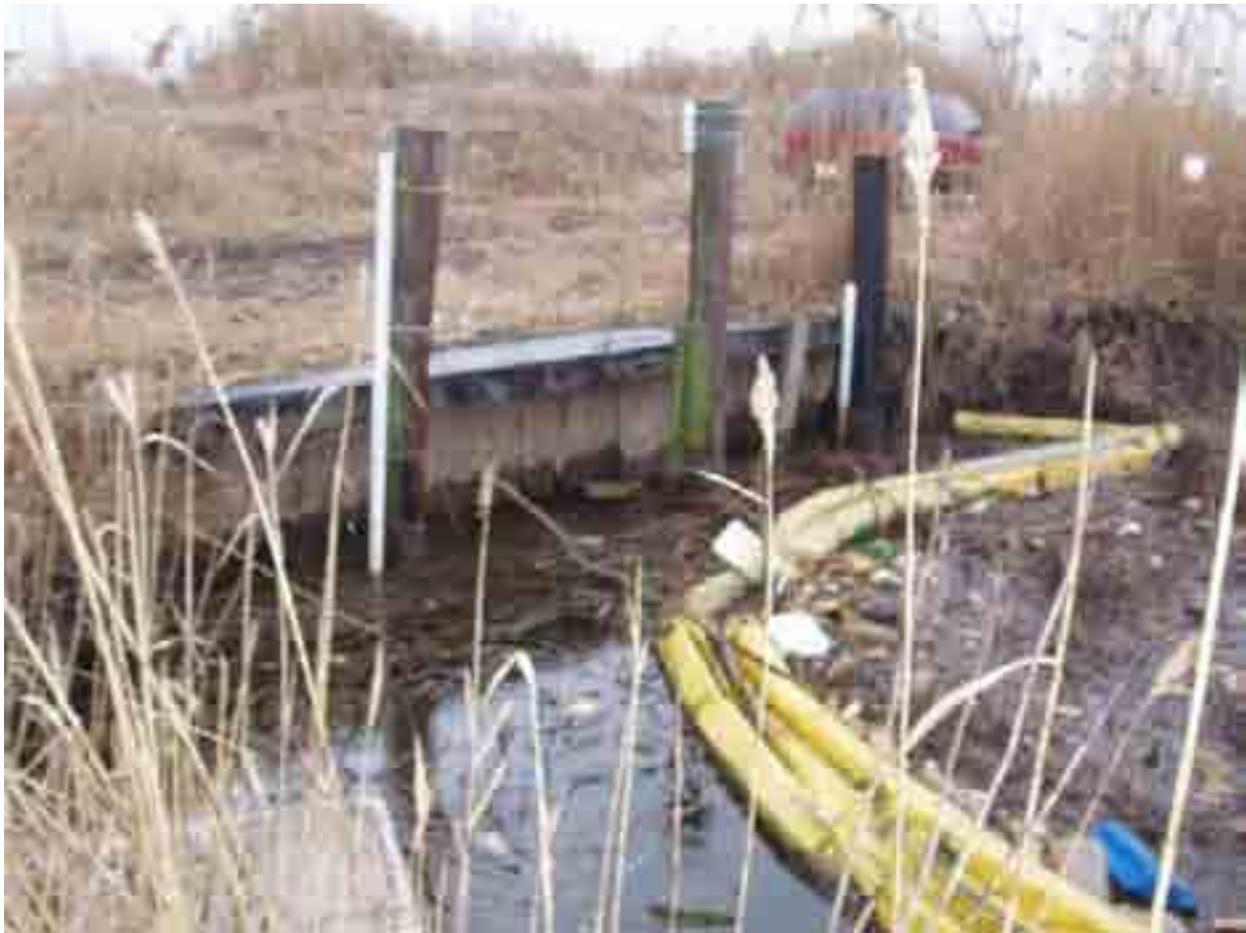
Photo 1 Description: Trash rack system

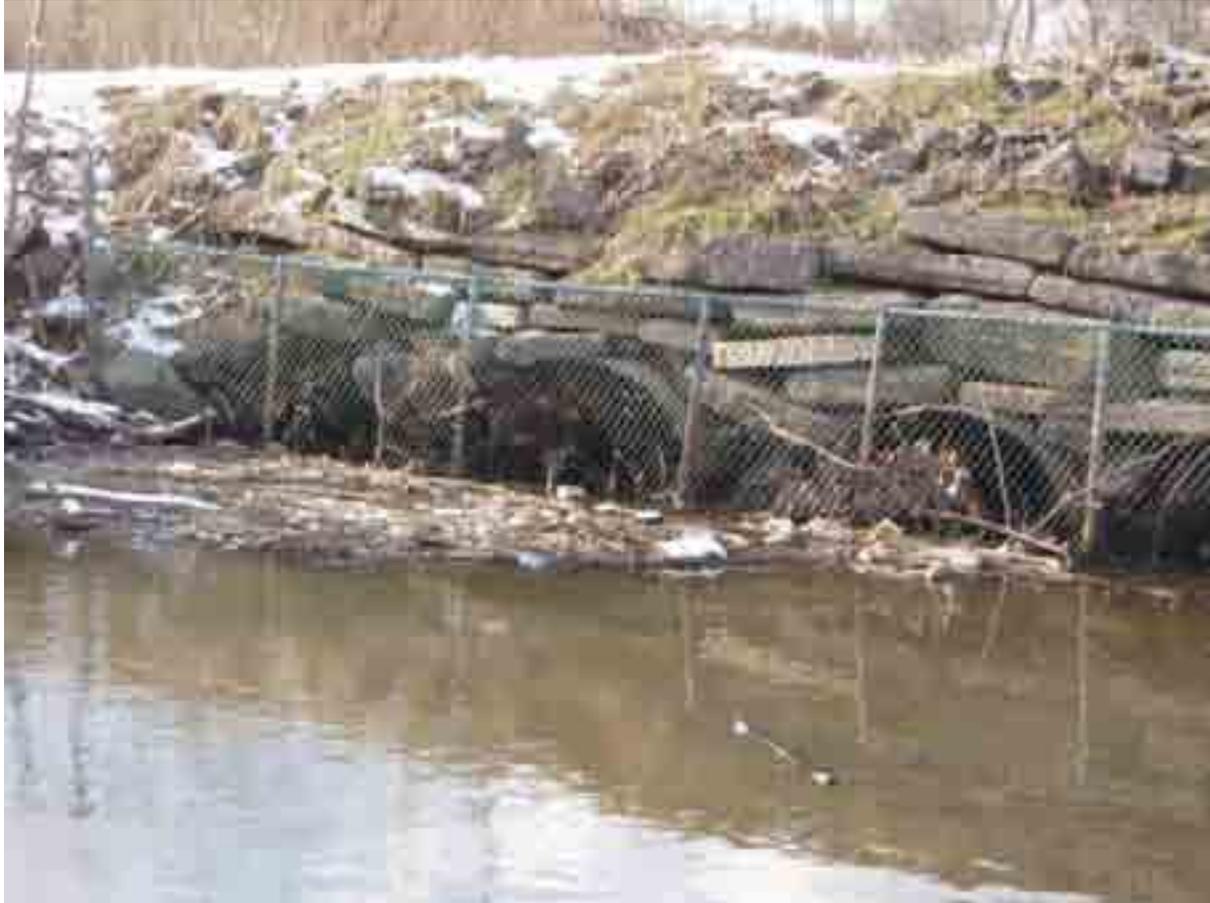
Photo 1 Description: Trash rack on upstream side of the tide gates

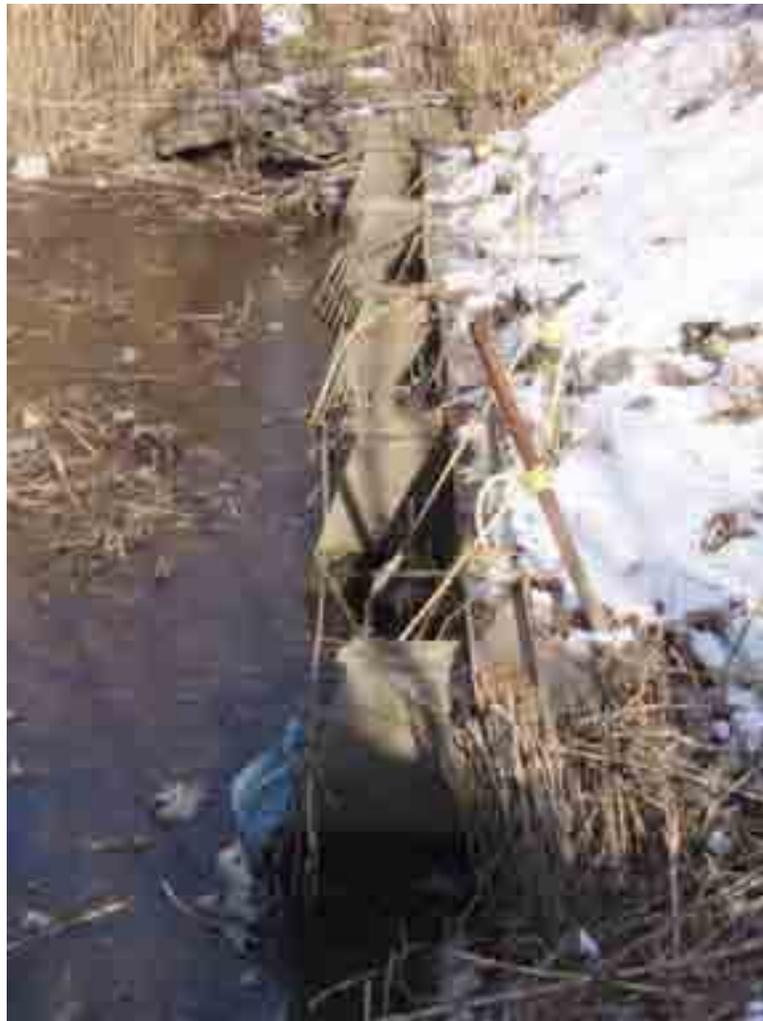
The tide gates do not seat properly during high tide conditions and a small amount of water continues to seep through and into the upstream system.

Photo 2 Description: 4 metal flap gates

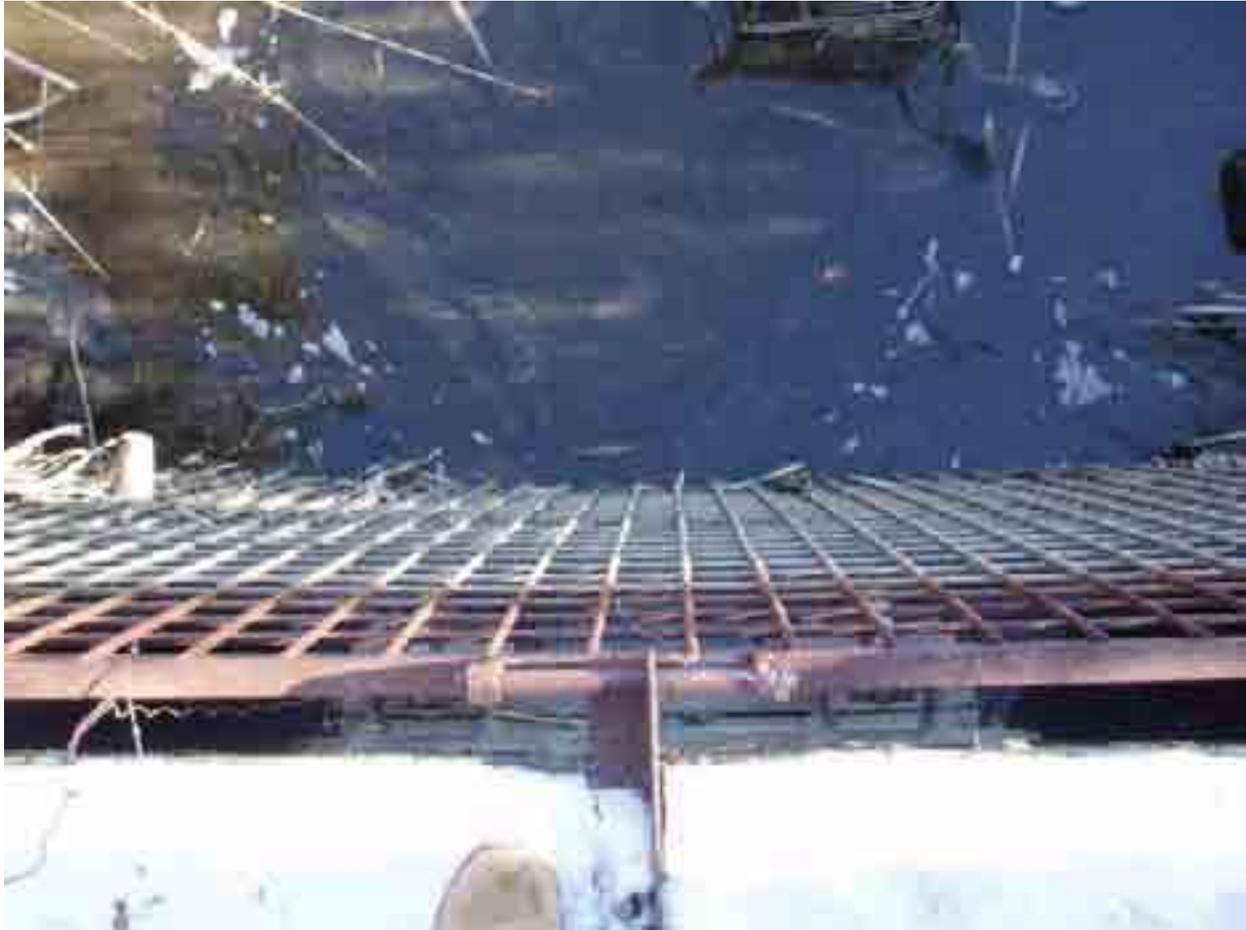
Photo 1 Description: Metal flap gate with a trash rack

The trash rack needs to be replaced.

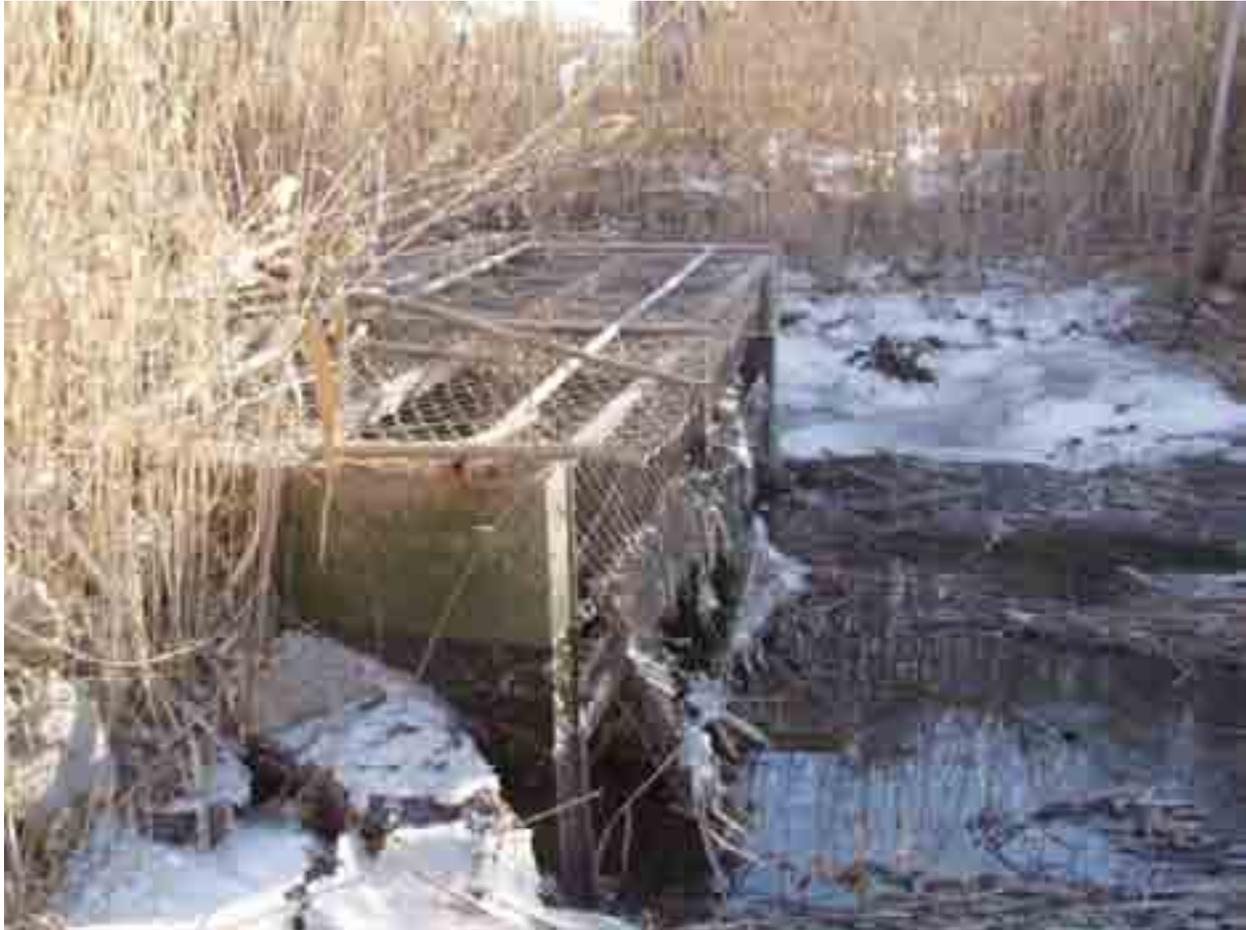
Photo 1 Description: Tide gate structure

The tide gates are not seating properly and debris has accumulated in front of the tide gates. A feasibility study will be initiated in 2006 to investigate the overall functionality of the tide gates and the need for repairs and/or replacement.

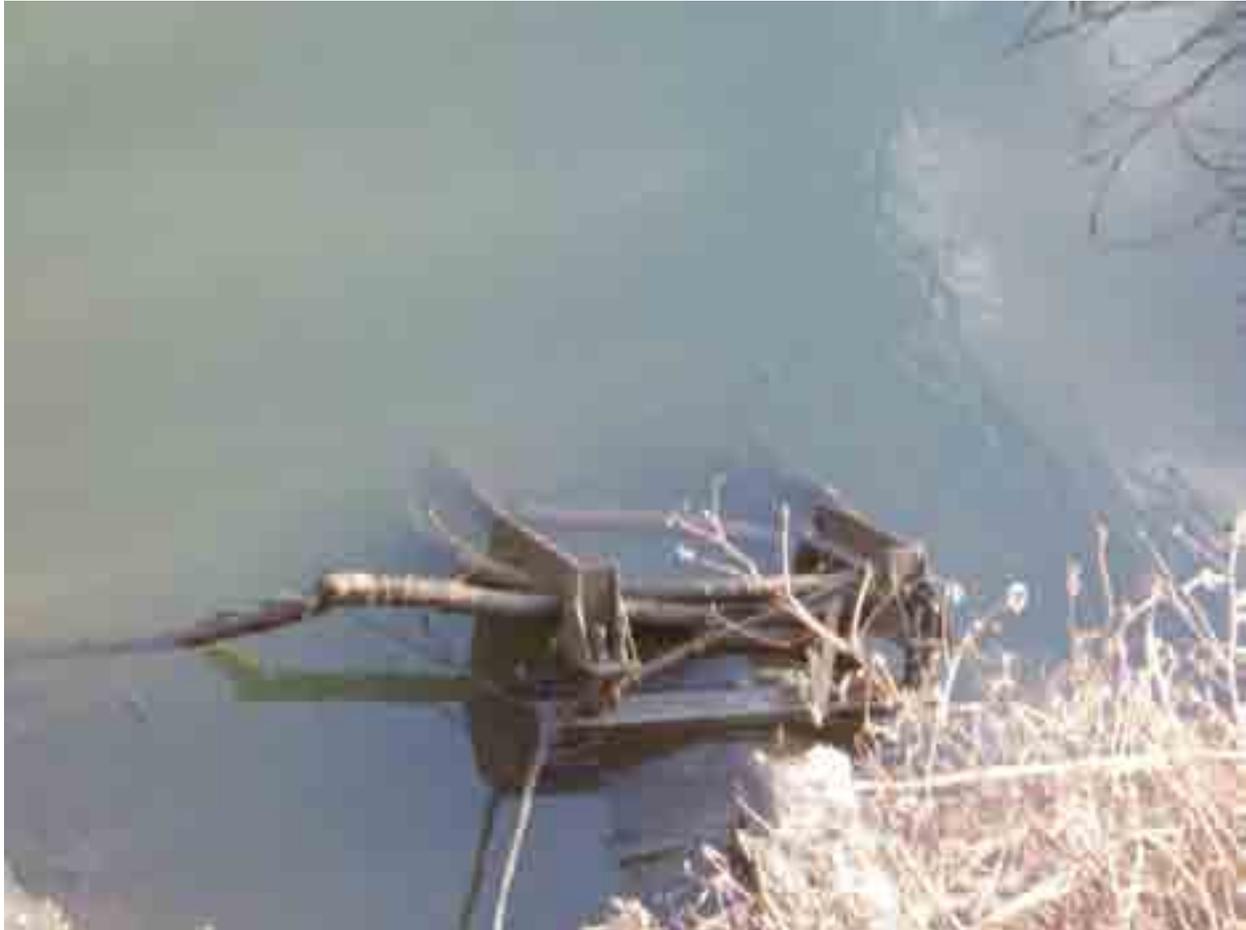
Photo 1 Description: Tide gate shown with debris keeping it from closing properly

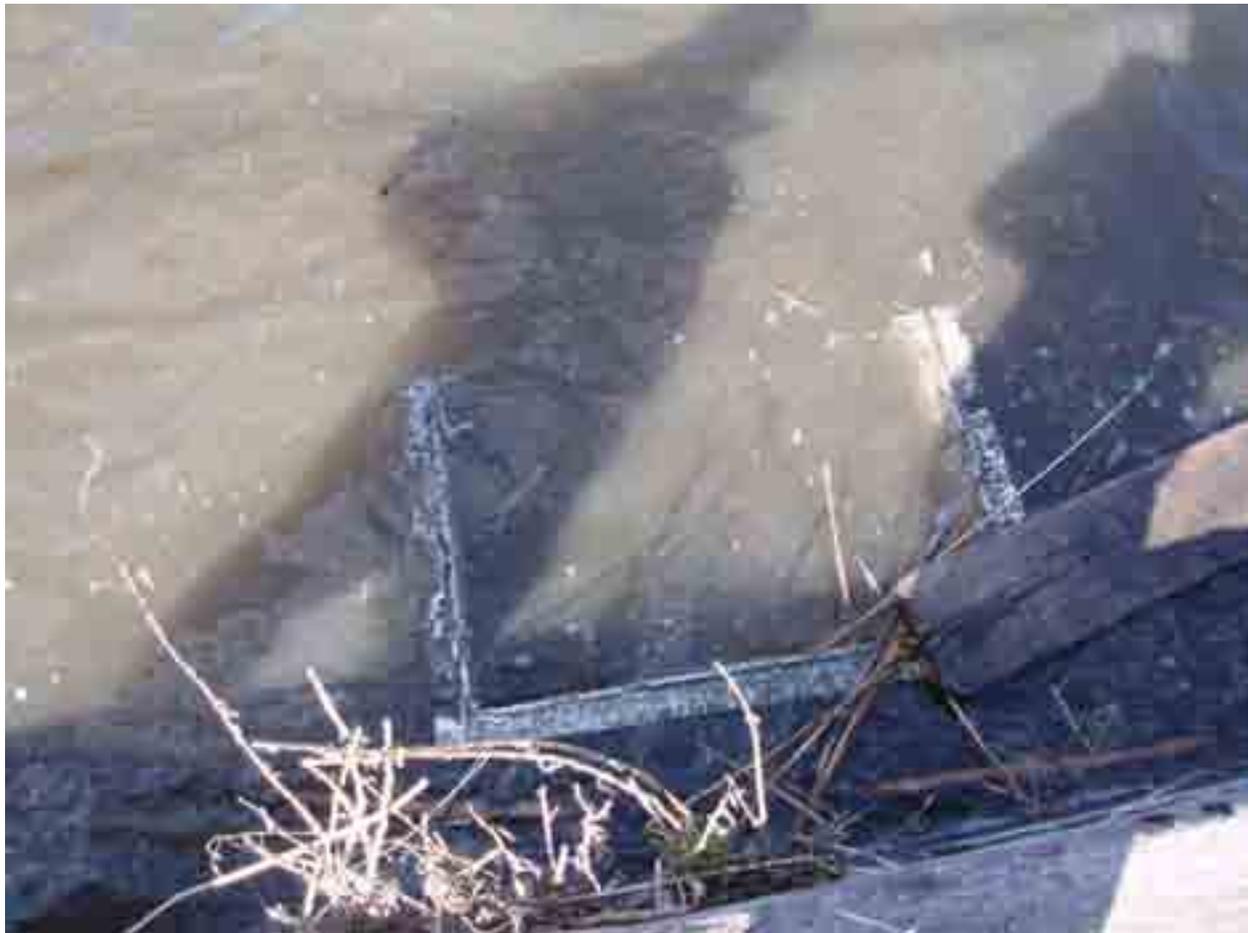
Three existing tide gates were found but the tide gate structures did not appear to be functional. The pump station is abandoned and without electrical service. Flow of water between the Hackensack River and the marsh across the dike might be seeping through the old tide gate structures. No signs or indications were found to prove the dike has been breached in the past.

Photo 1 Description: View of old tide gate structure

No interim maintenance is required because the Cayuga Dike system has deteriorated into a dilapidated state. An analysis of the Cayuga Dike system will be required to determine if the system is needed for flood control mitigation and should be repaired.

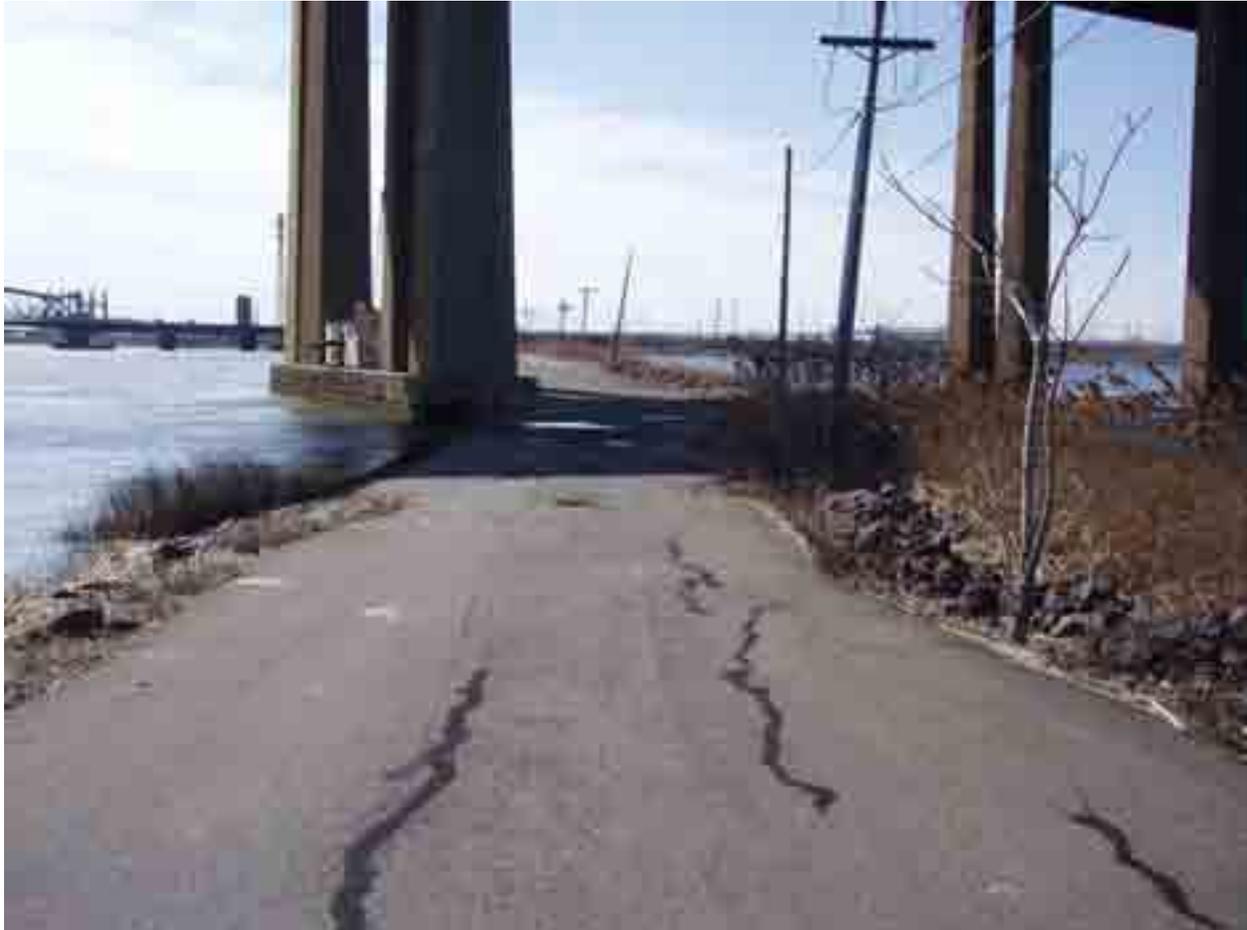
Photo 2 Description: View of pump station underneath the NJ Turnpike

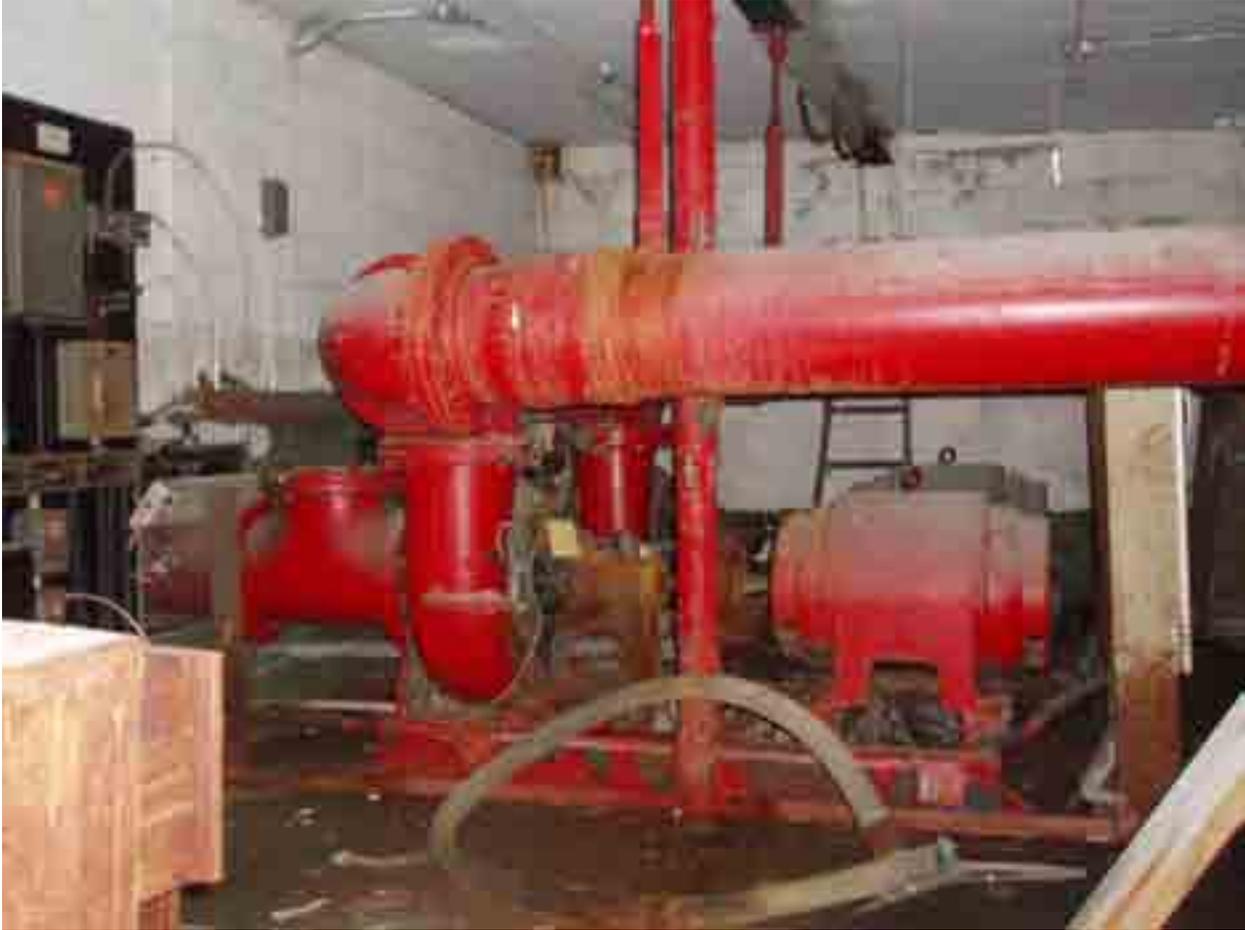
Photo 4 Description: Looking inside of the Cayuga Dike Pump Station

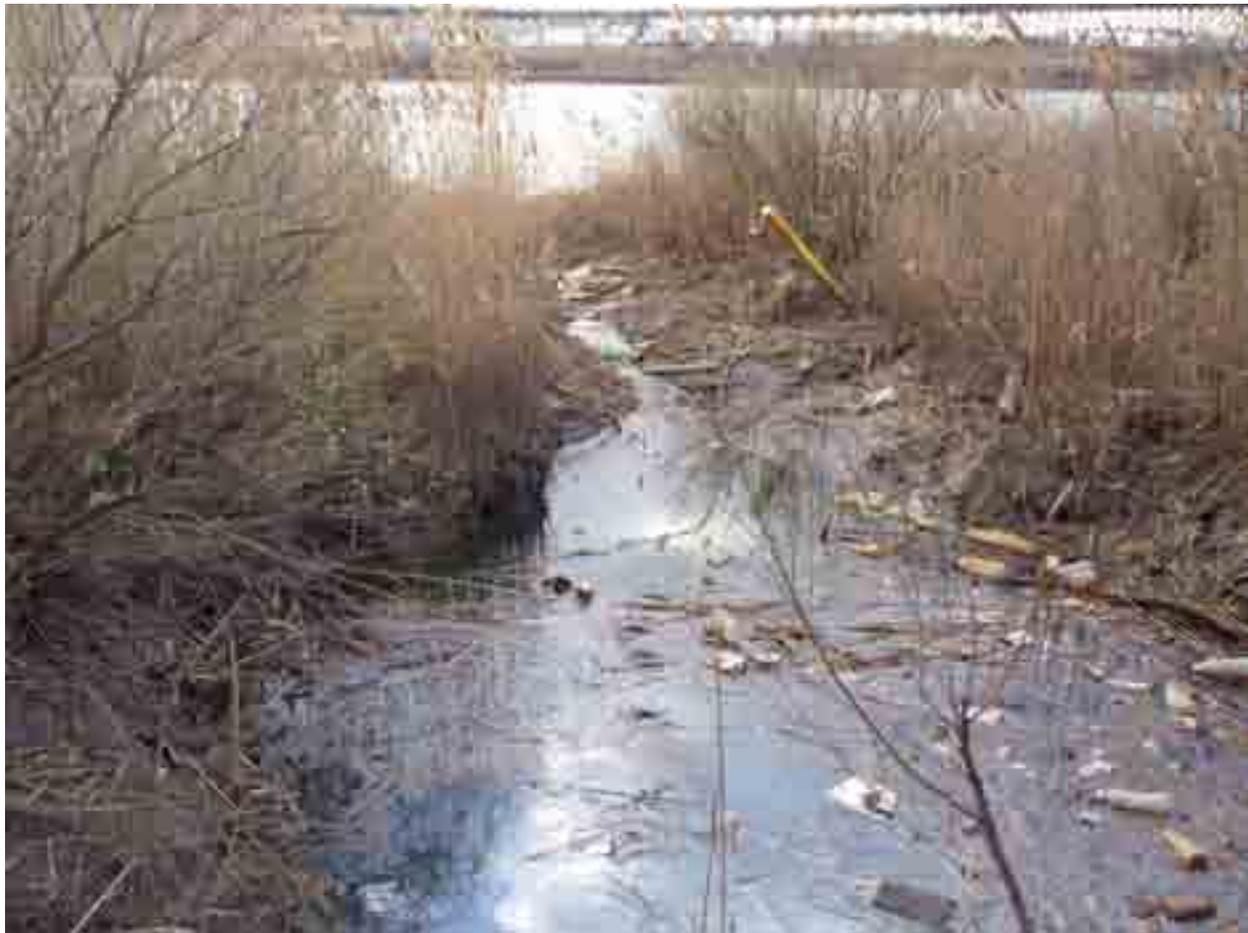
The site contains a Tideflex™ check valve; it appears to be functional during low tide conditions. The discharge channel is clogged with debris and sediment.

Photo 1 Description: Downstream view from tide gate

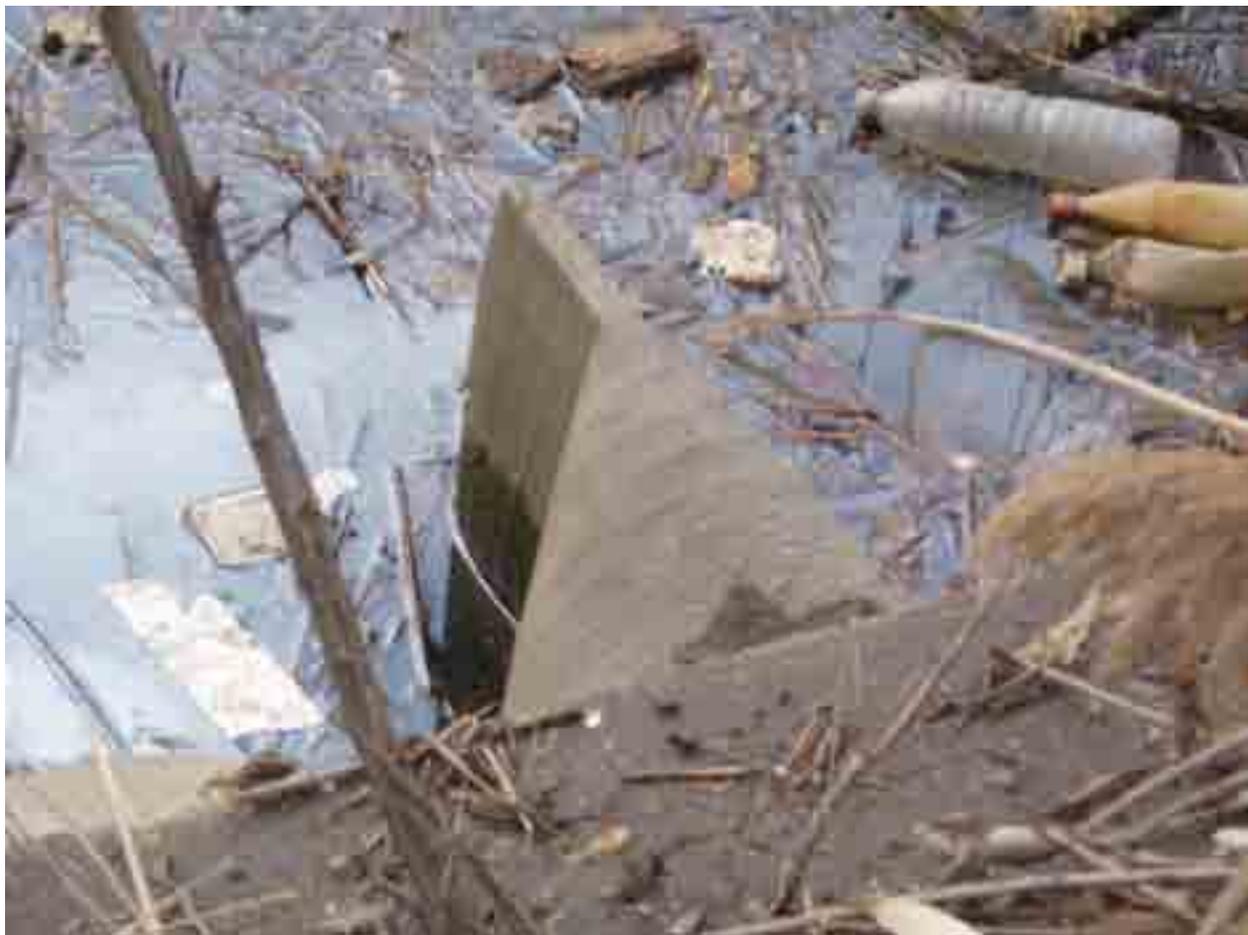
Photo 2 Description: Tideflex™ check valve

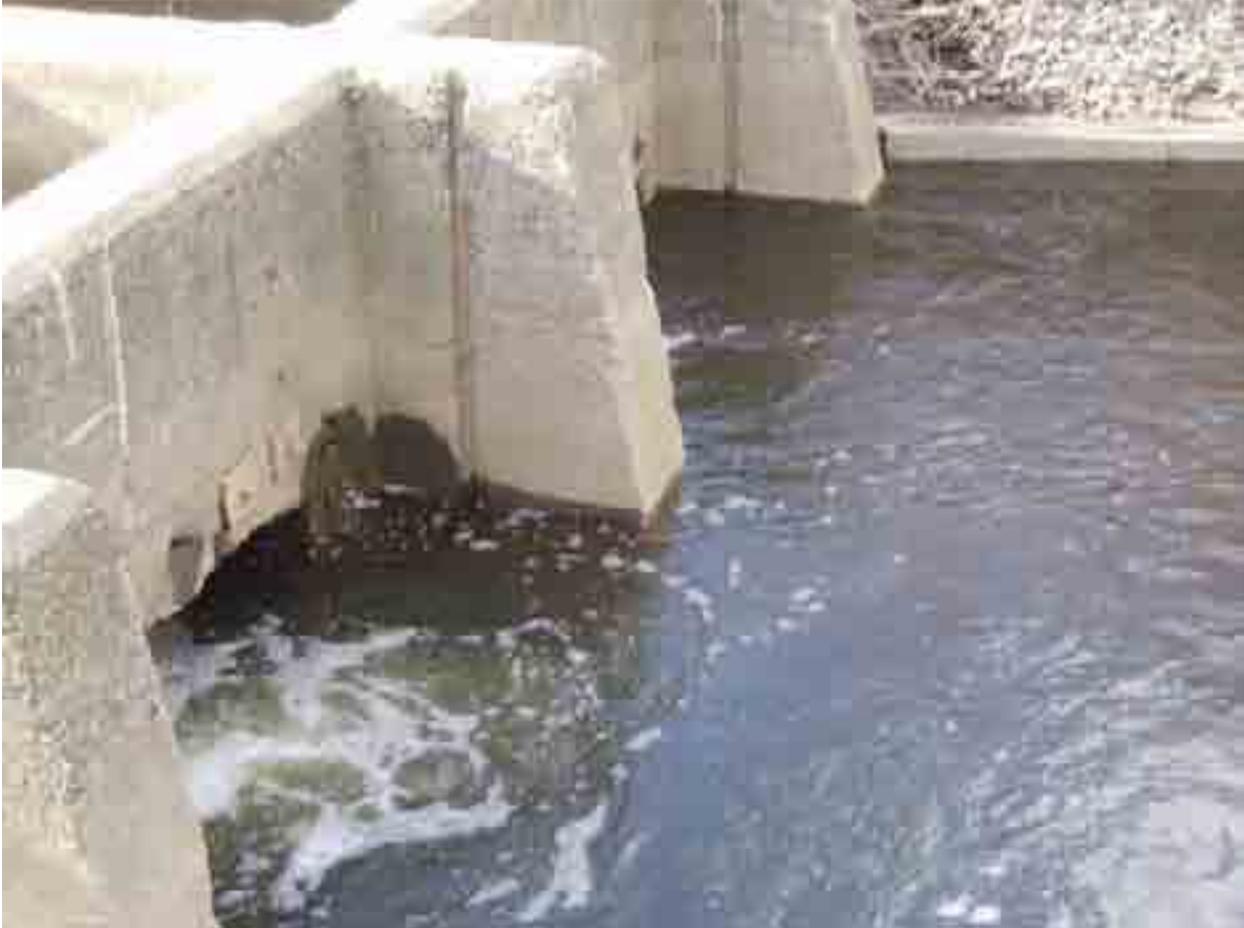
The tide gates are not functioning properly. Water is seeping through during high tide conditions due to the tide gates not seating properly.

Photo 1 Description: Notice water (bubbles) traveling upstream of the tide gate during high tide conditions
