Hackensack Meadowlands Tide Gates Inspection Report

**The New Jersey Meadowlands Commission
One DeKorte Park Plaza
Lyndhurst, New Jersey**

March 27, 2006

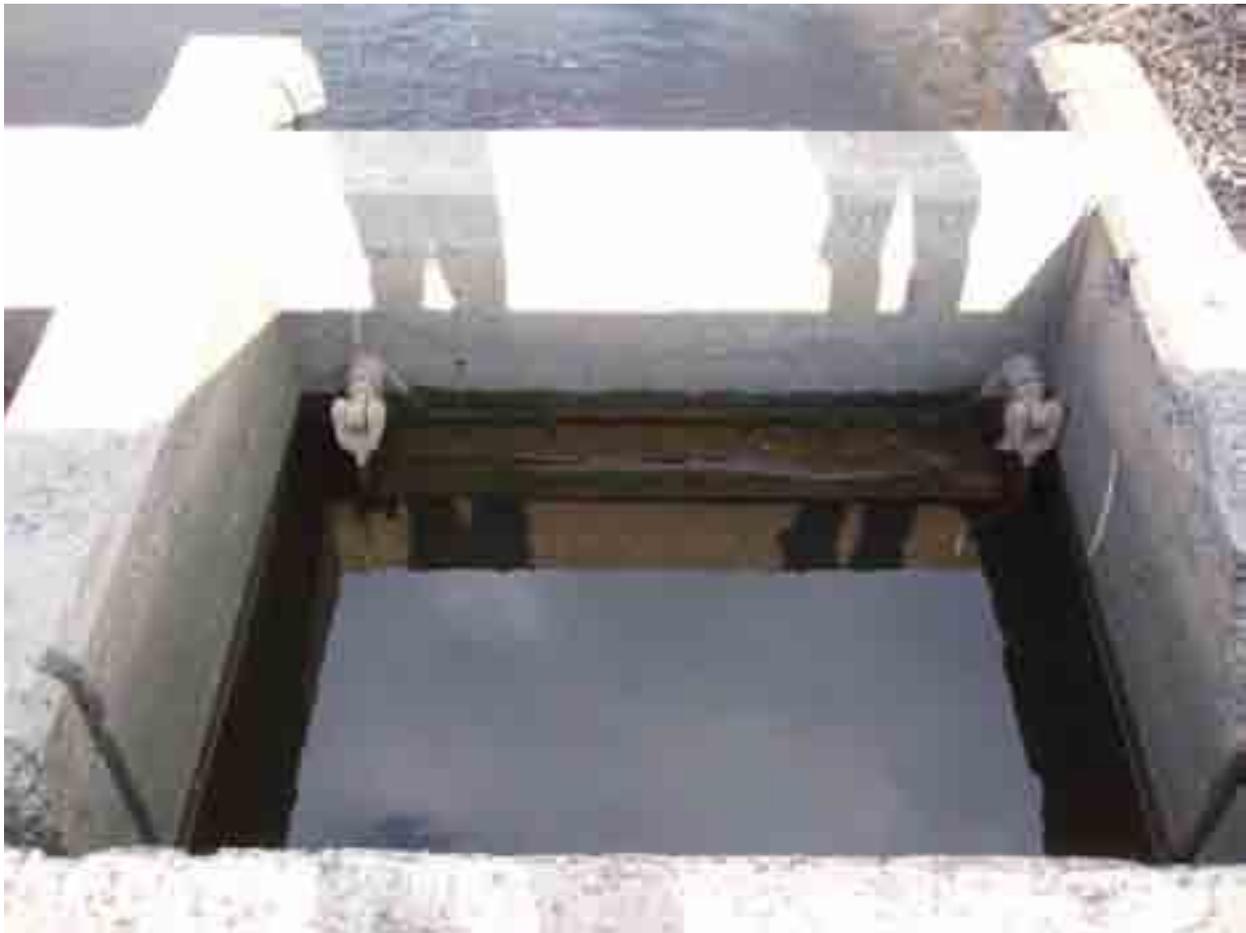
The tide gates are not functioning properly. Water is seeping through during high tide conditions due to the tide gates not seating properly.

Photo 2 Description: One of two metal flap gates

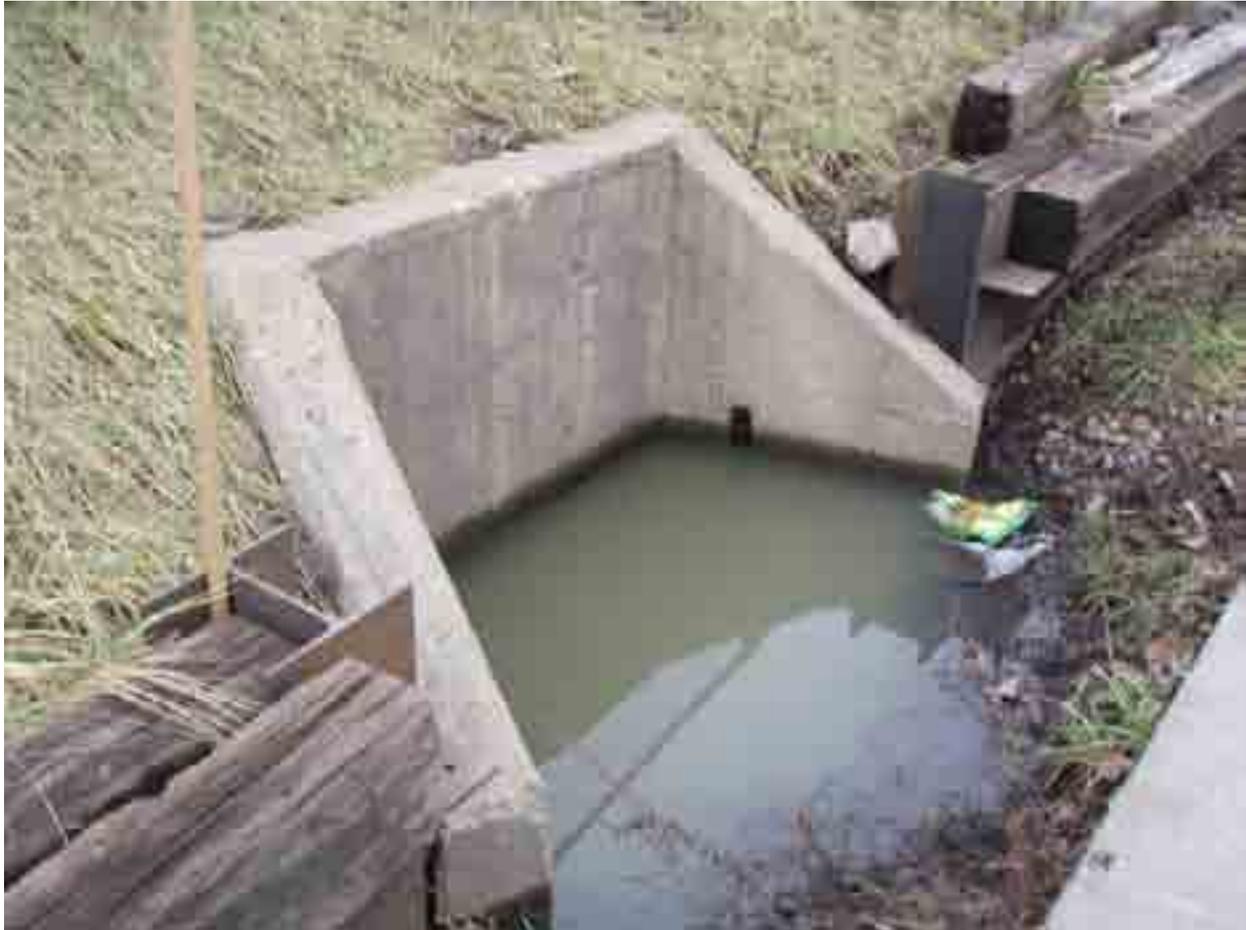
Headwalls were found during the inspection. The tide gate can not be found due to stagnant water around the structures.

Photo 1 Description: Location of possible submersed tide gate

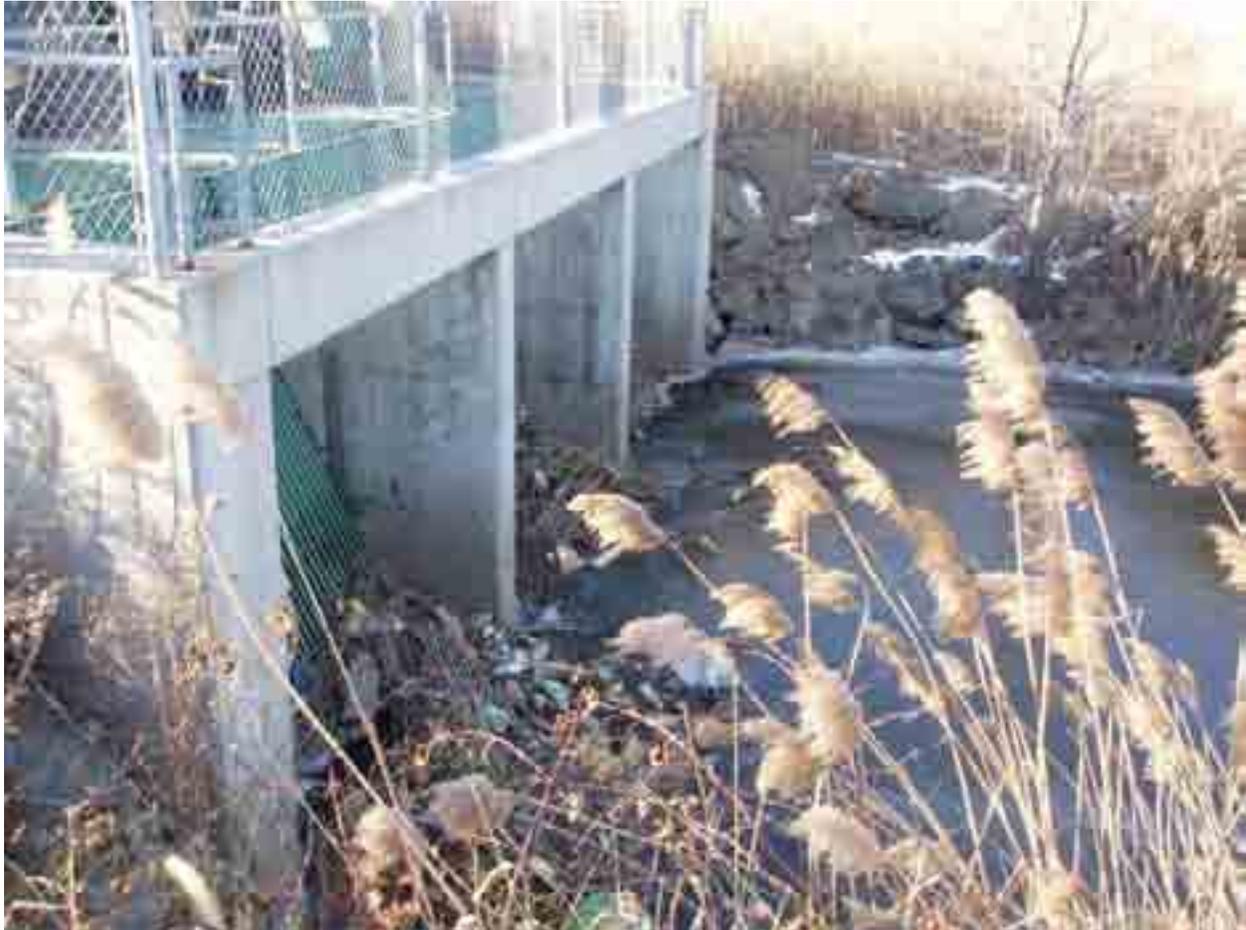
Photo 1 Description: View of trash racks at in-take structure

Drainage ditch needs to be cleaned out. The gates need cleaning and repairs made. Gates are timber and in the future may need to be replaced. A trash rack system also needs to be installed to keep debris out of the tide gates. The metal access walkway appears to be deteriorating and needs to be cleaned and repainted.

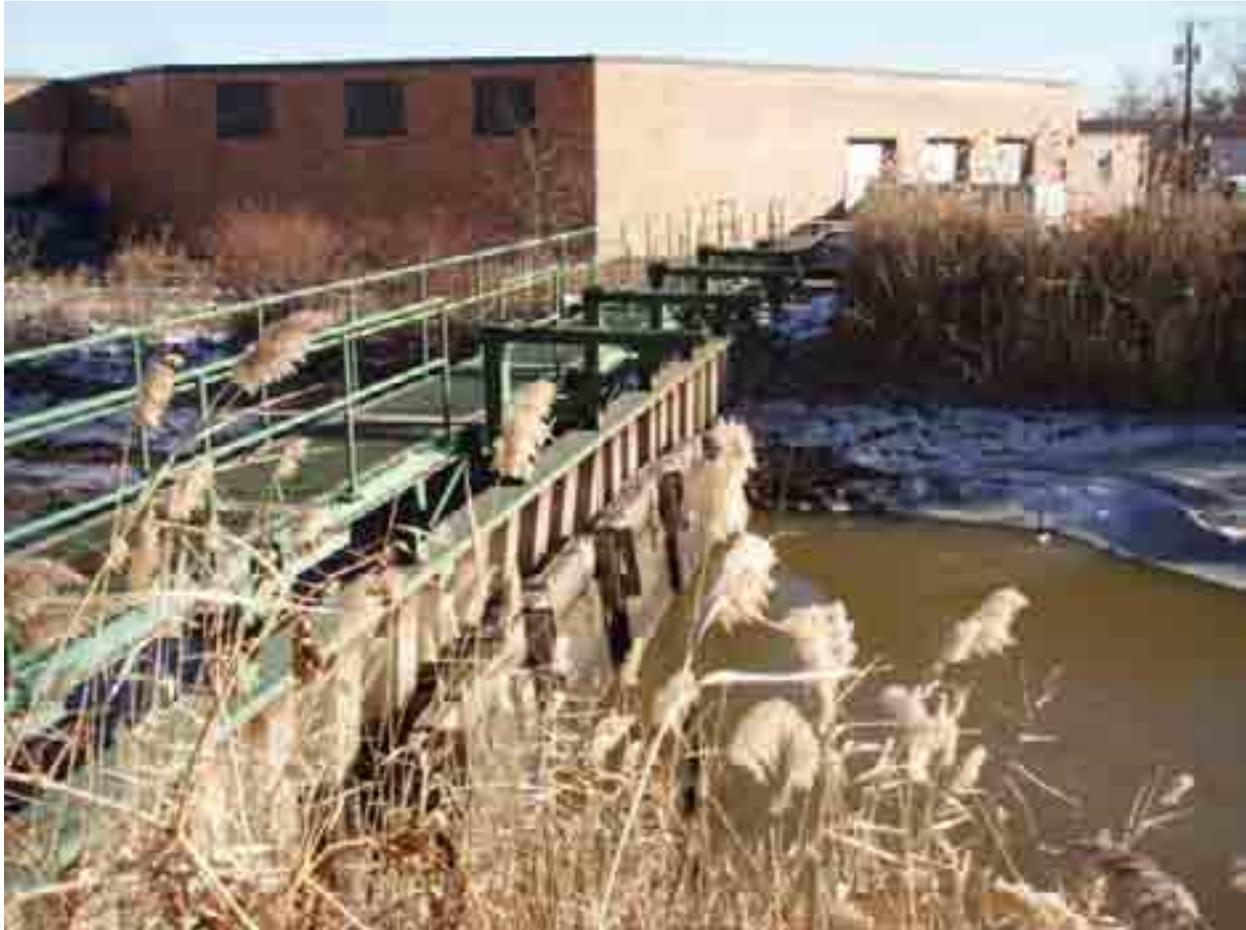
Photo 1 Description: 4 timber tide gates

Tide gates are not seating properly. Maintenance needs to be performed on the gates. The gates foundation is also being undermined

Routine cleaning will help keep the gates operating properly. Gates may need to be replaced with metal flap gates in the future, currently they are timber. A trash rack system would also help to alleviate the collection of debris.

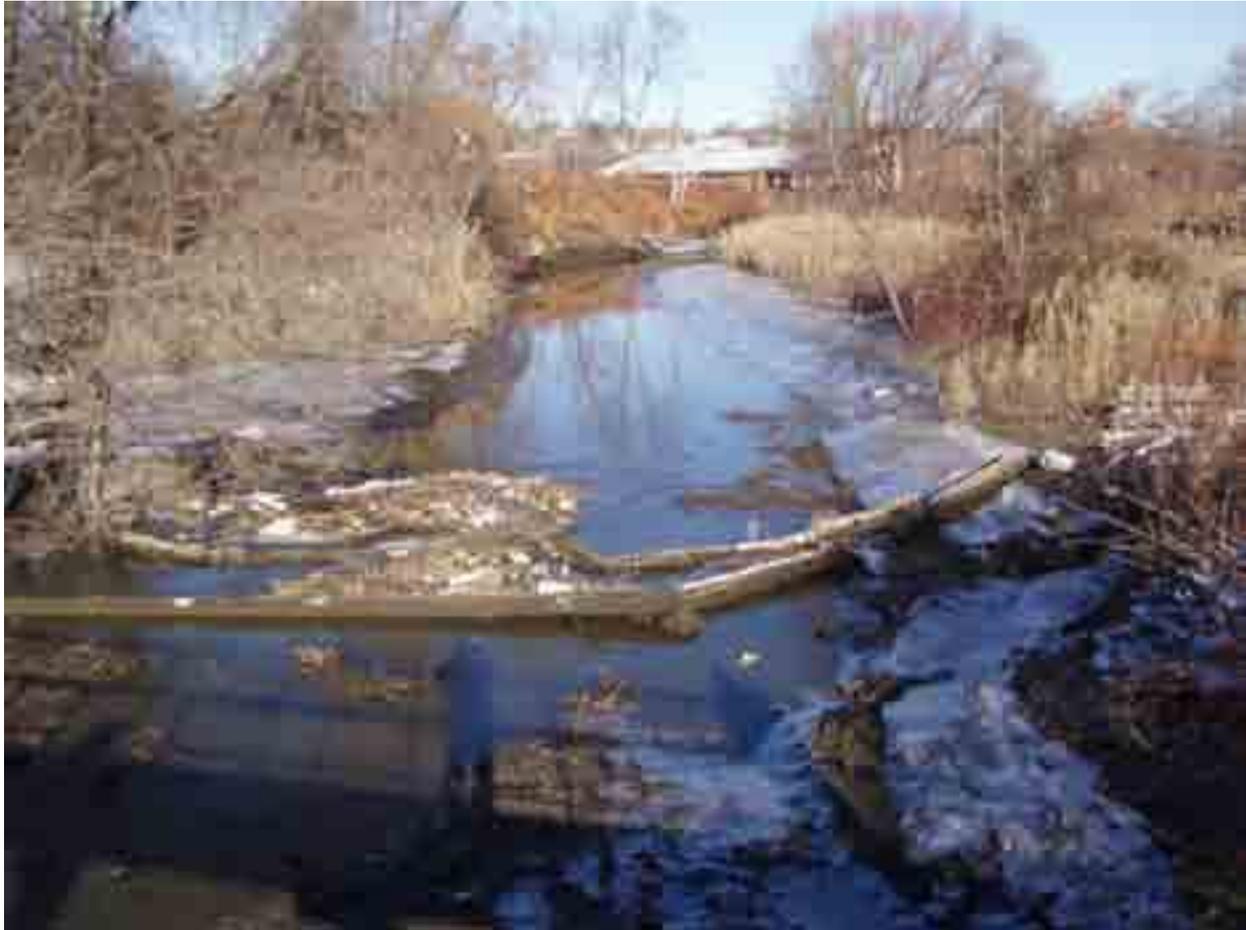
Photo 2 Description: Upstream view from the gates

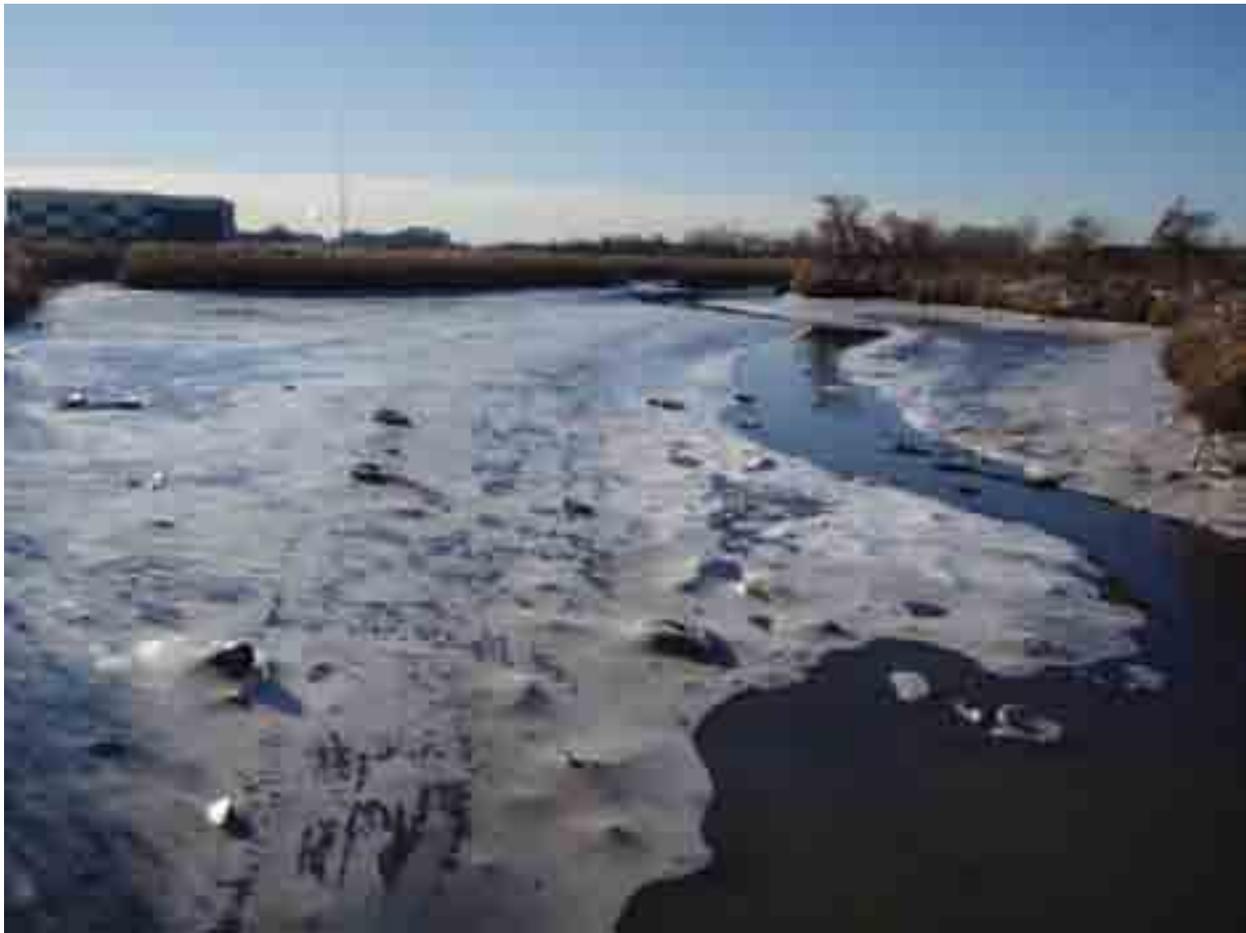
Photo 3 Description: Downstream view from the gates

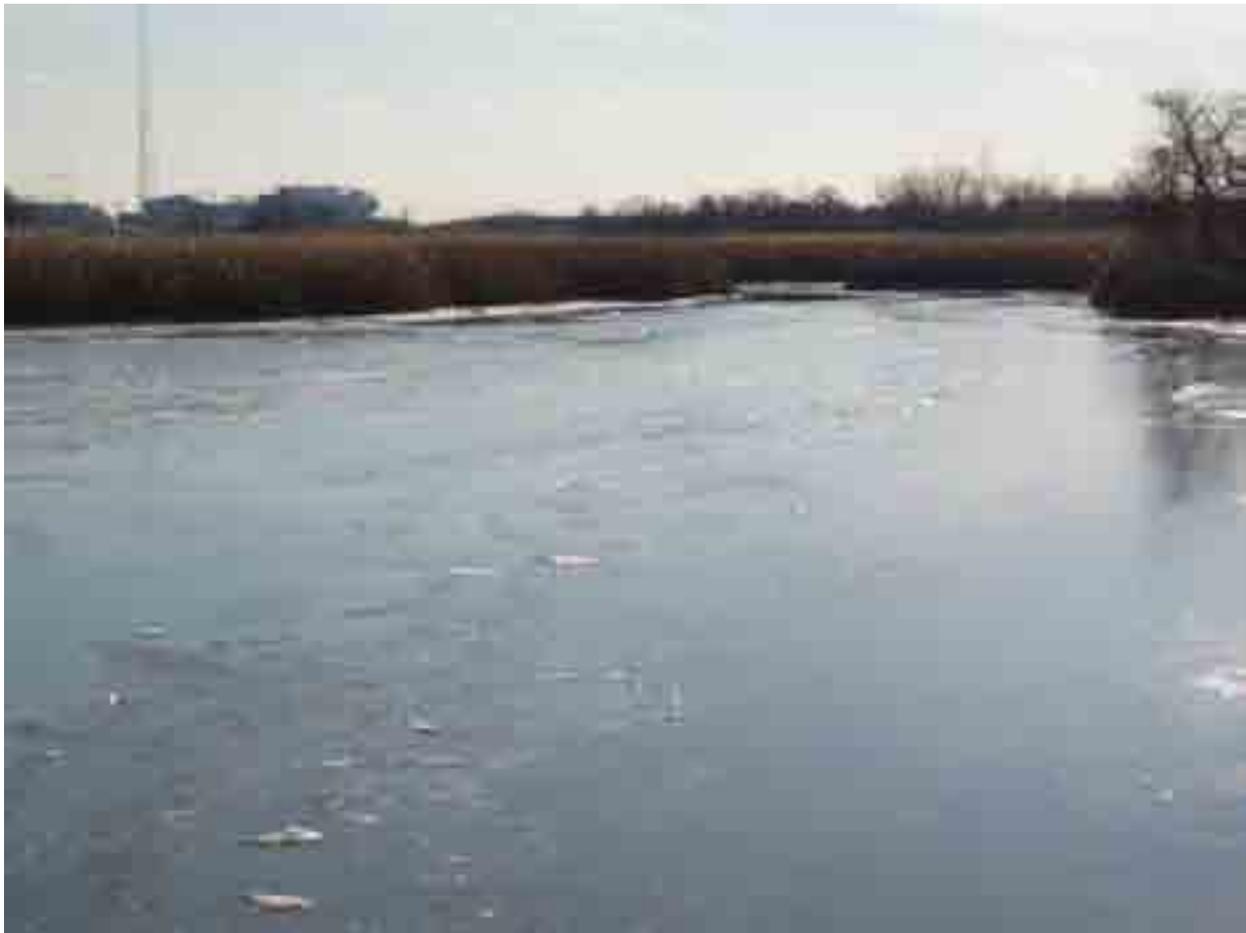
Photo 3 Description: Downstream view from the tide gates

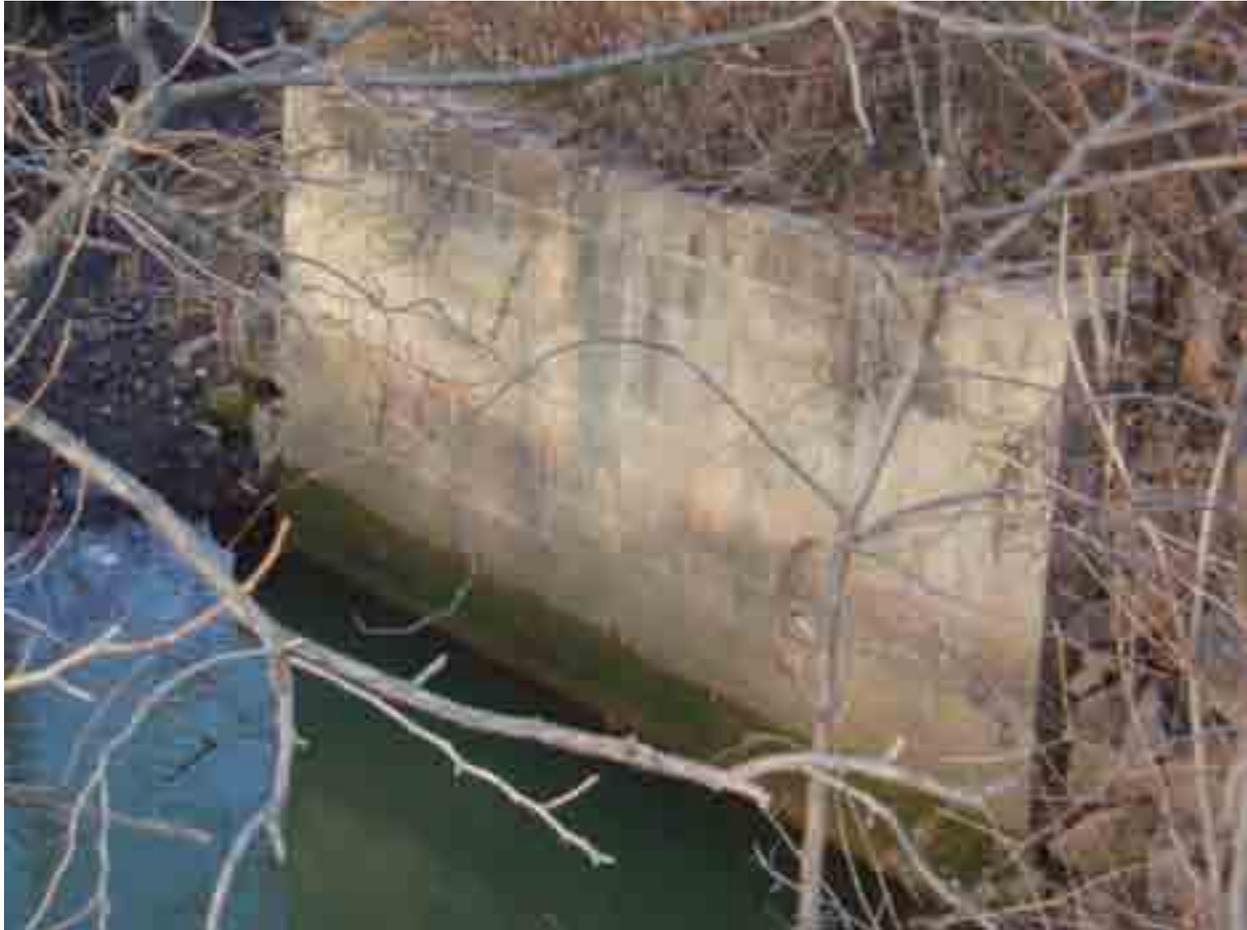
Photo 1 Description: Location of removed tide gates

Tide gate was removed according to a microstation drawing file from Army Corps of Engineers. This information could not be verified during high tide conditions.

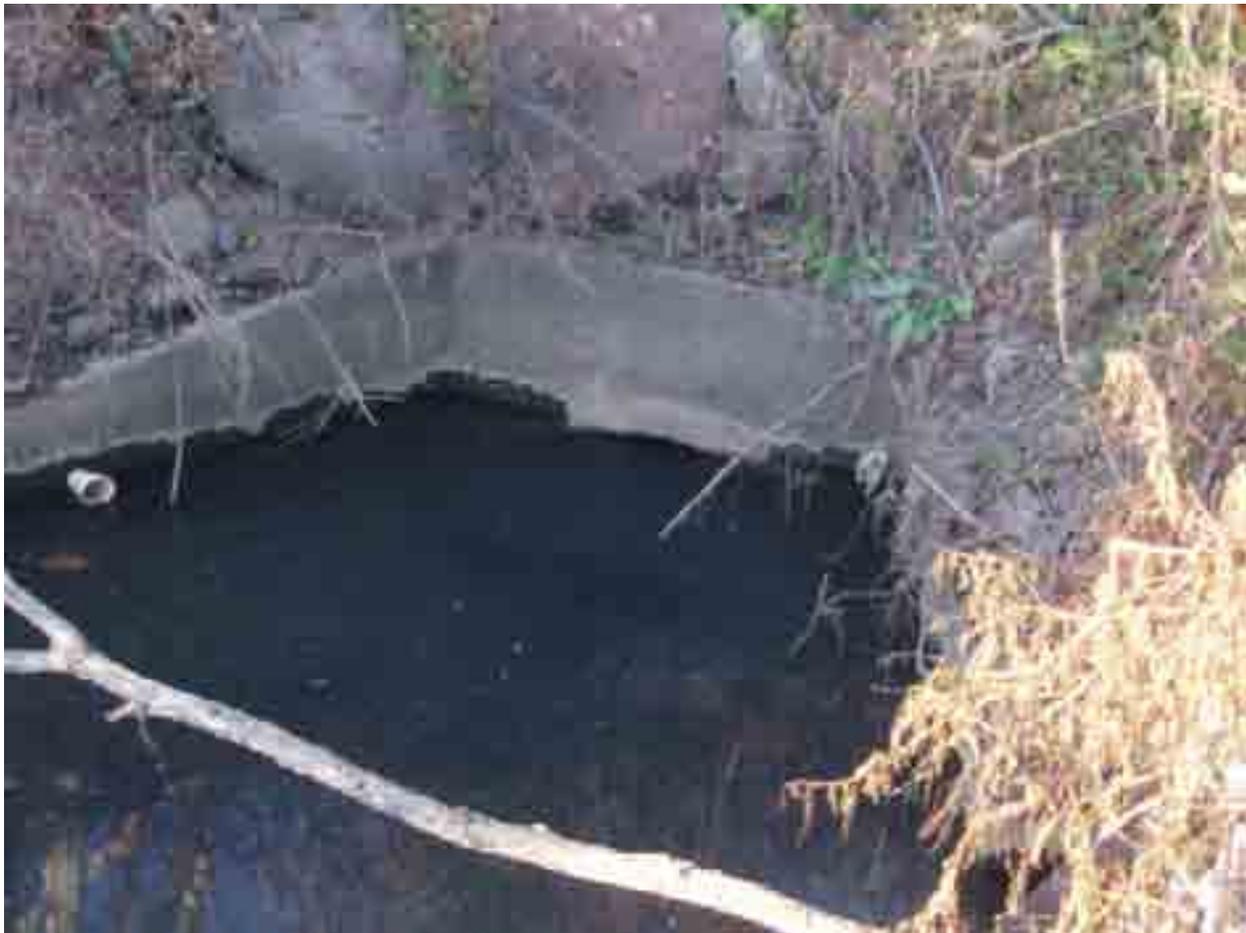
Photo 1 Description: Tide gate structure

The system is in excellent condition.

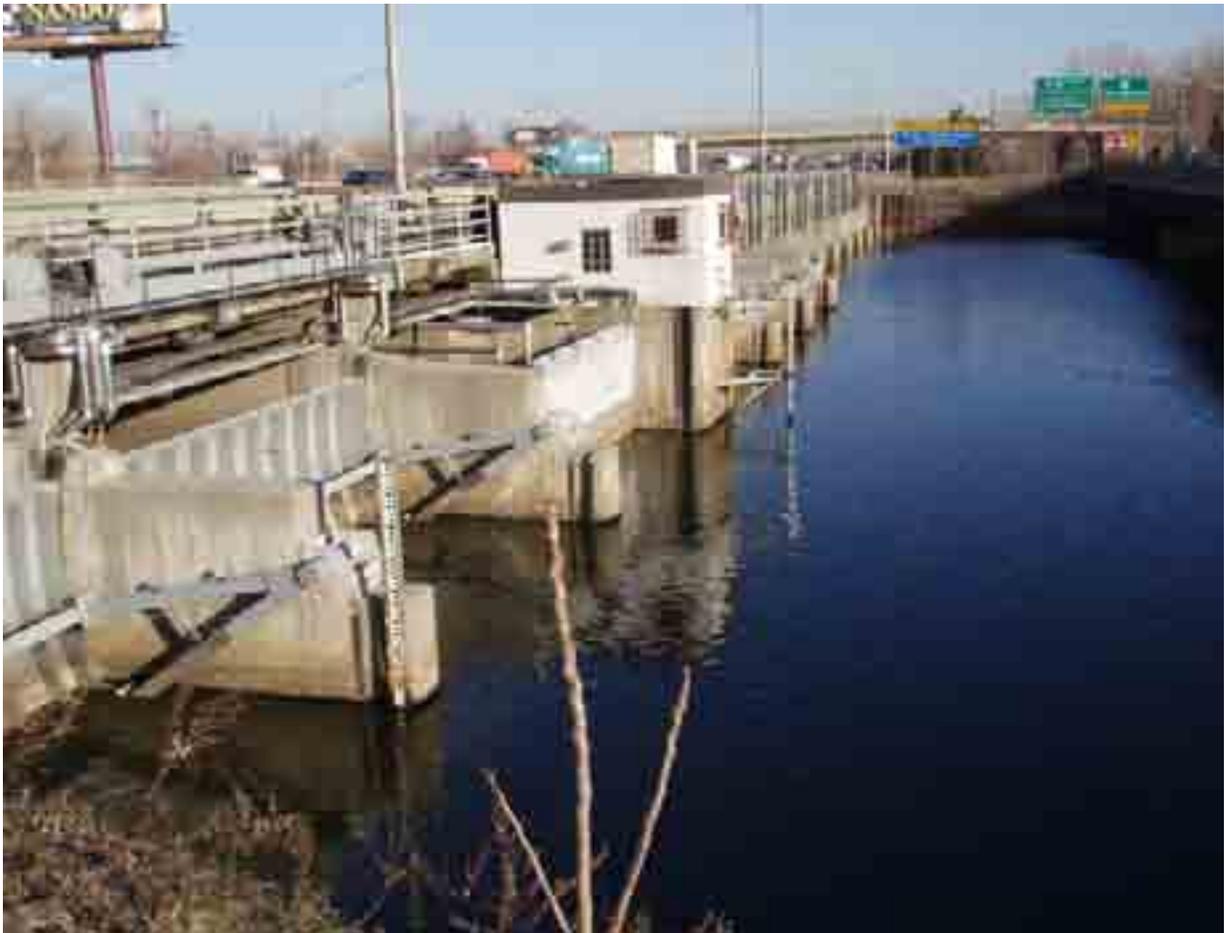
Photo 2 Description: Overview of entire structure

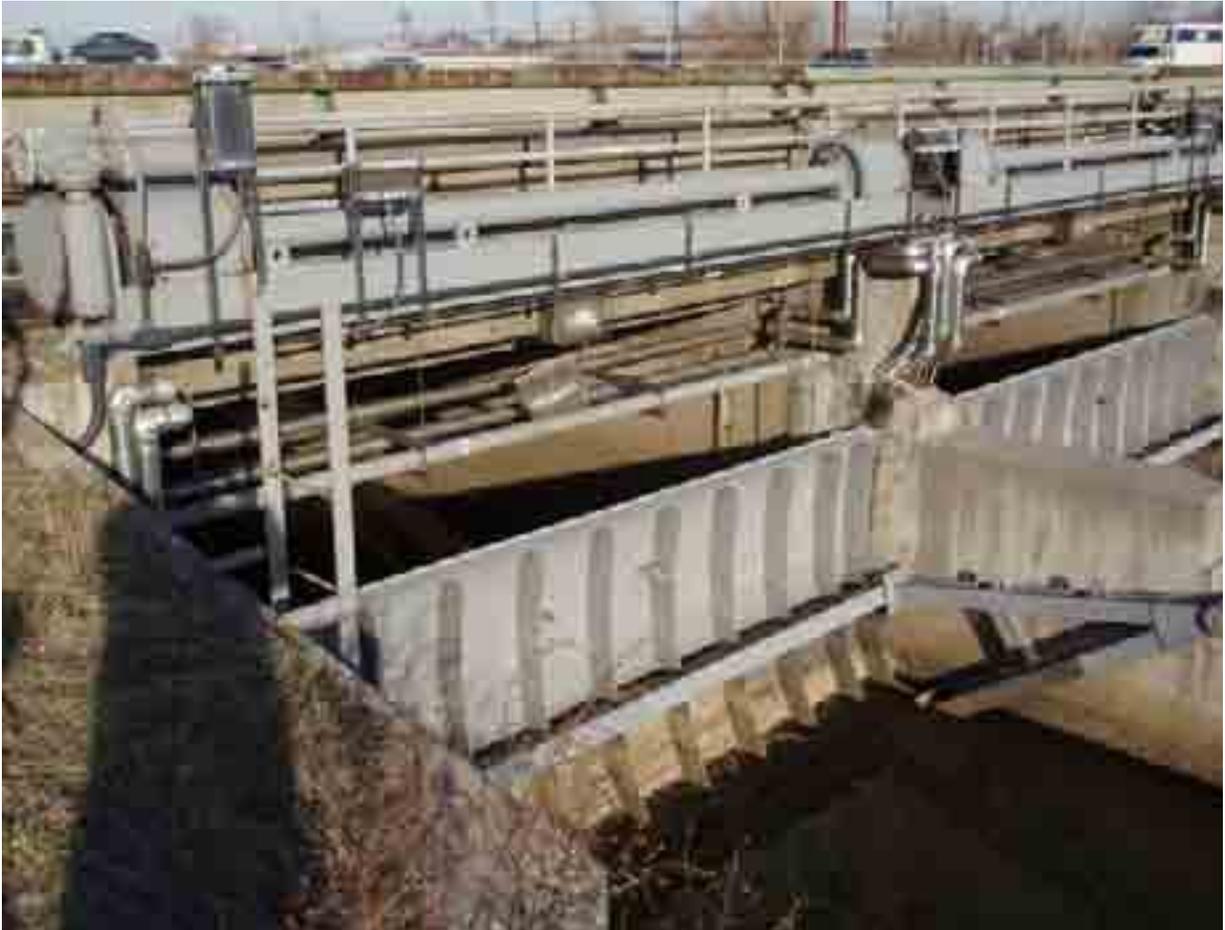
Photo 3 Description: View of bascule tide gate

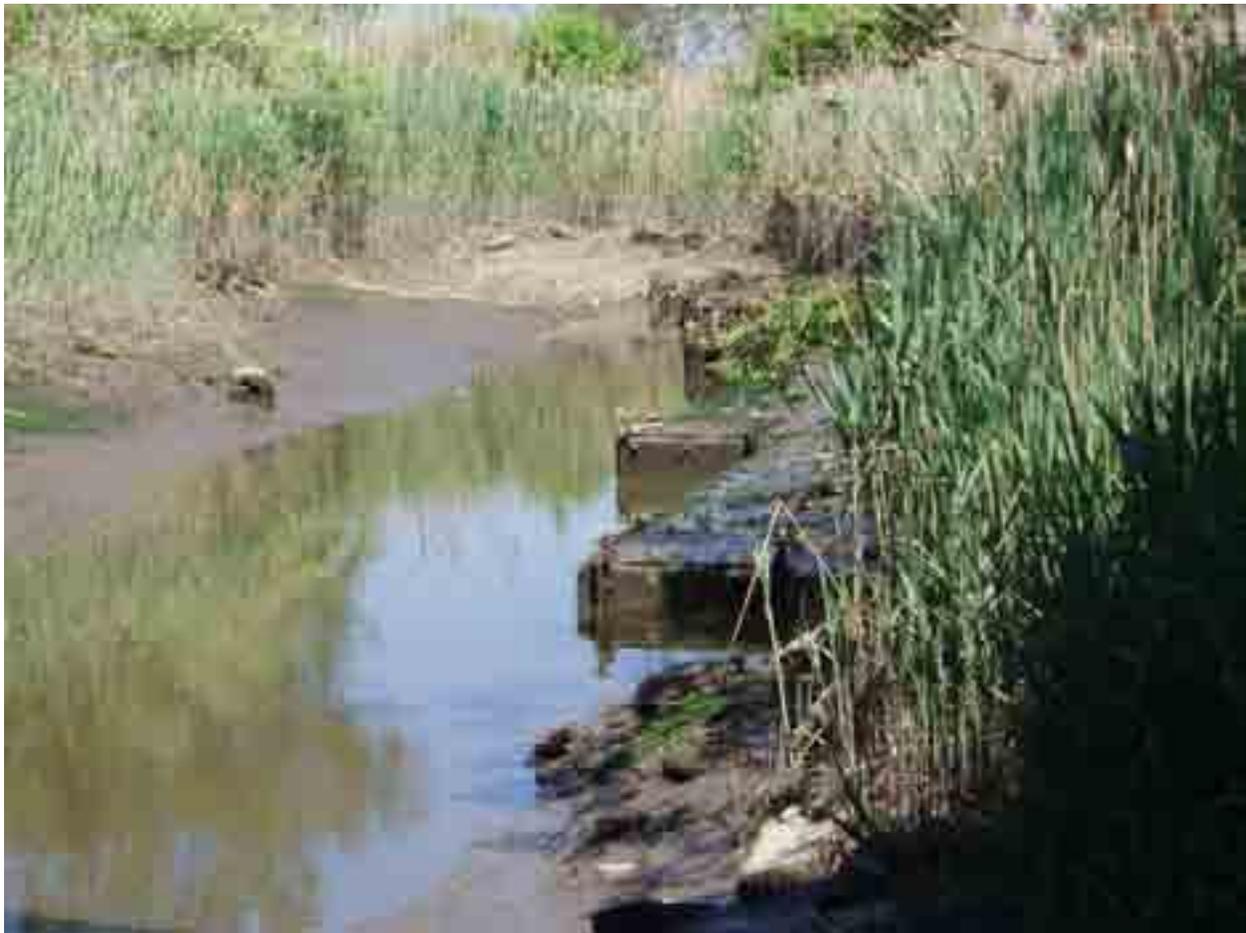
Photo 1 Description: View of tide gates

Water continues to seep through the gates and enter the upstream system. Of the five original designed 3 foot pipes, only three are functional and they are partially silted with their flap gates in varying degrees of damage. Two of the flap gates (culvert no. 4 and 5) have been welded closed.

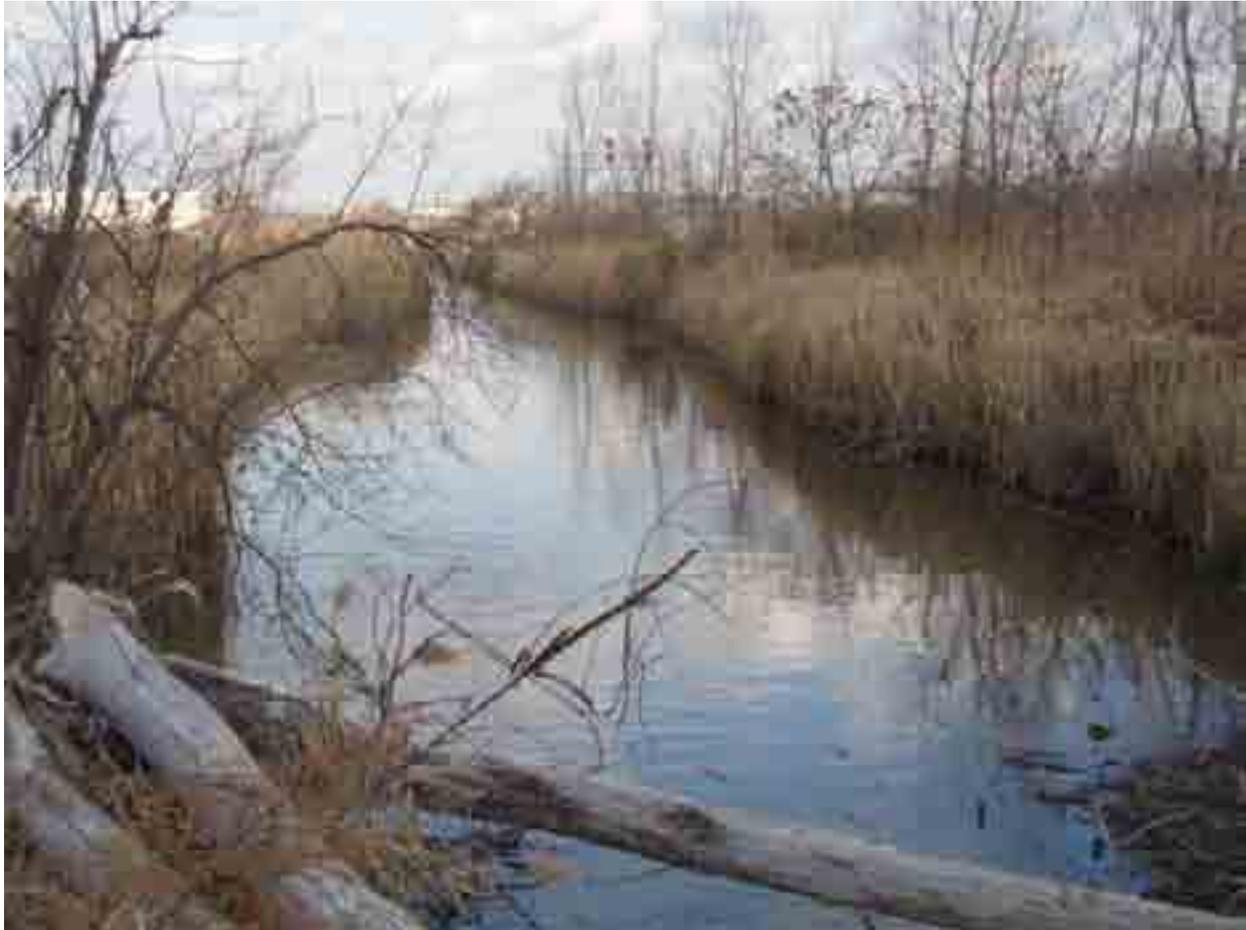
Photo 2 Description: Upstream view from the tide gates

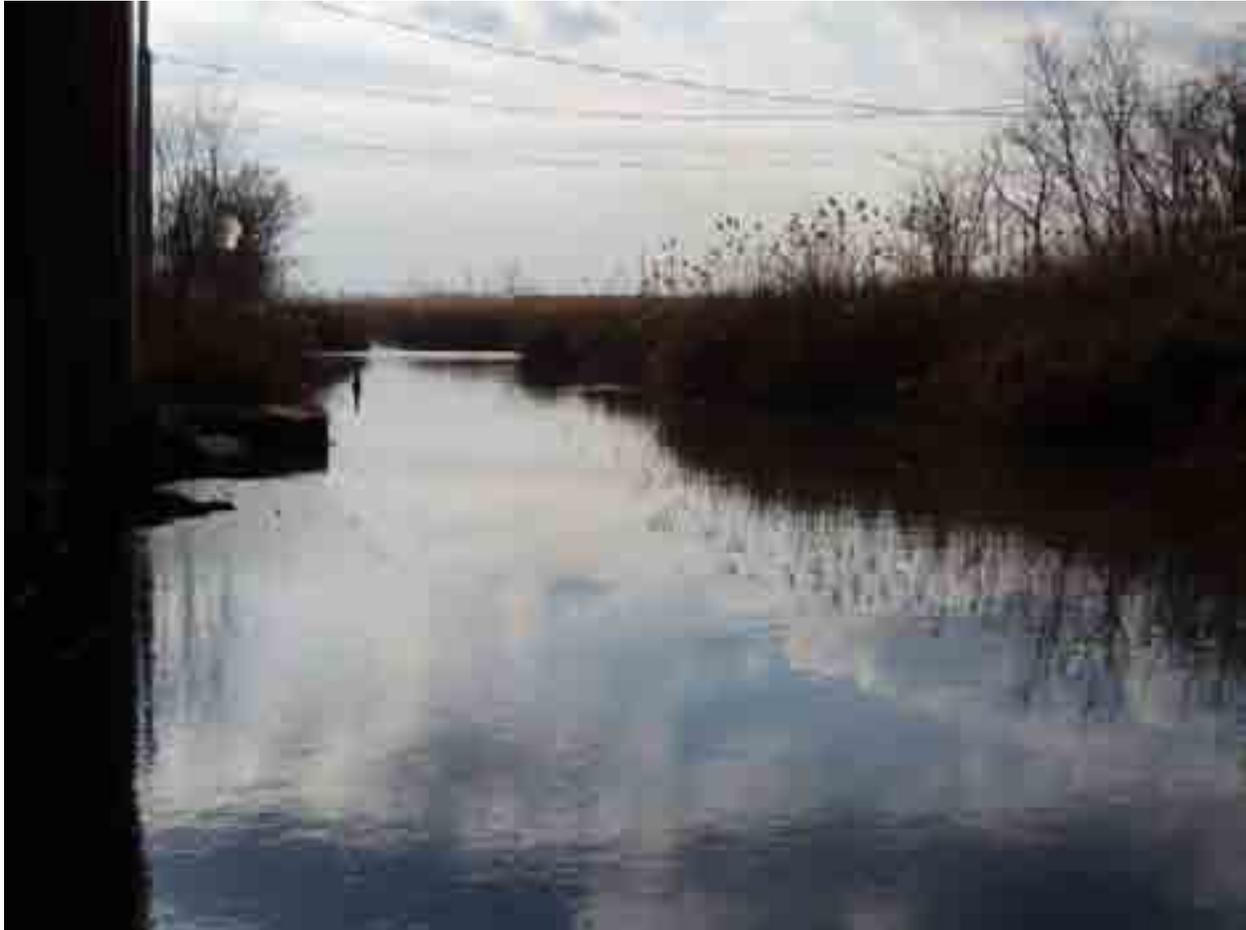
Photo 3 Description: Downstream view from the tide gates

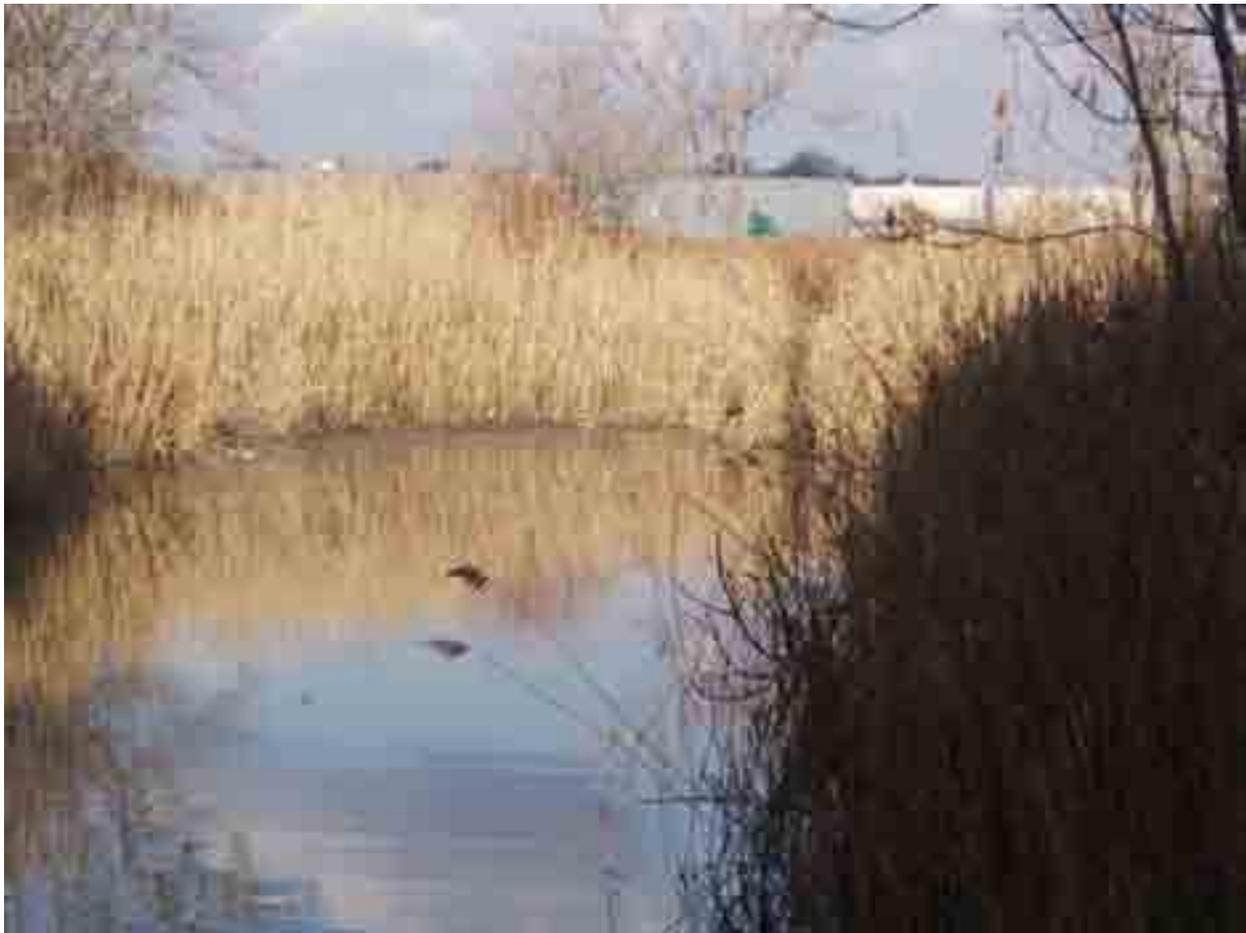
Photo 1 Description: Location of the tide gates

Tide gate appears to be in good condition and functioning properly.

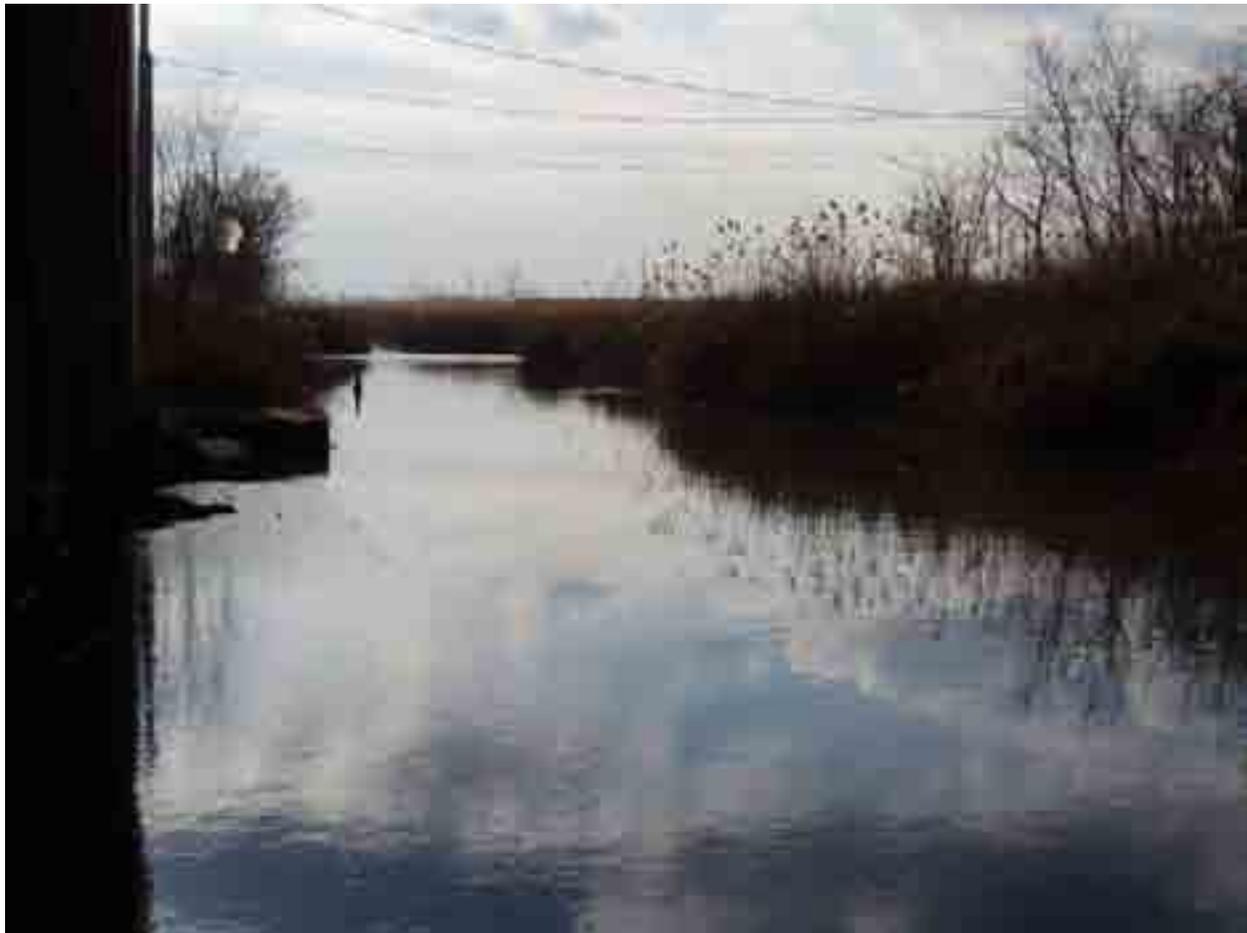
Photo 3 Description: Downstream view from the tide gates

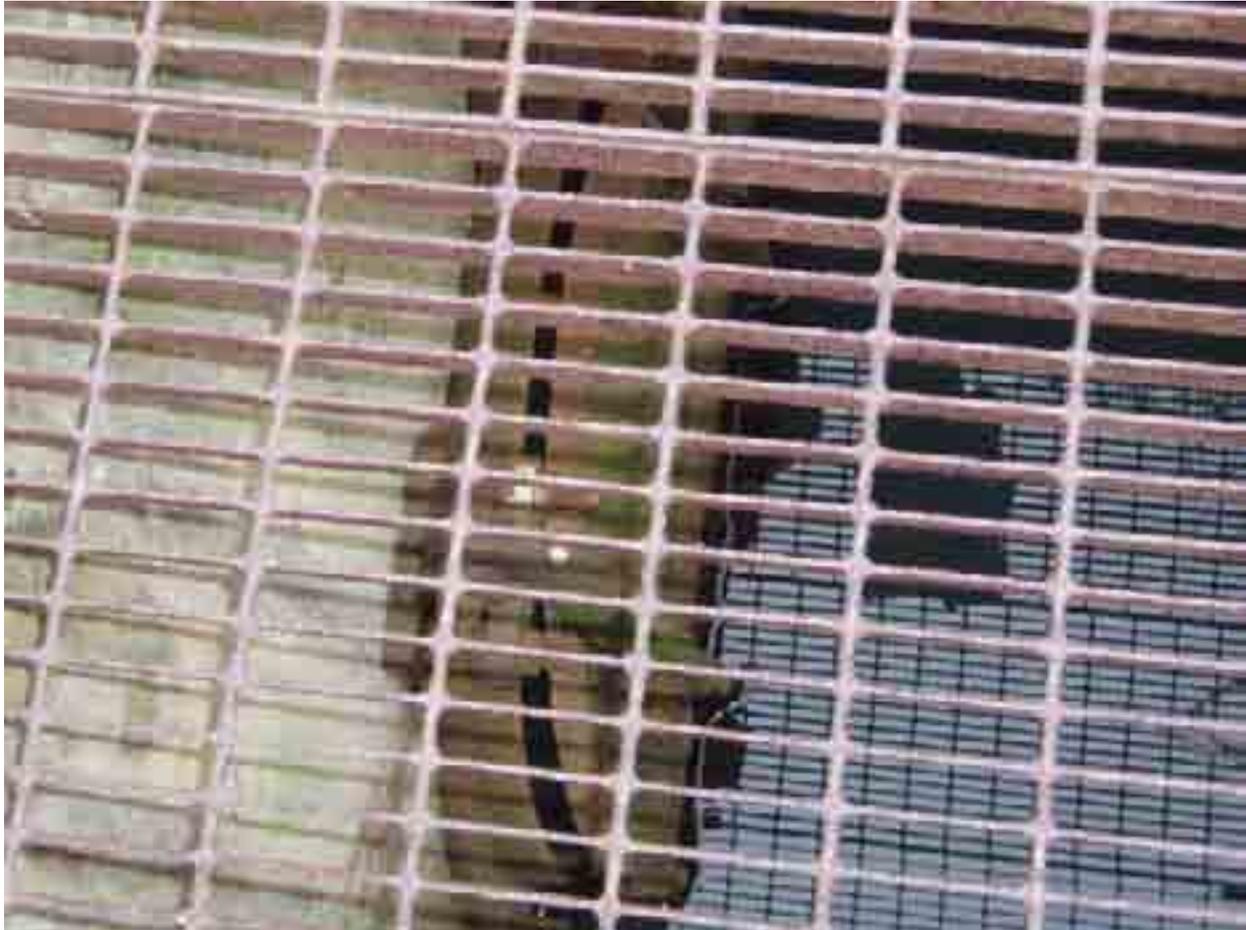
Photo 2 Description: First 48-inch metal flap gate

Gated access needs to be added at this location. The chamber in which the gates are housed needs to be cleaned out and repaired.

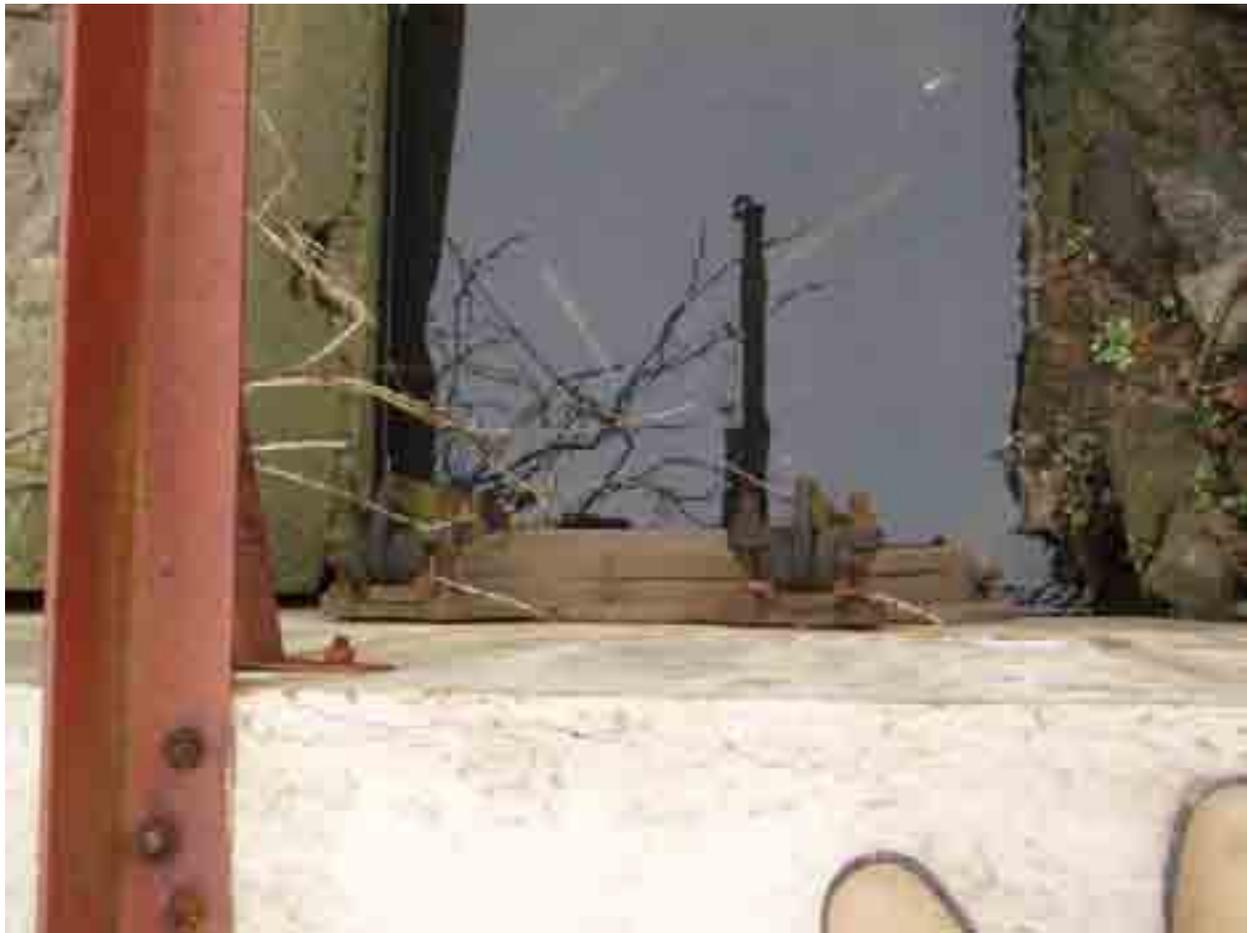
Photo 3 Description: Second 48-inch metal flap gate

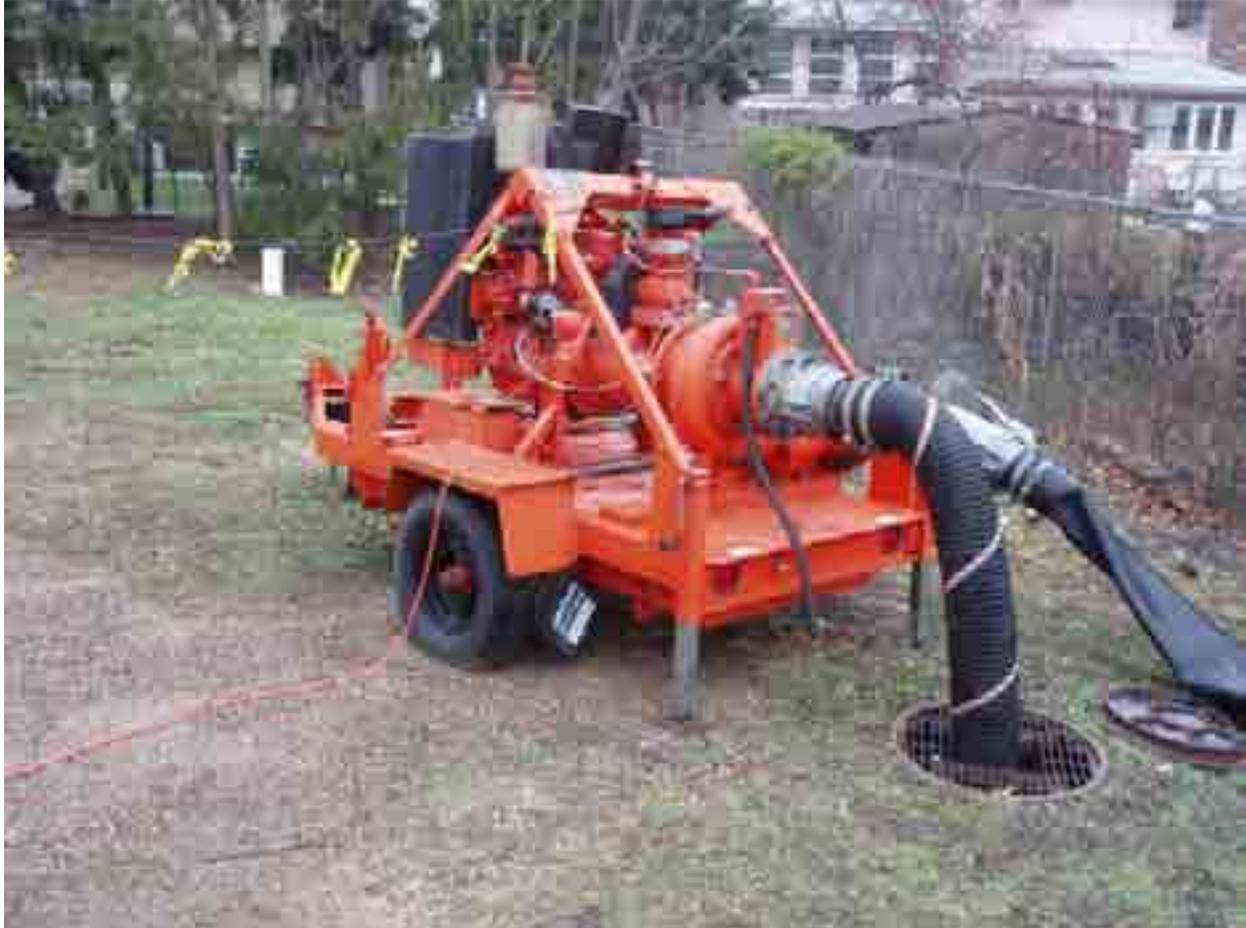
Photo 4 Description: Godwin diesel back-up pump
