Hackensack Meadowlands Tide Gates Inspection Report

**The New Jersey Meadowlands Commission
One DeKorte Park Plaza
Lyndhurst, New Jersey**

March 27, 2006

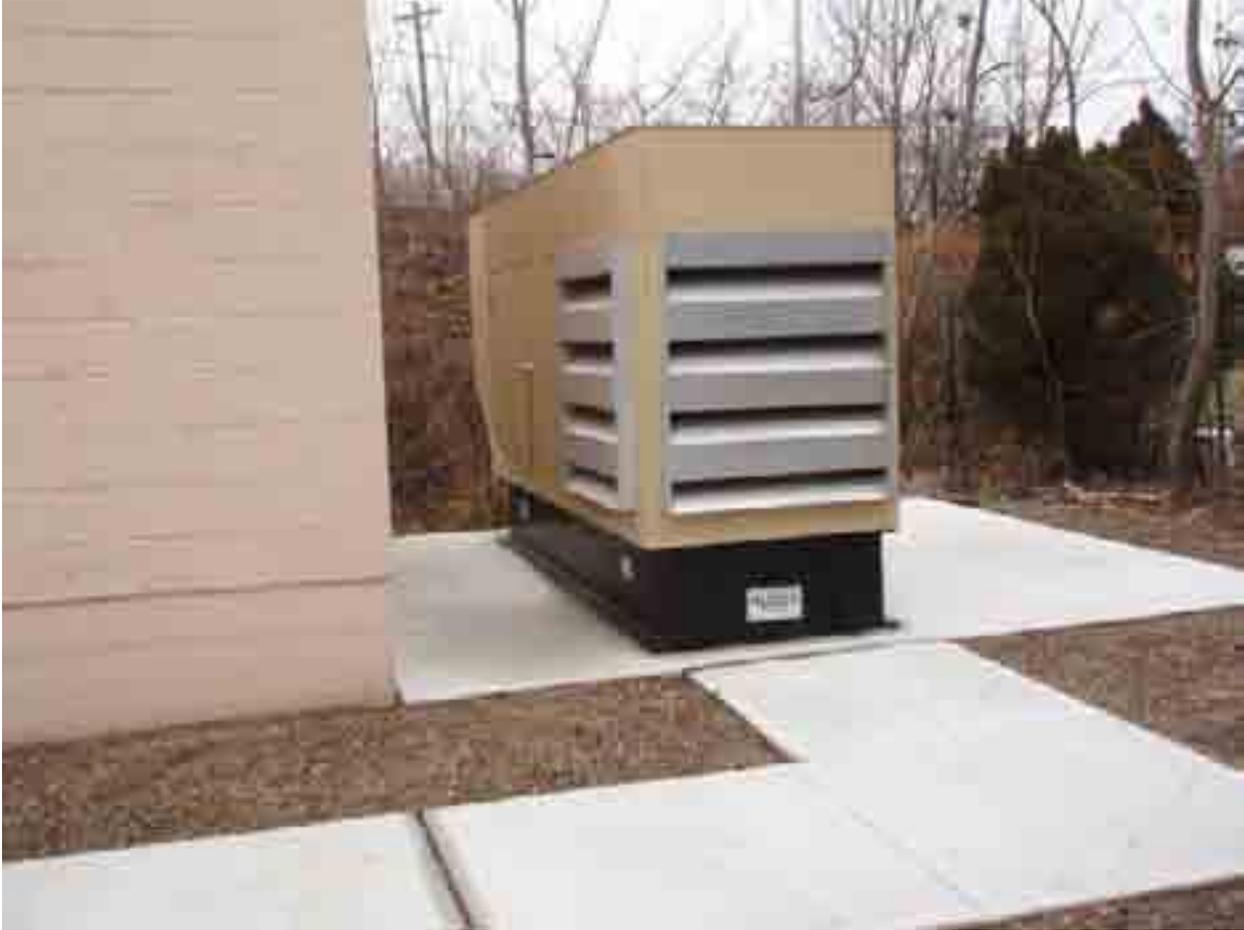
Photo 5 Description: View of emergency power generator

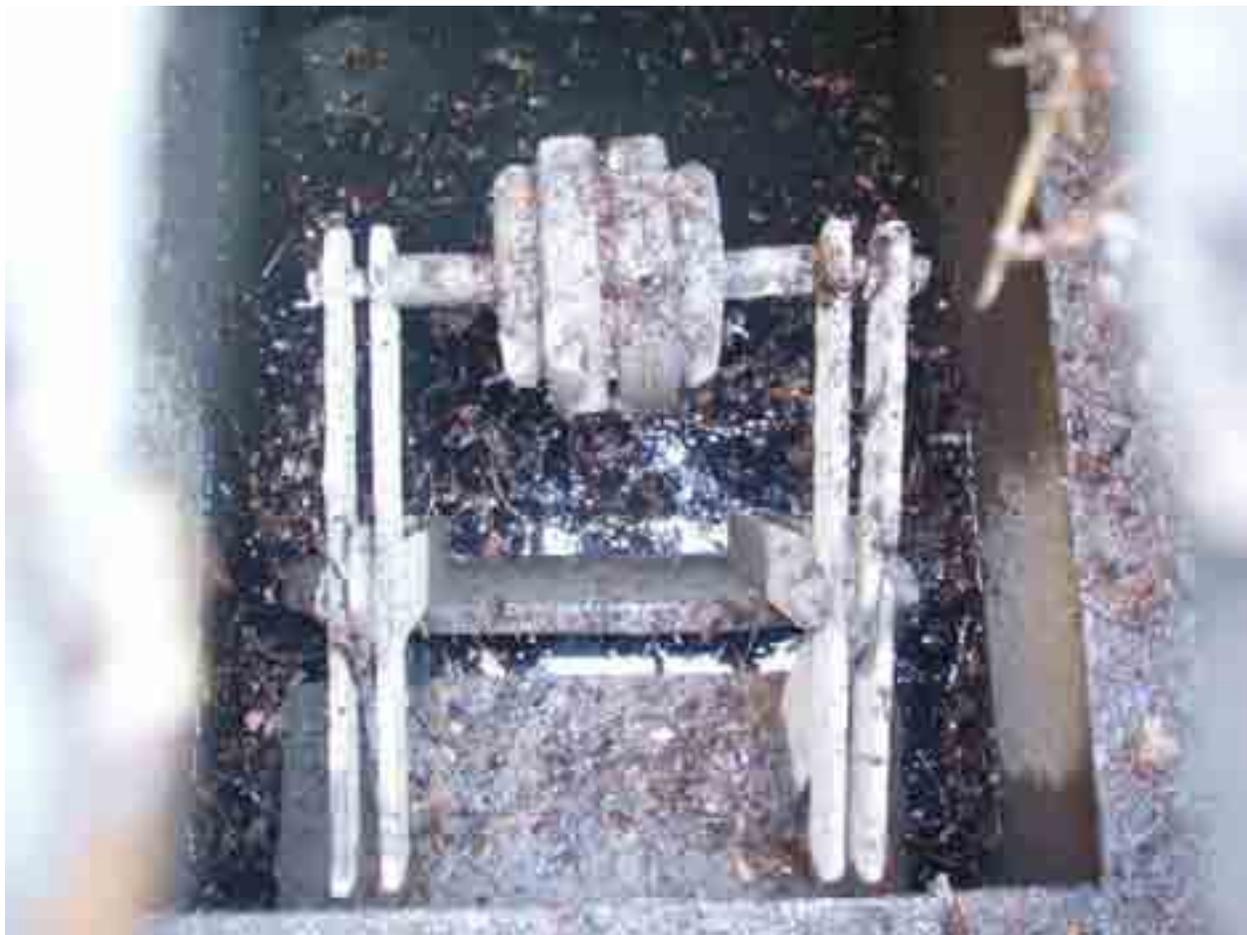
Photo 2 Description: View of metal flap gate

No problems observed.

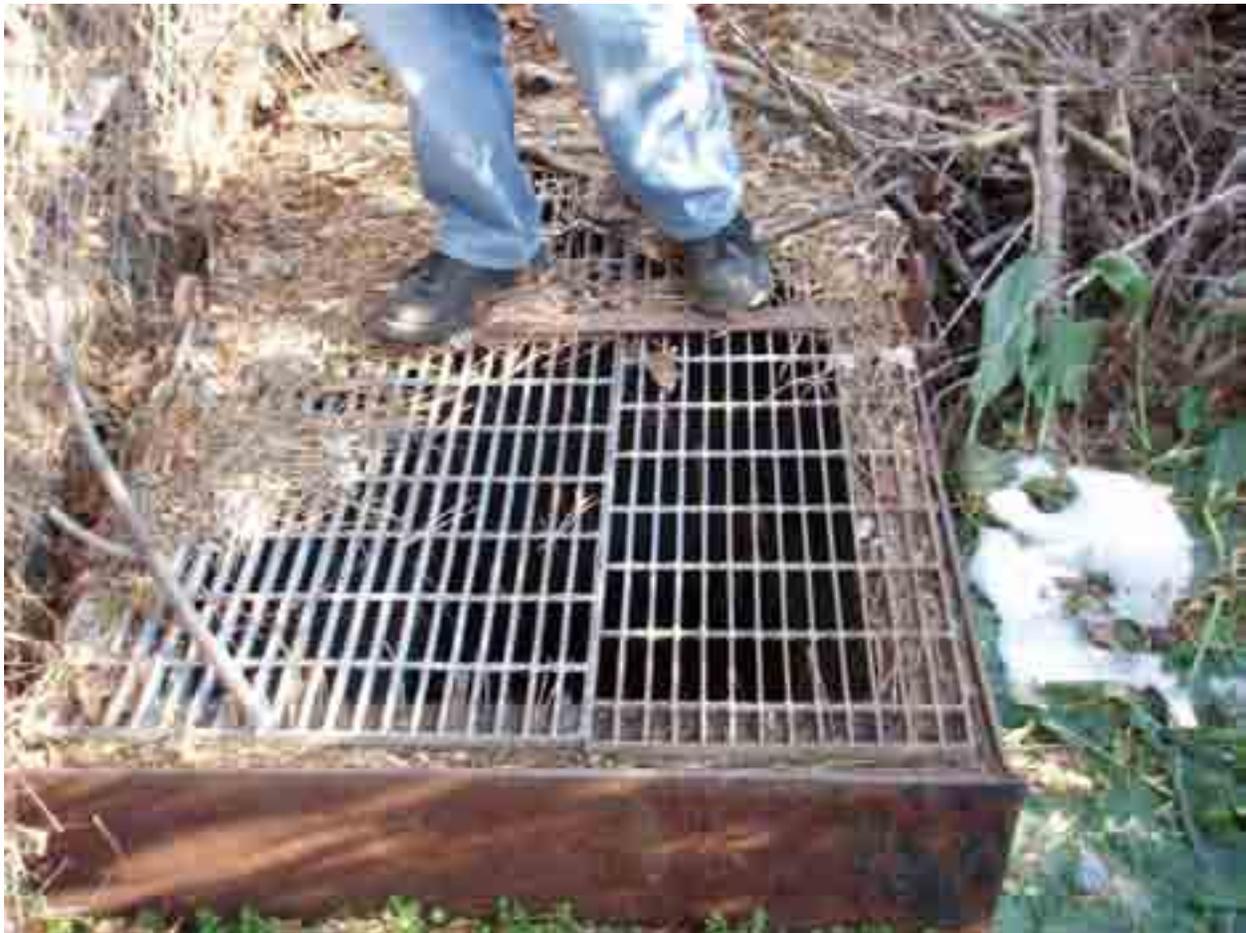
Photo 3 Description: View of tide gate chamber

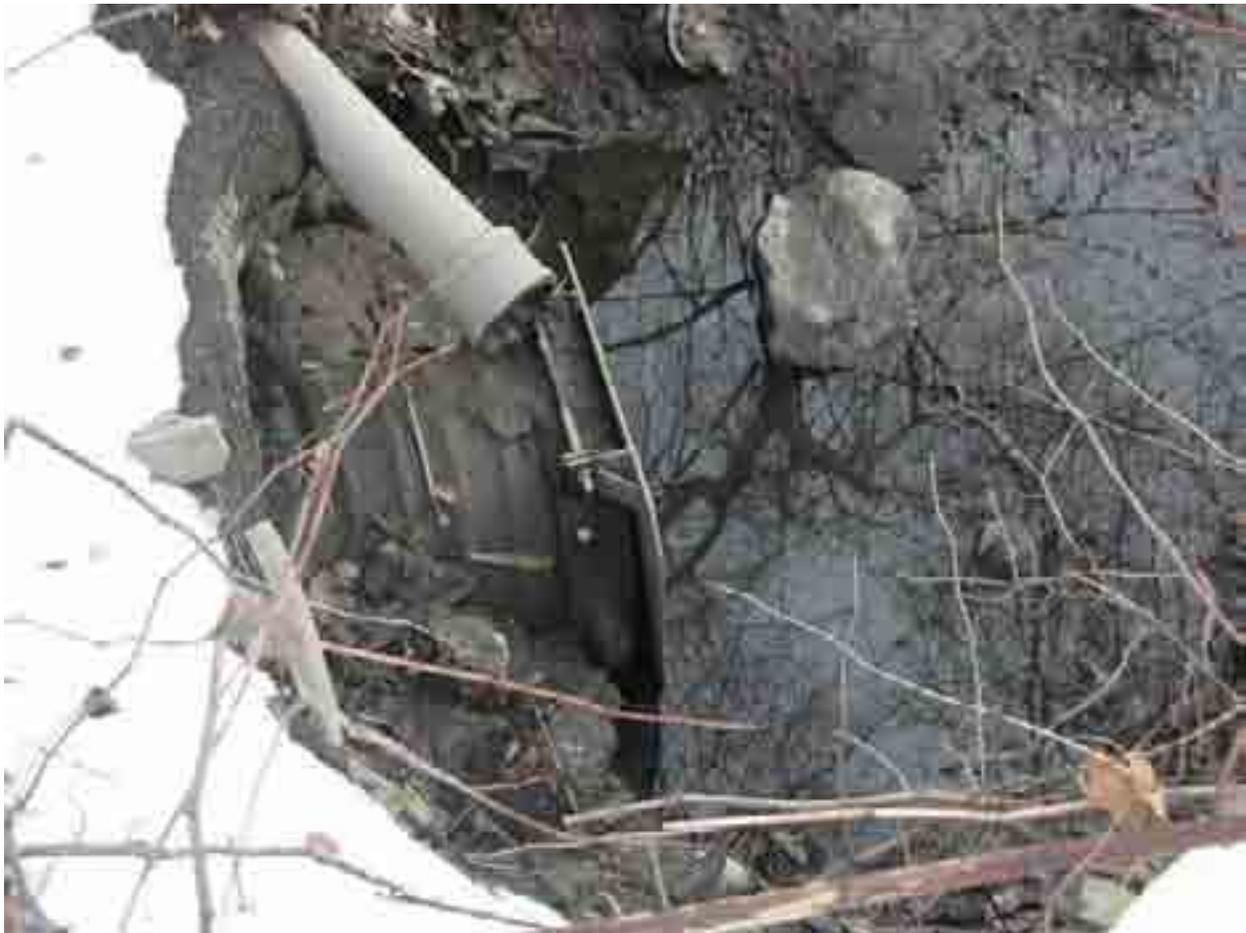
Photo 1 Description: Tide gate structure

No problems observed.

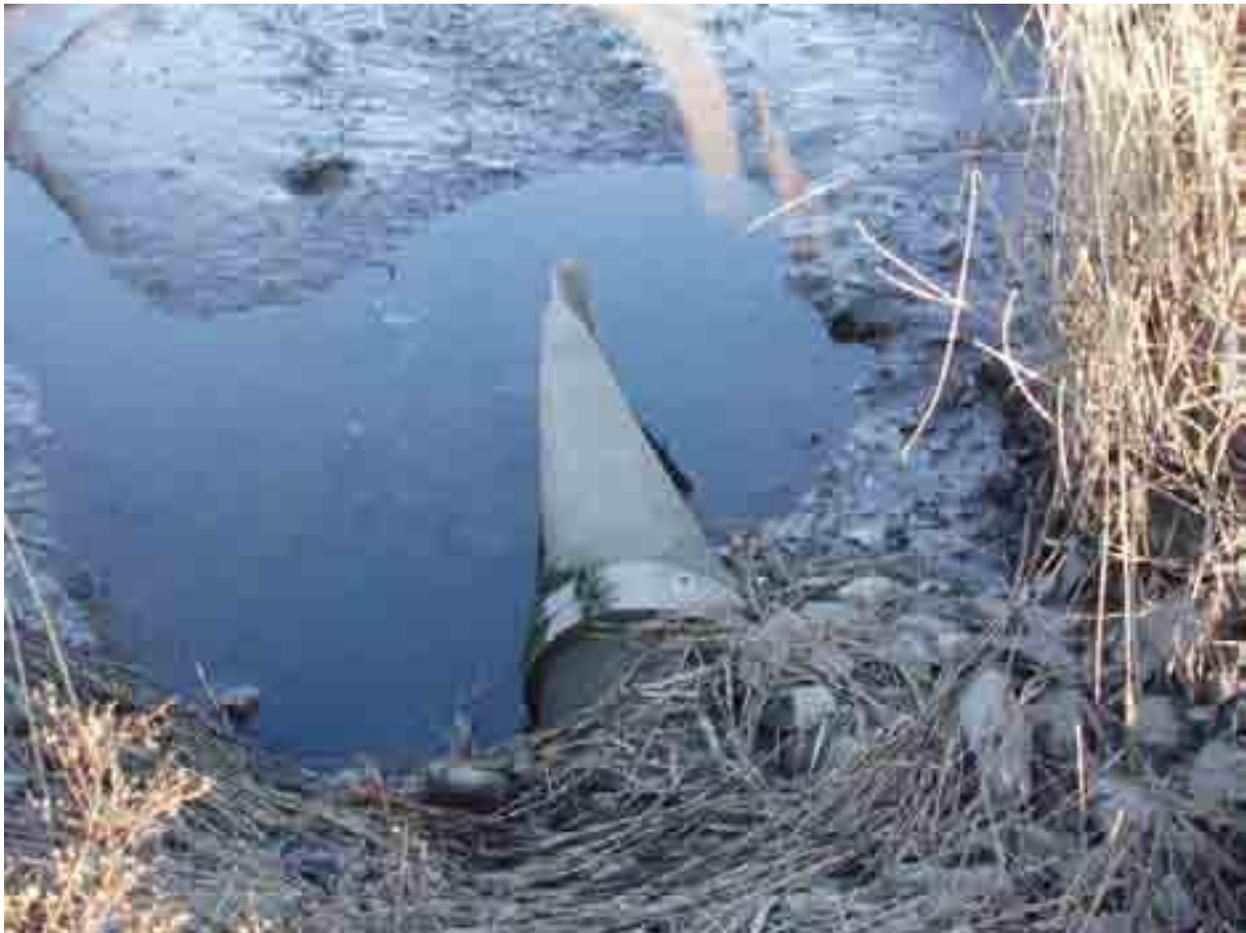
Photo 2 Description: Tideflex™ check valve

The tide gate appears to seat properly. The gate is attached directly to storm drains located on Mill Ridge Road. In order to know if the gate is functional an inspection needs to be completed during a rain event to see if the gate opens. One of the tide gates found is located behind the property of 17 Mill Ridge Road.

The hinges located on the gate appear to be rusted and need to be cleaned and lubricated.

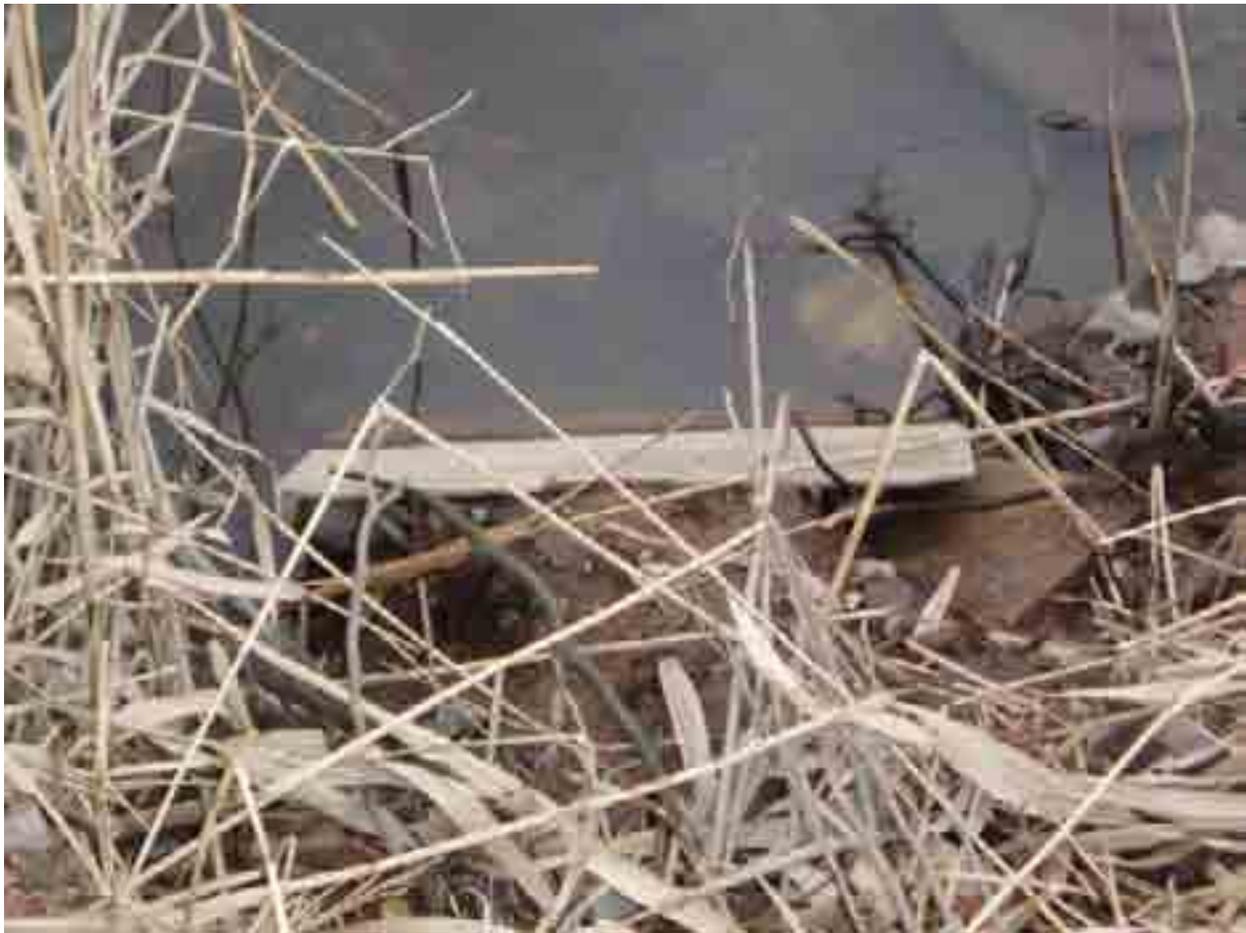
Photo 1 Description: Metal flap gate shown

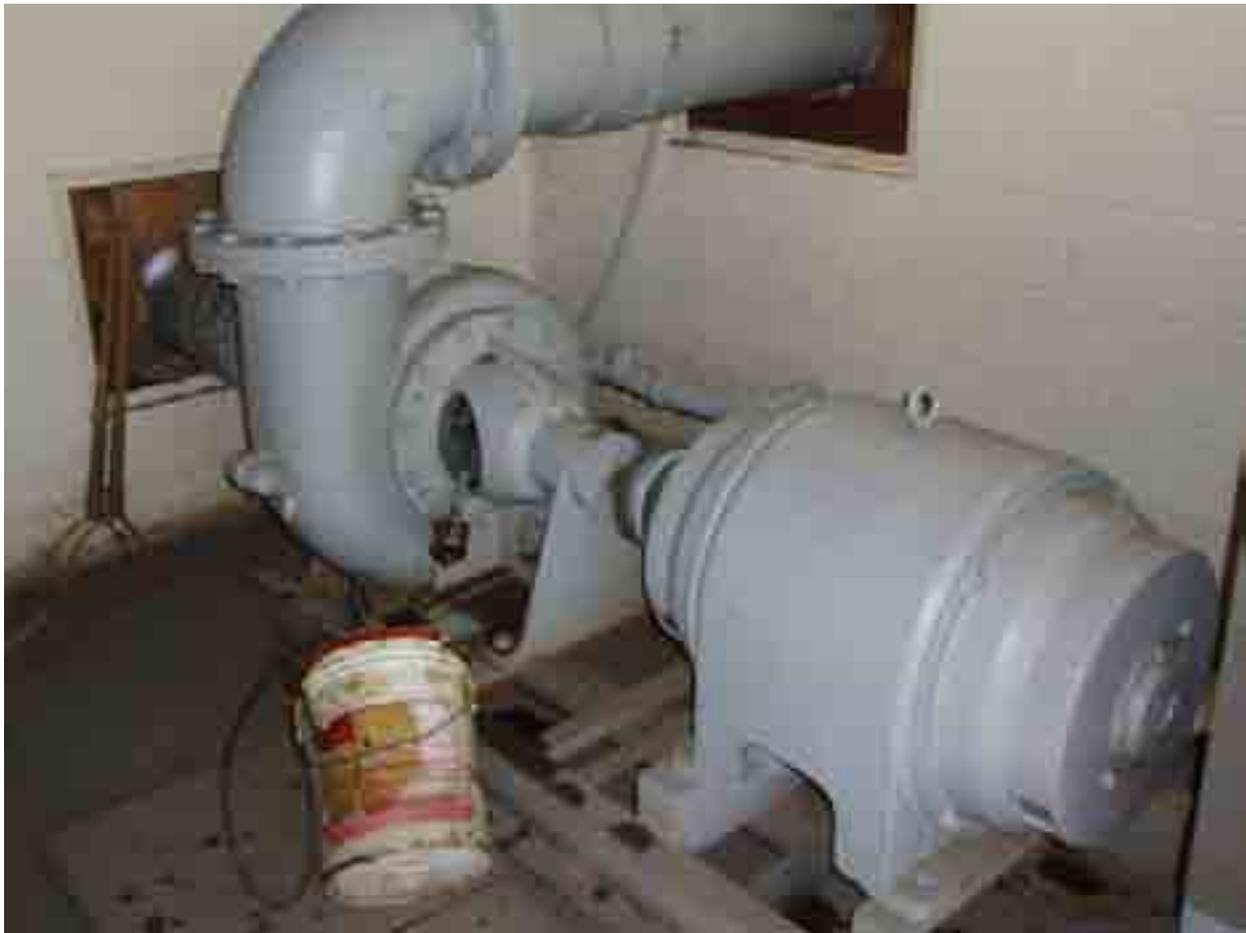
Photo 2 Description: View of pump

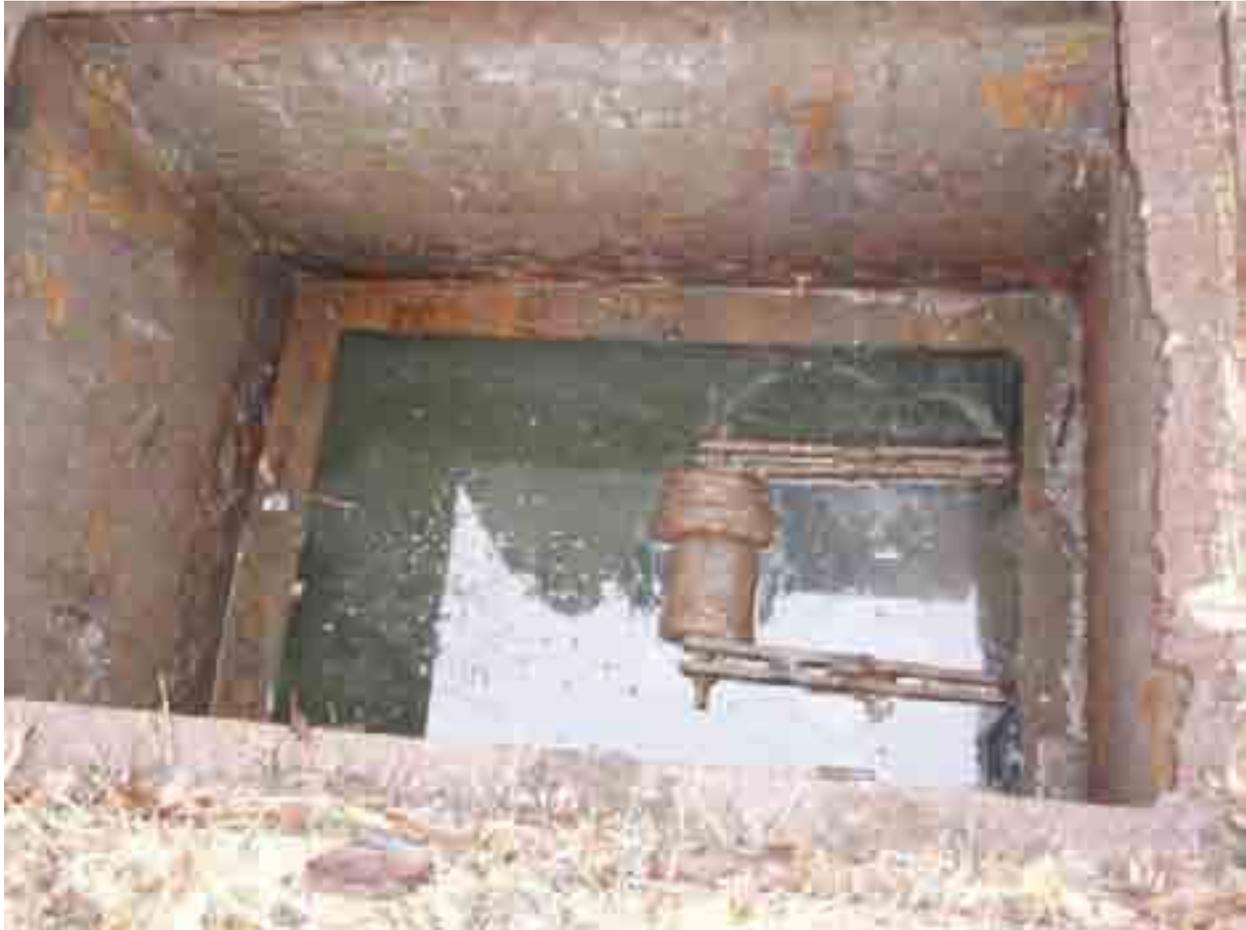
Photo 1 Description: 1st 30-inch flap gate

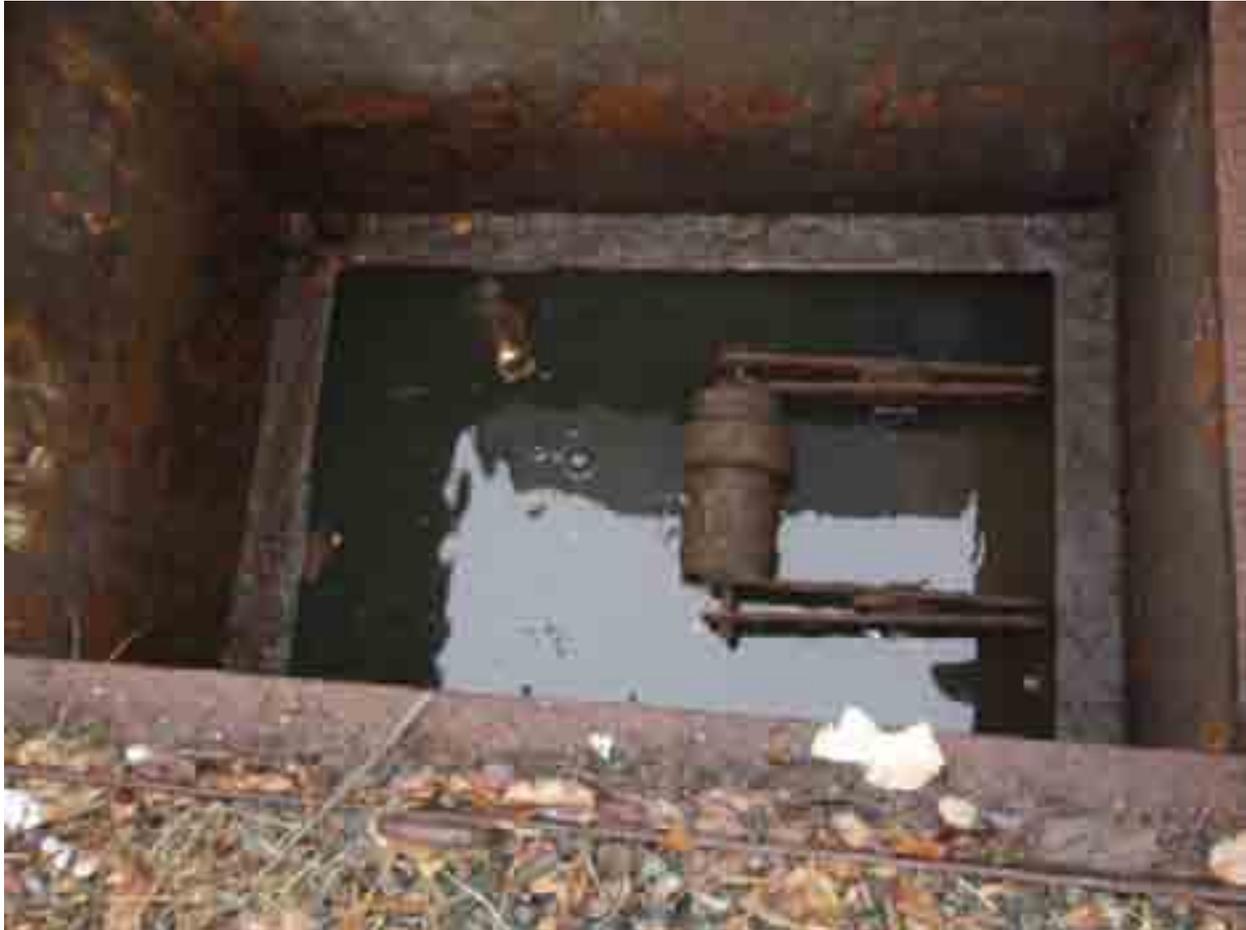
Photo 2 Description: 2nd 30-inch flap gate

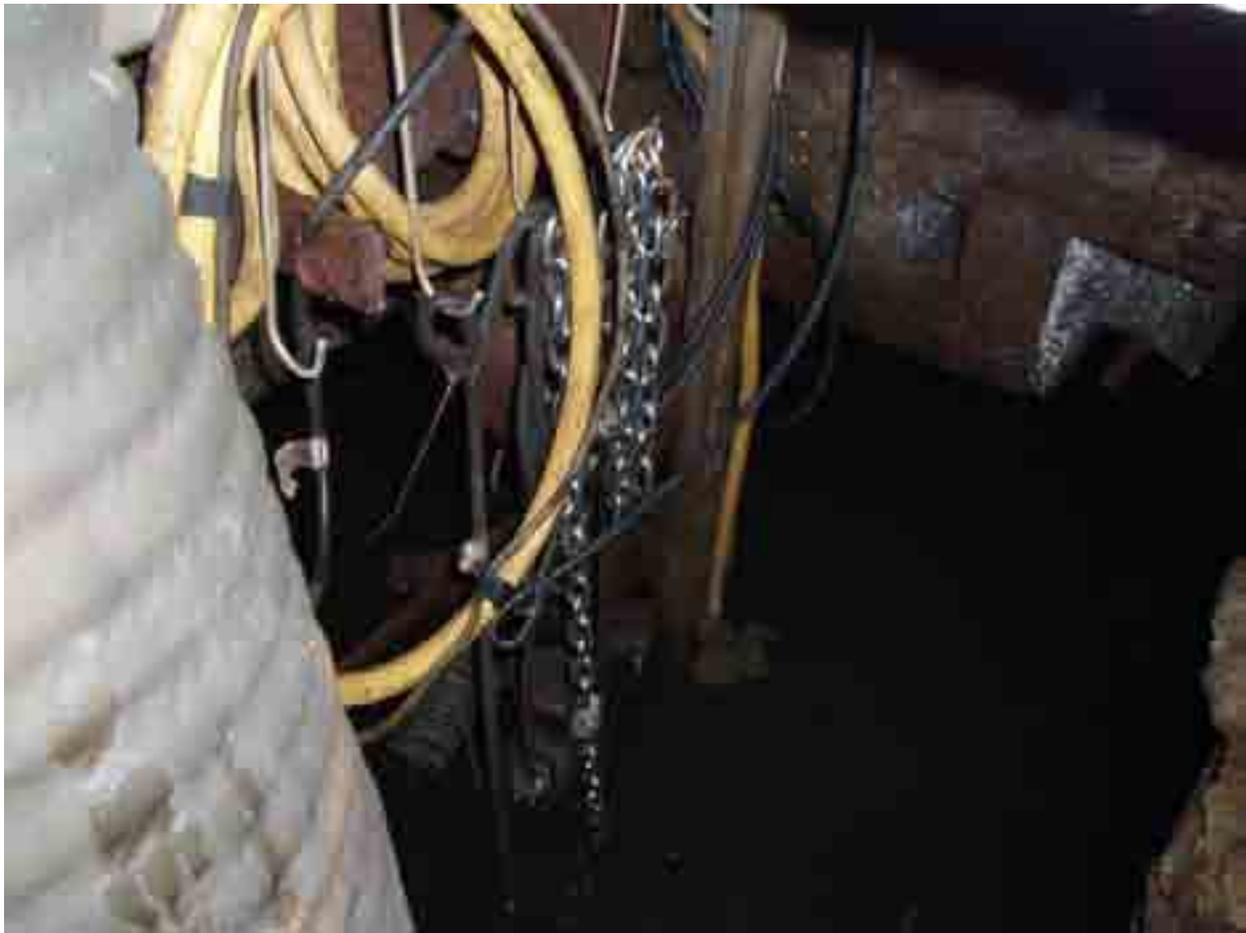
Photo 3 Description: View of submersible pump

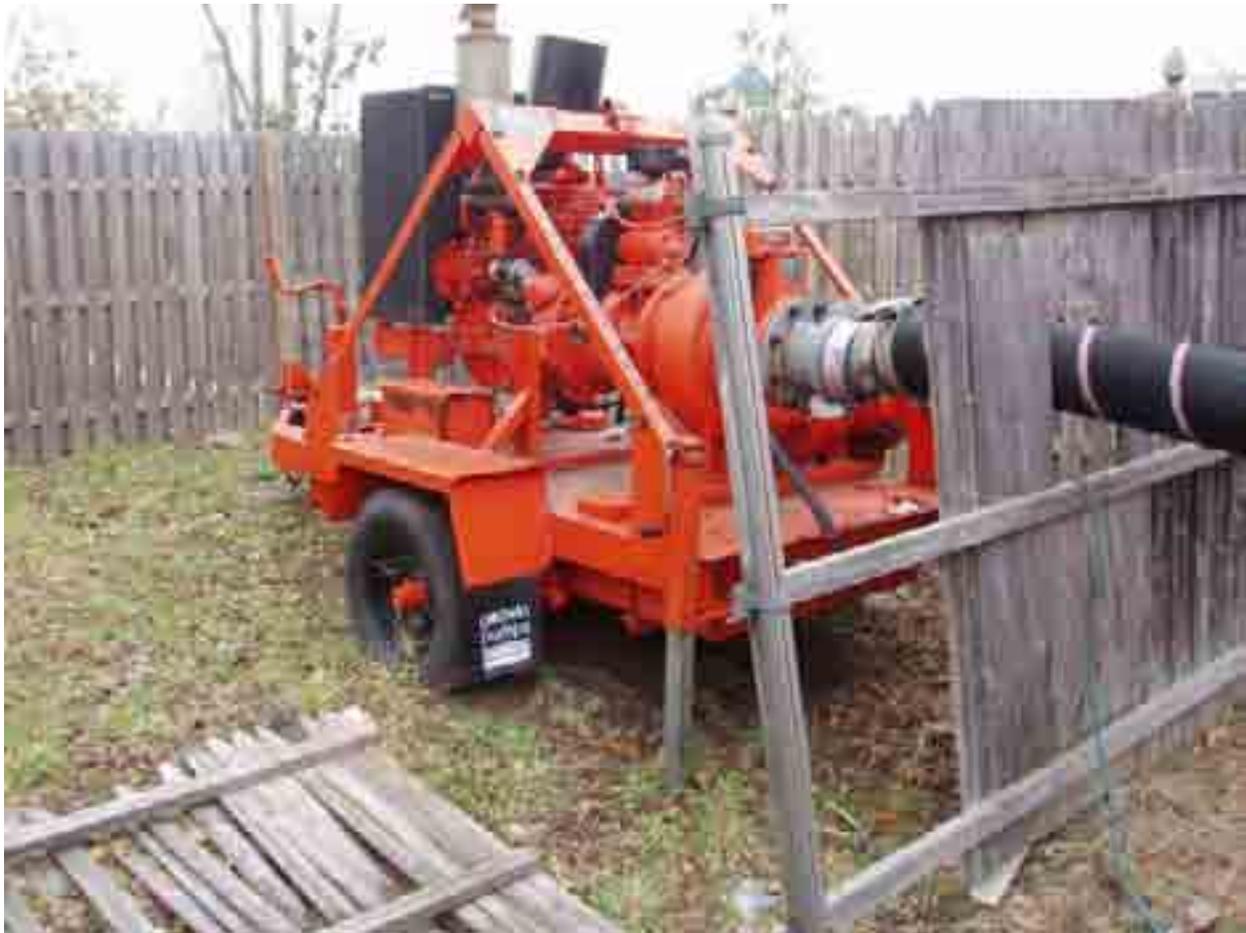
Photo 4 Description: Godwin back-up pump

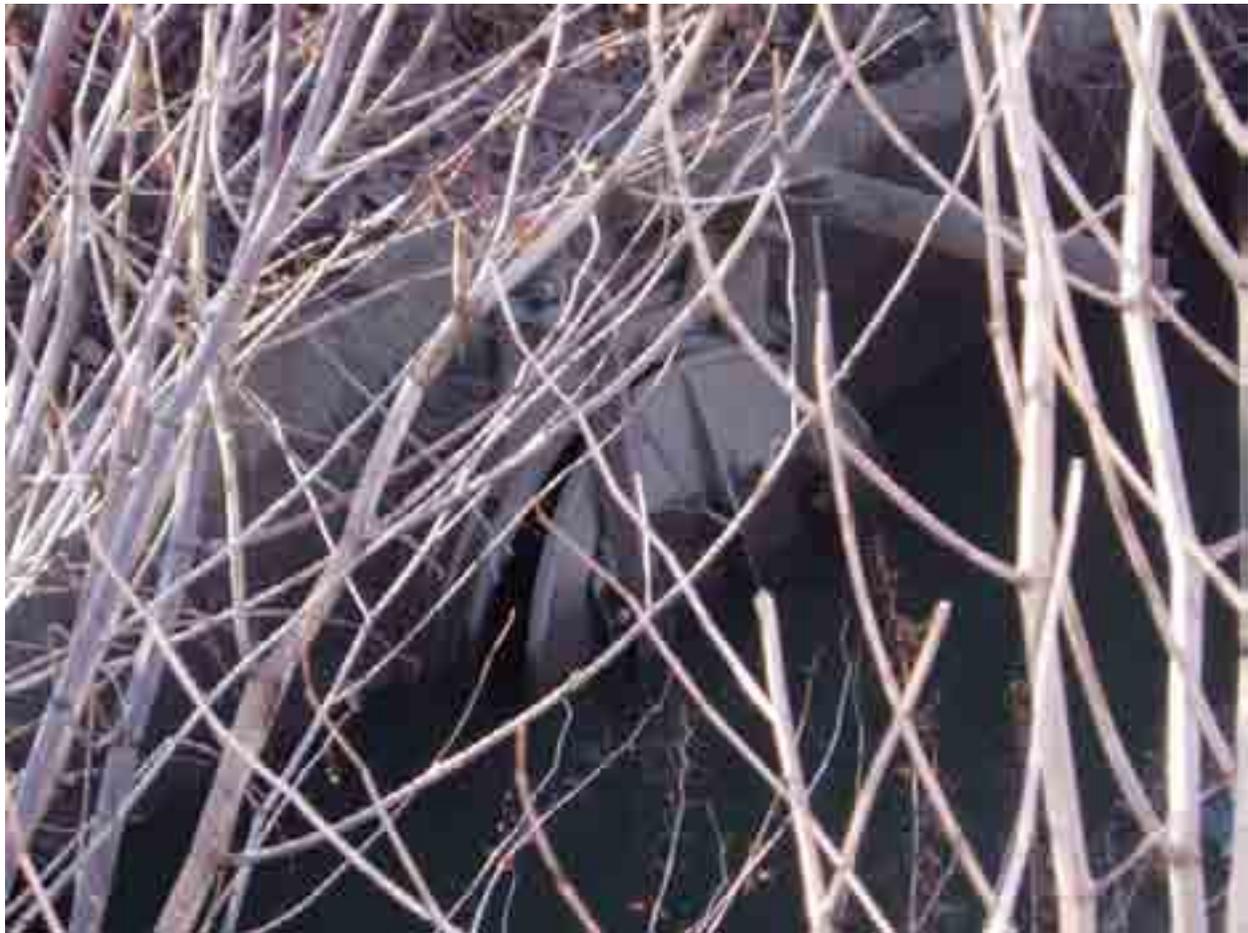
Photo 1 Description: 1 metal flap gate

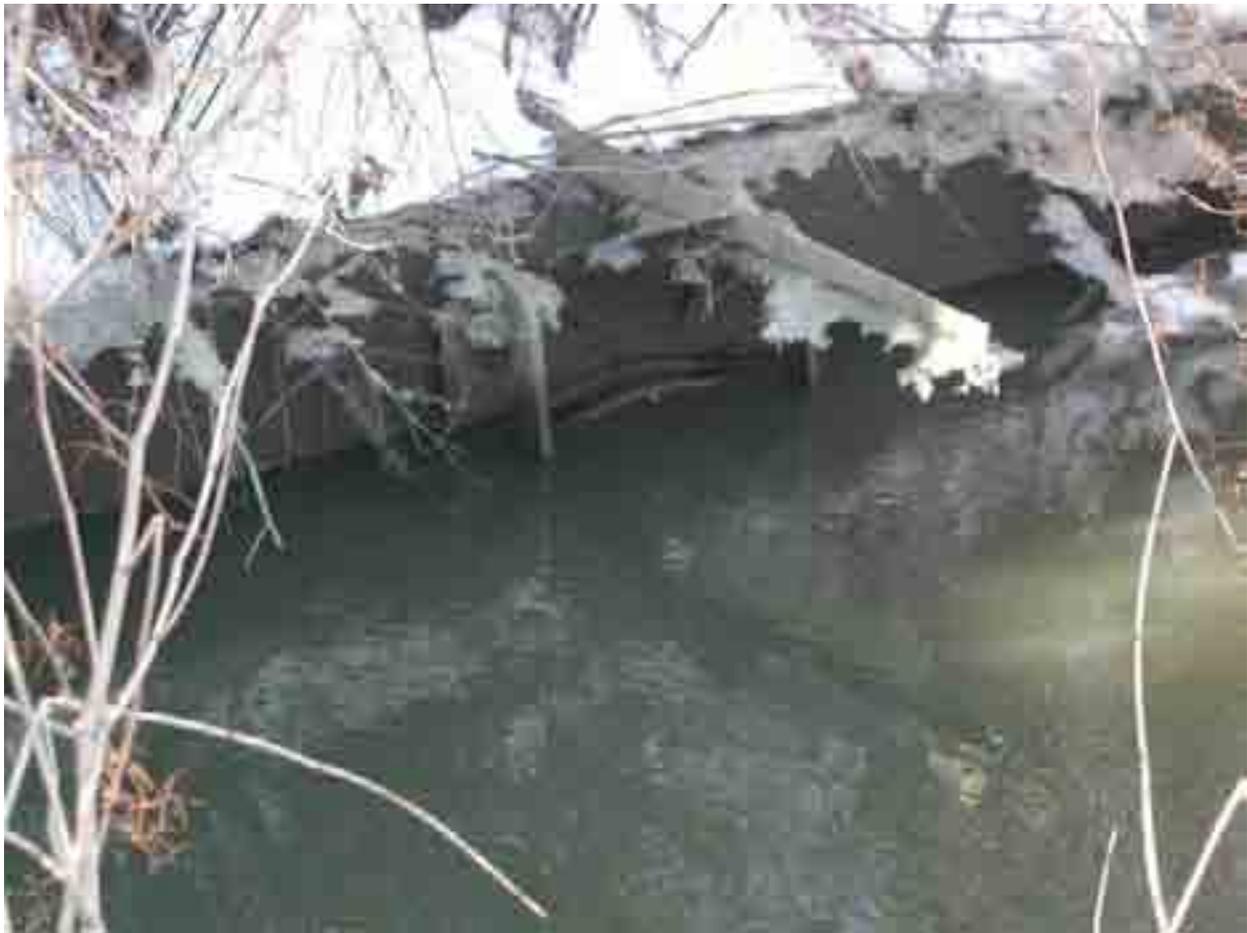
No problems observed.

Photo 1 Description: 1 metal flap gate

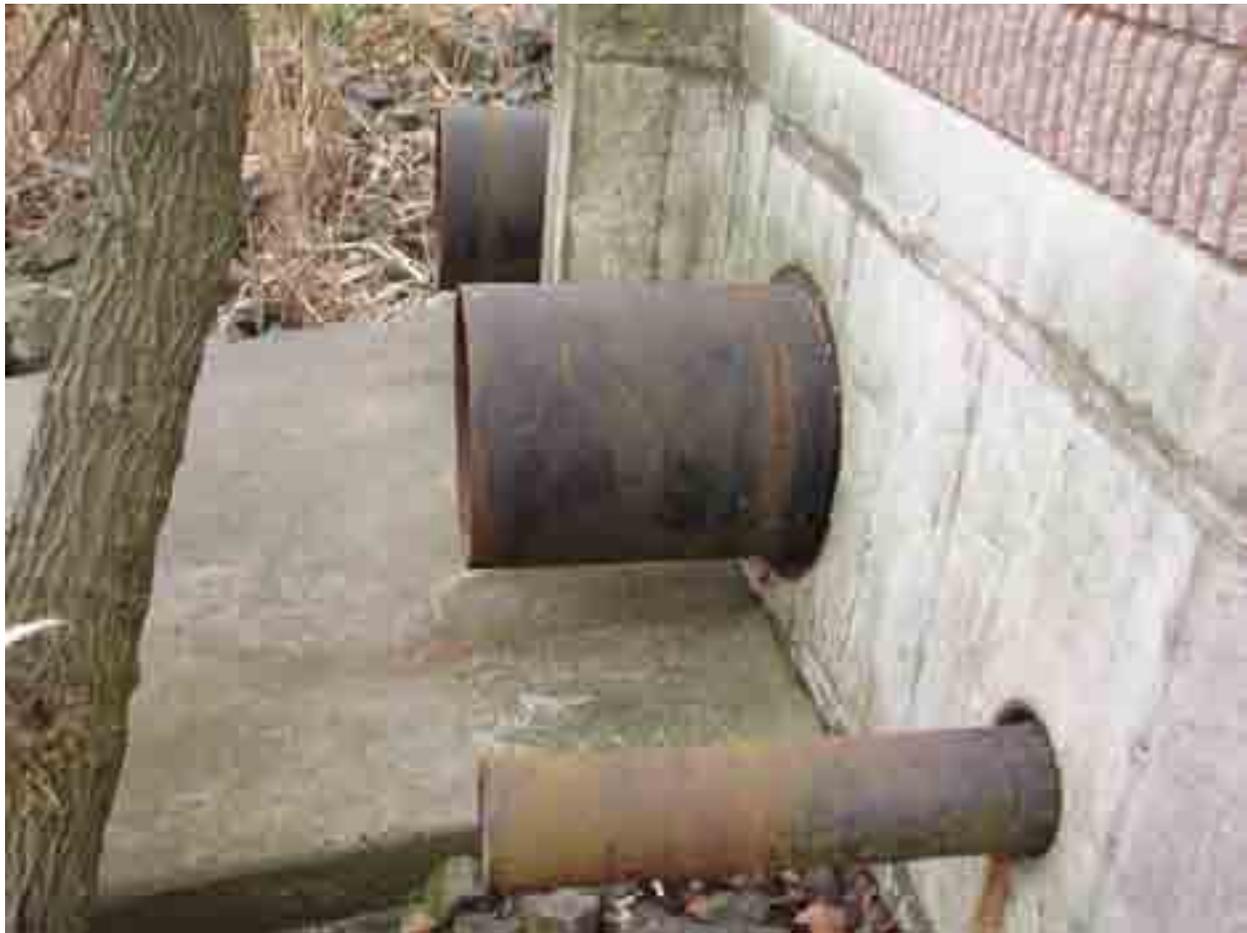
Photo 1 Description: View of outlet pipes

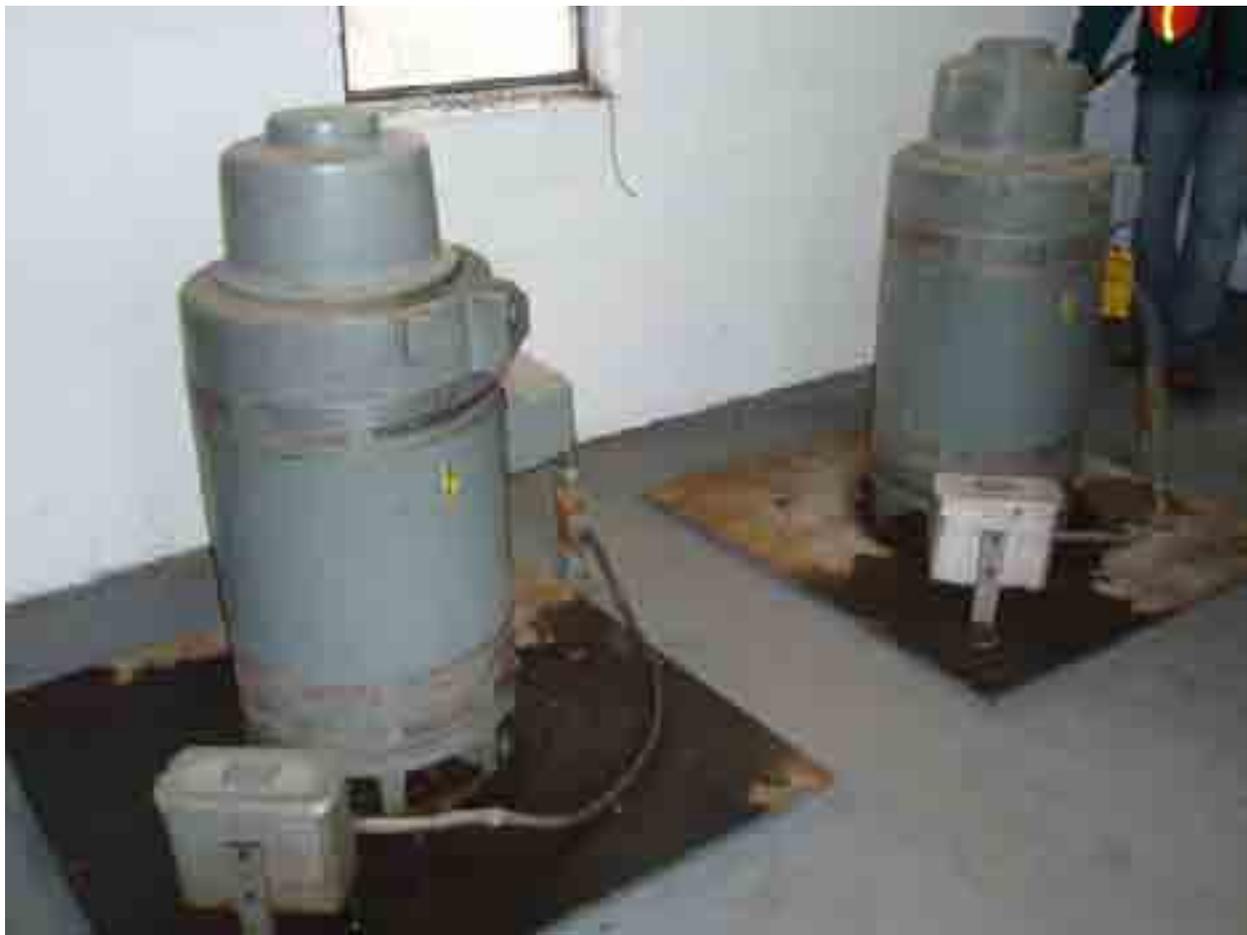
Photo 2 Description: View of pump systems

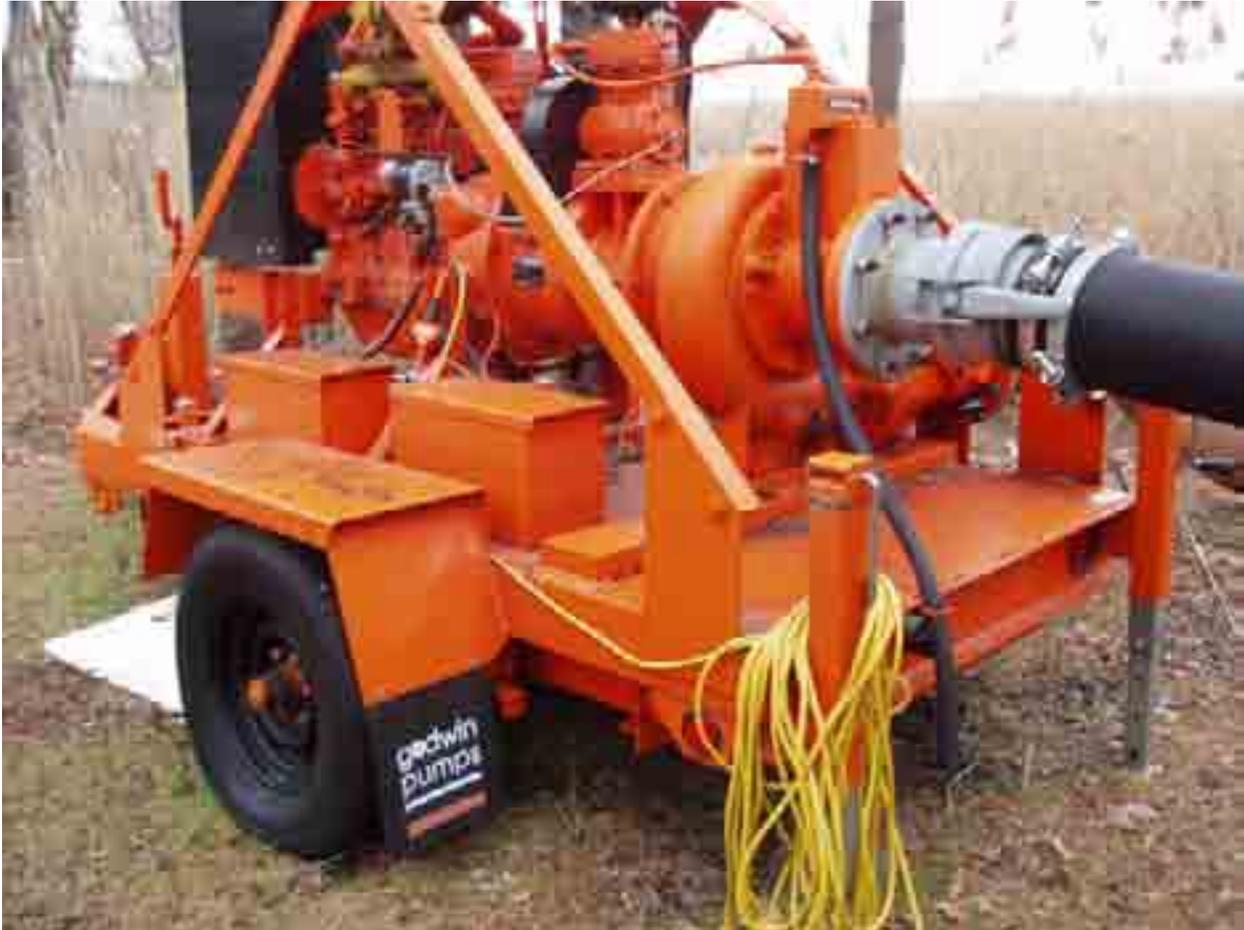
Photo 3 Description: Godwin diesel back-up pump system

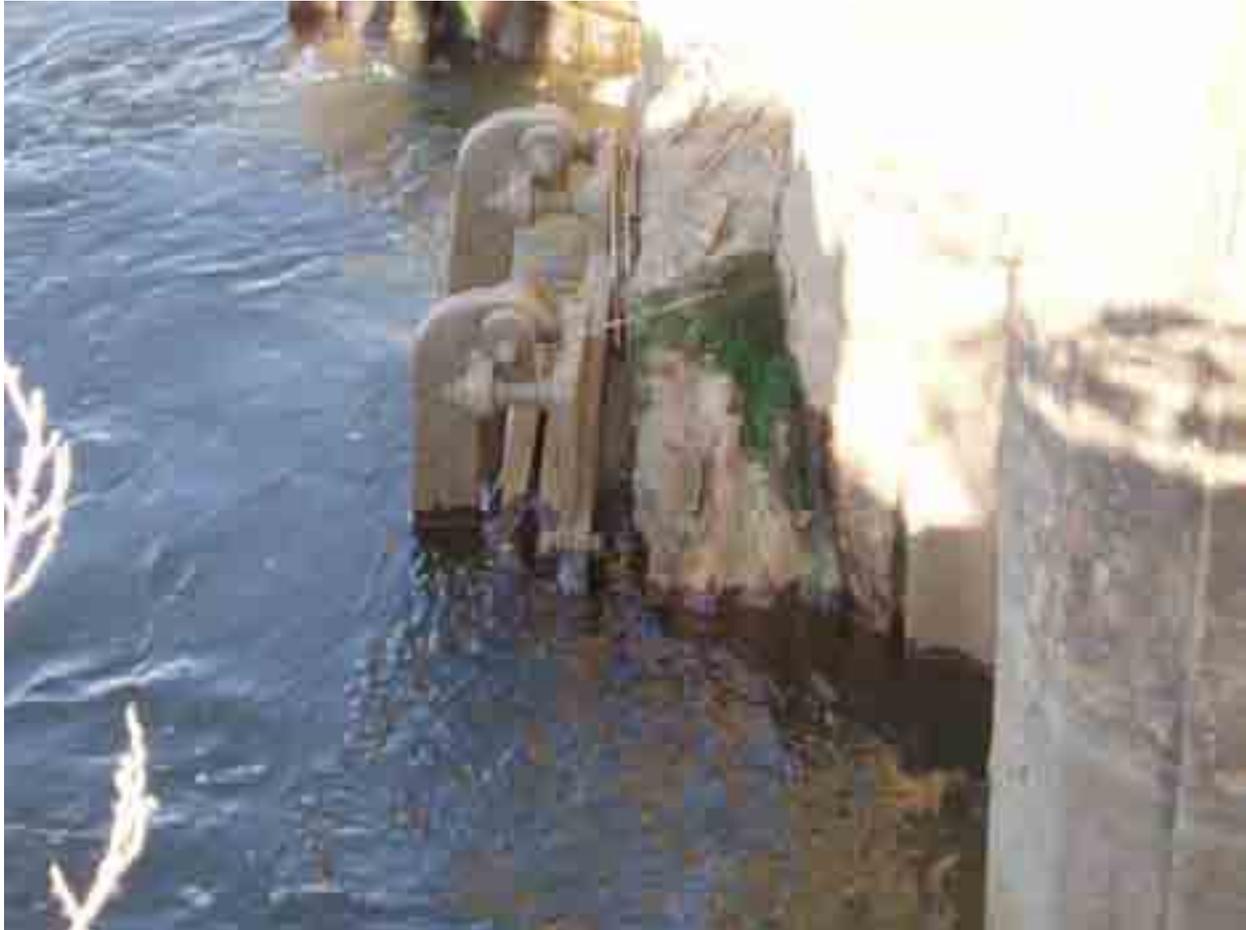
Photo 1 Description: Metal flap gate shown closed

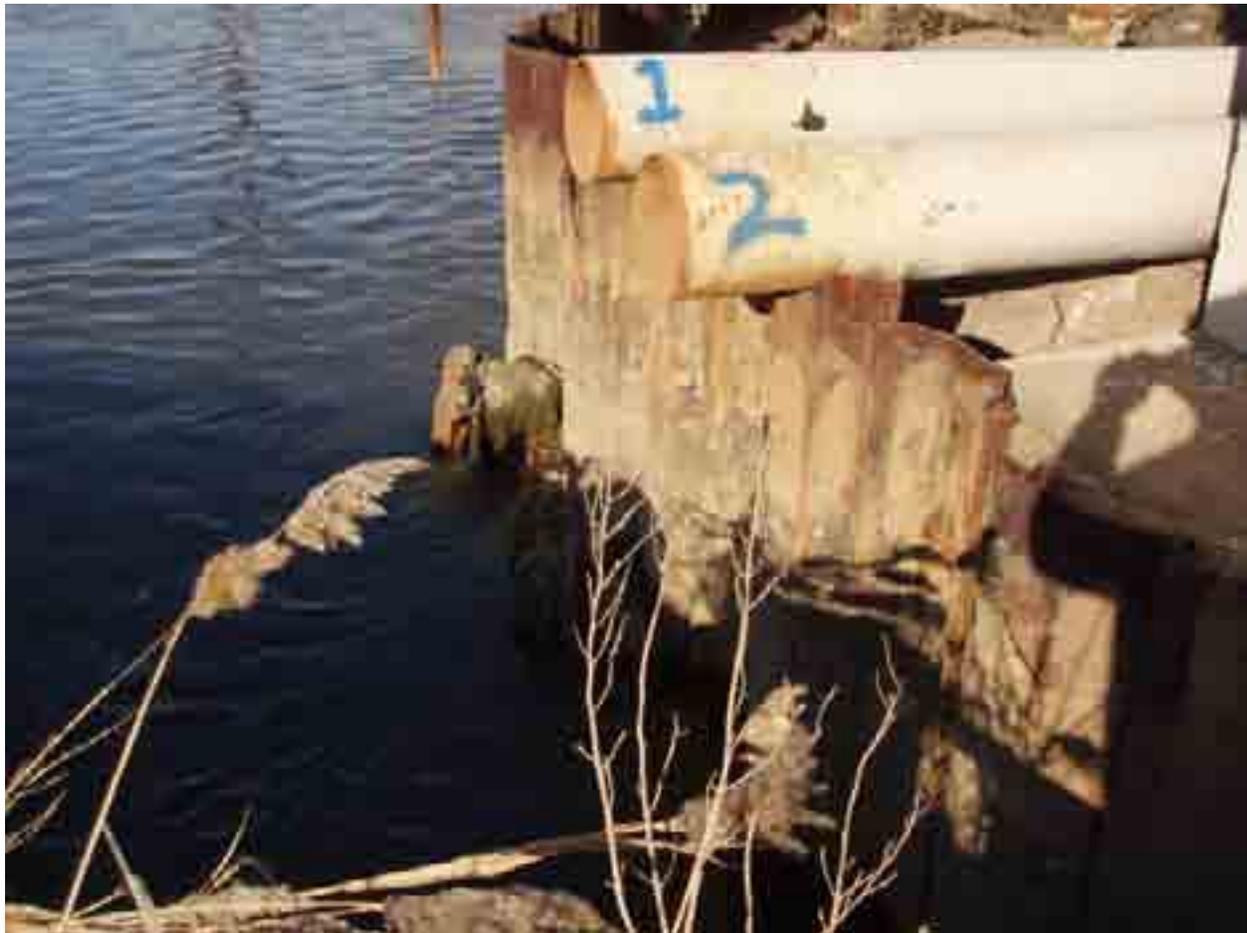
Photo 2 Description: Pump discharge pipes

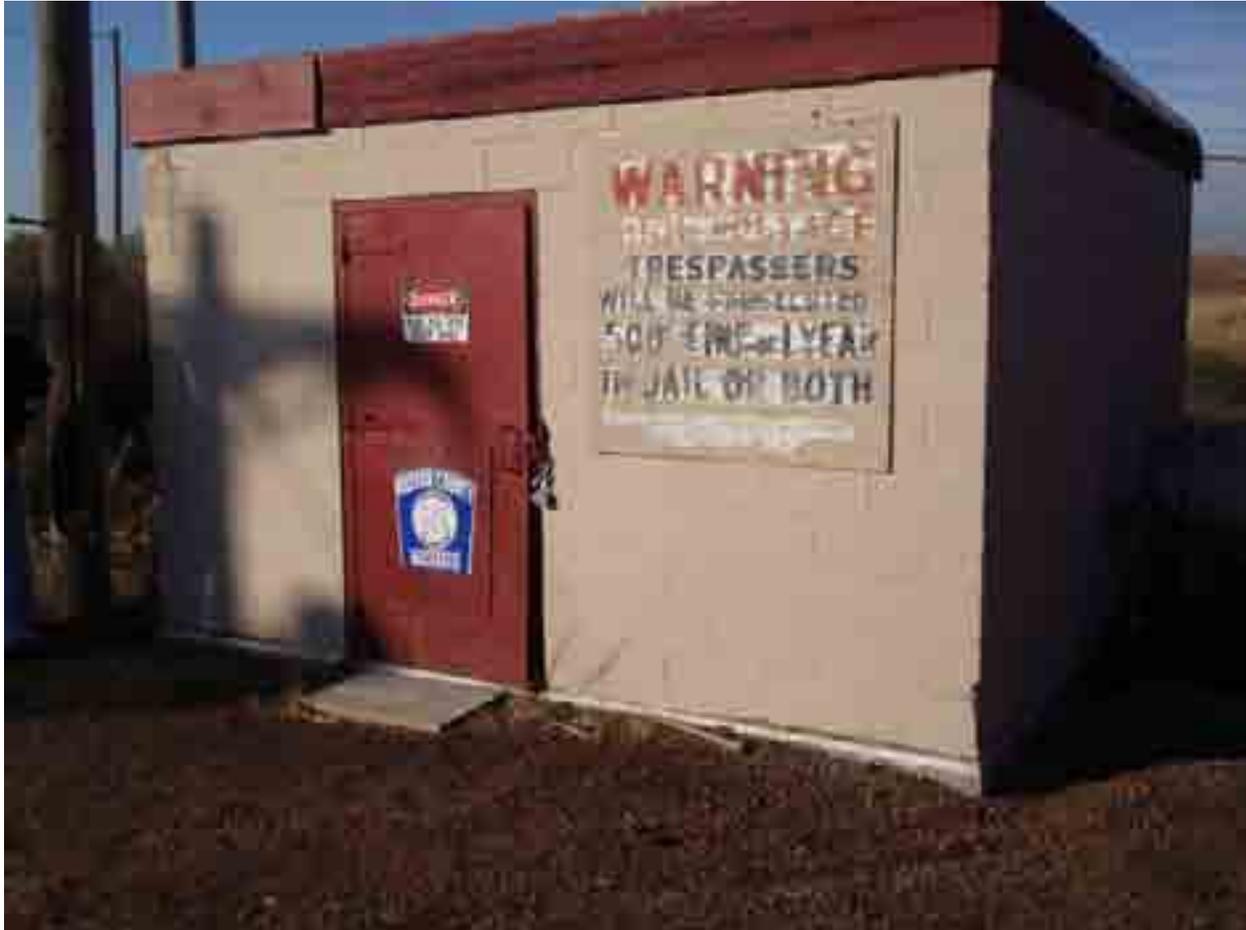
Photo 3 Description: Pump station facility
