Hackensack Meadowlands Tide Gates Inspection Report

**The New Jersey Meadowlands Commission
One DeKorte Park Plaza
Lyndhurst, New Jersey**

March 27, 2006

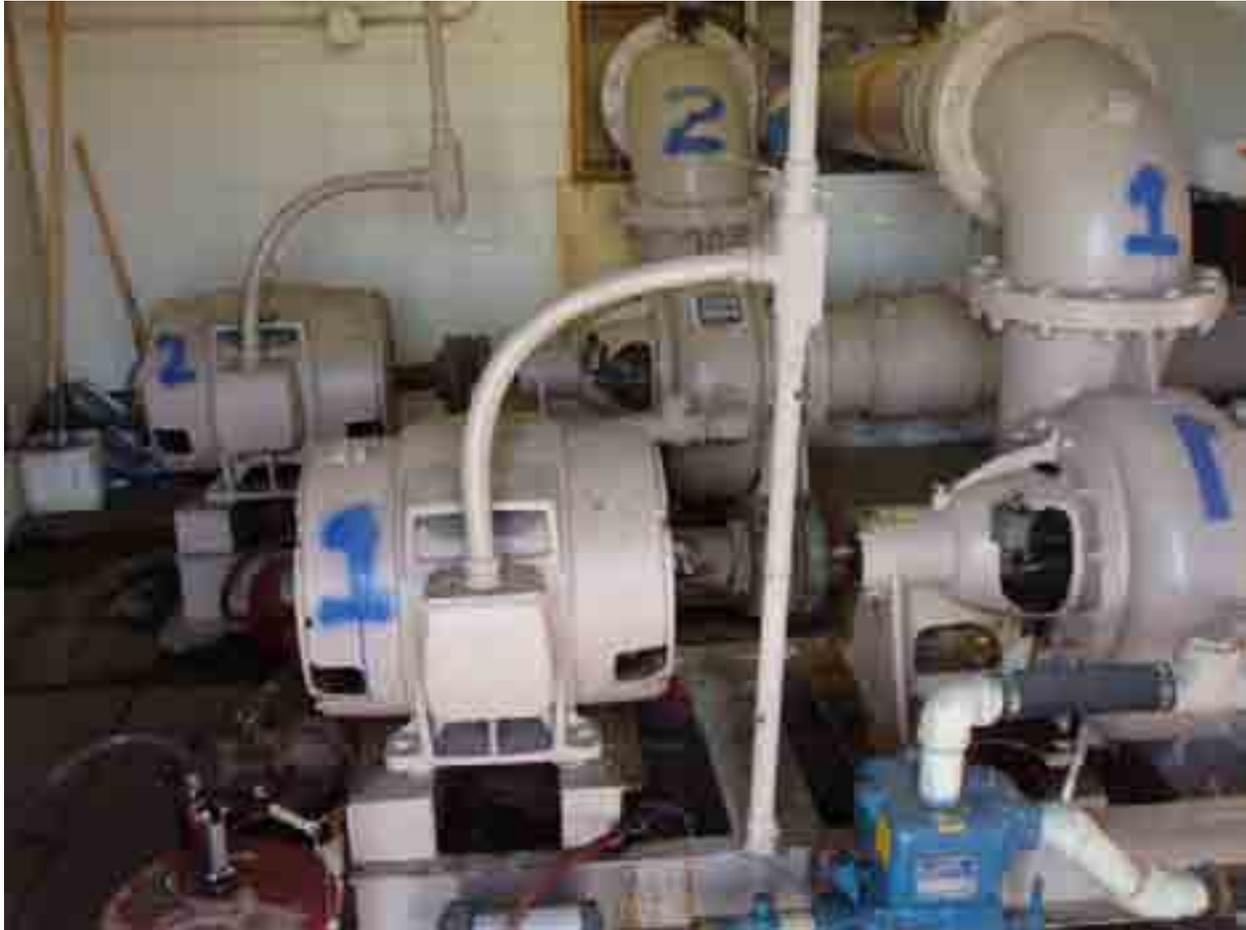
Photo 4 Description: View of pumps

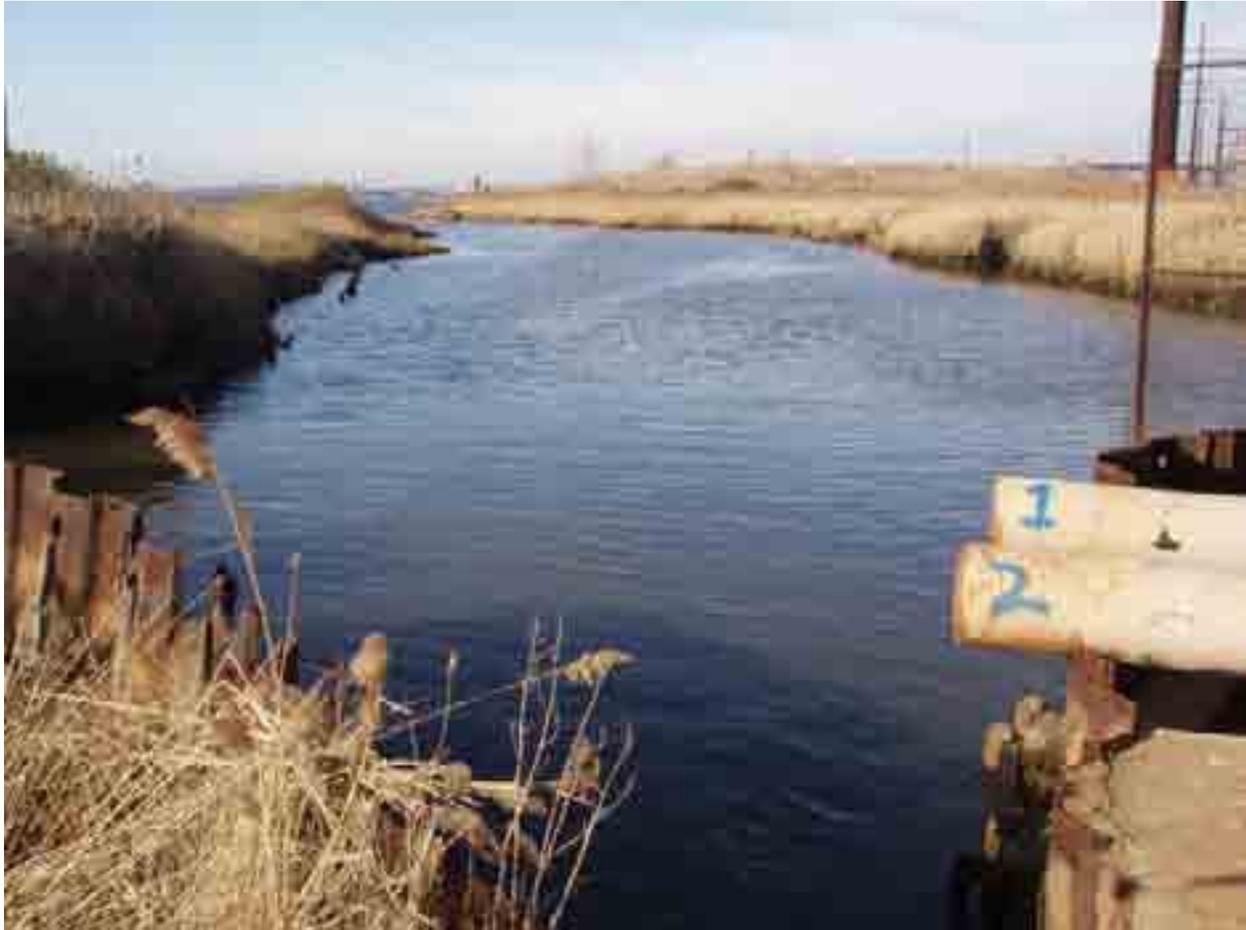
Photo 5 Description: Downstream view from the pump station facility

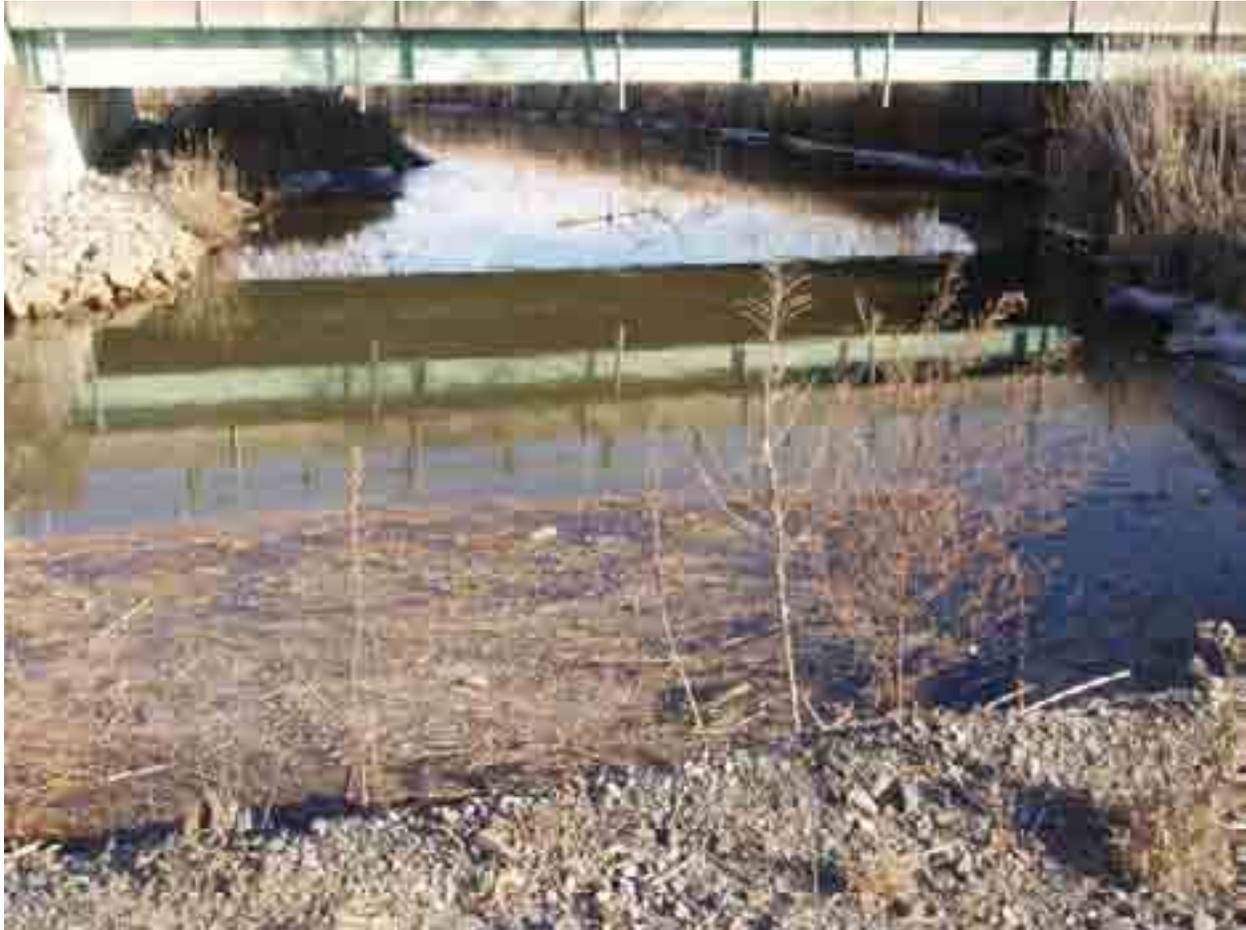
Photo 6 Description: Upstream view from the pump station facility

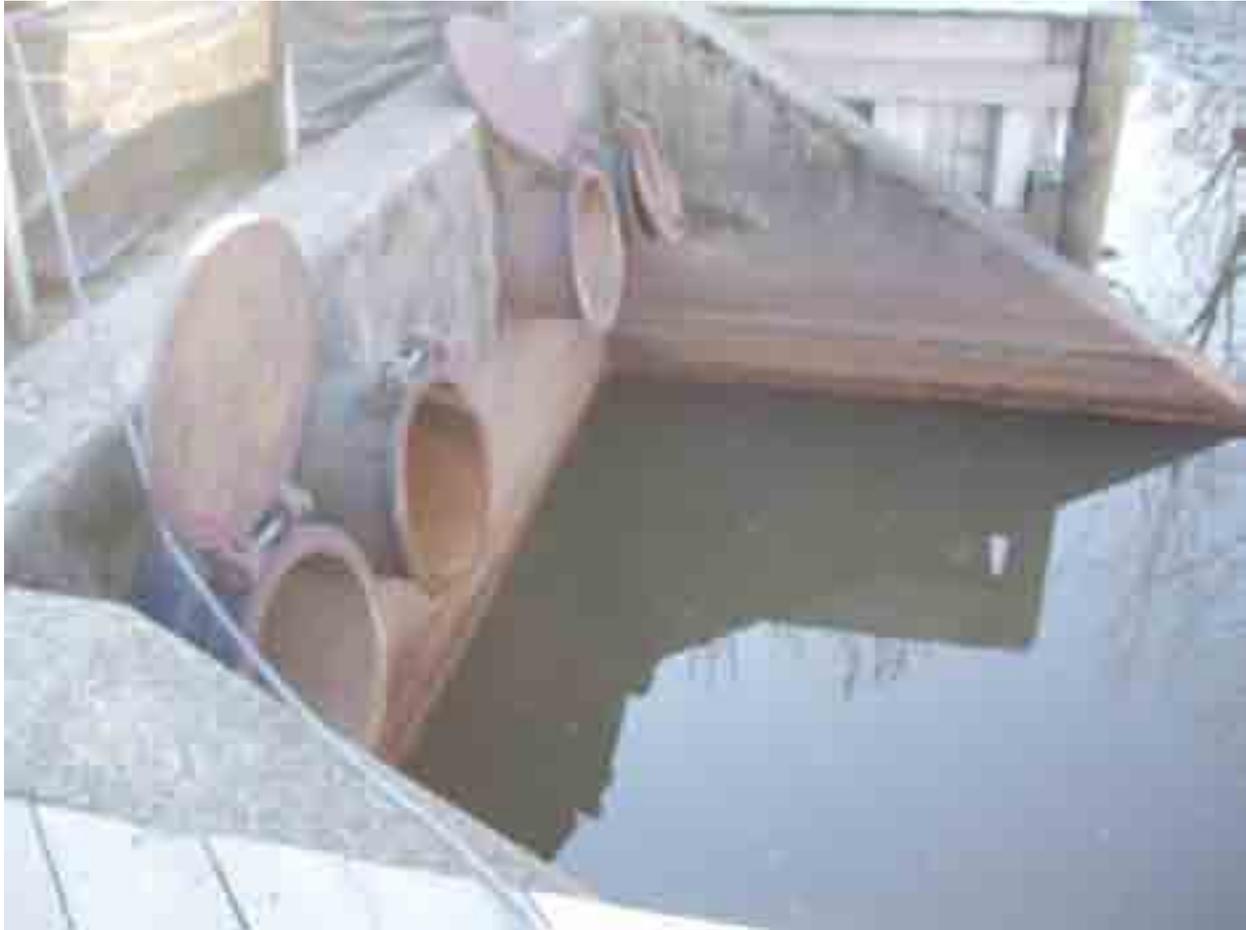
A new pump station is currently being constructed. The current conditions are: 3 out of 4 pumps function, 1 out of 4 tide gates function. The two tide gates that function at discharge are seating properly.

Photo 1 Description: Flap gates shown on outlet structure

Trash racks are clean and are in good condition. The construction by-pass appears to be undersized. The pump house is in good condition with a functional alarm system. Access needs to be cleared to all system components. The pumps were maintained as follows: pump #1 in 2006, pump # 2 in 2005 and pump #3 in 2000.

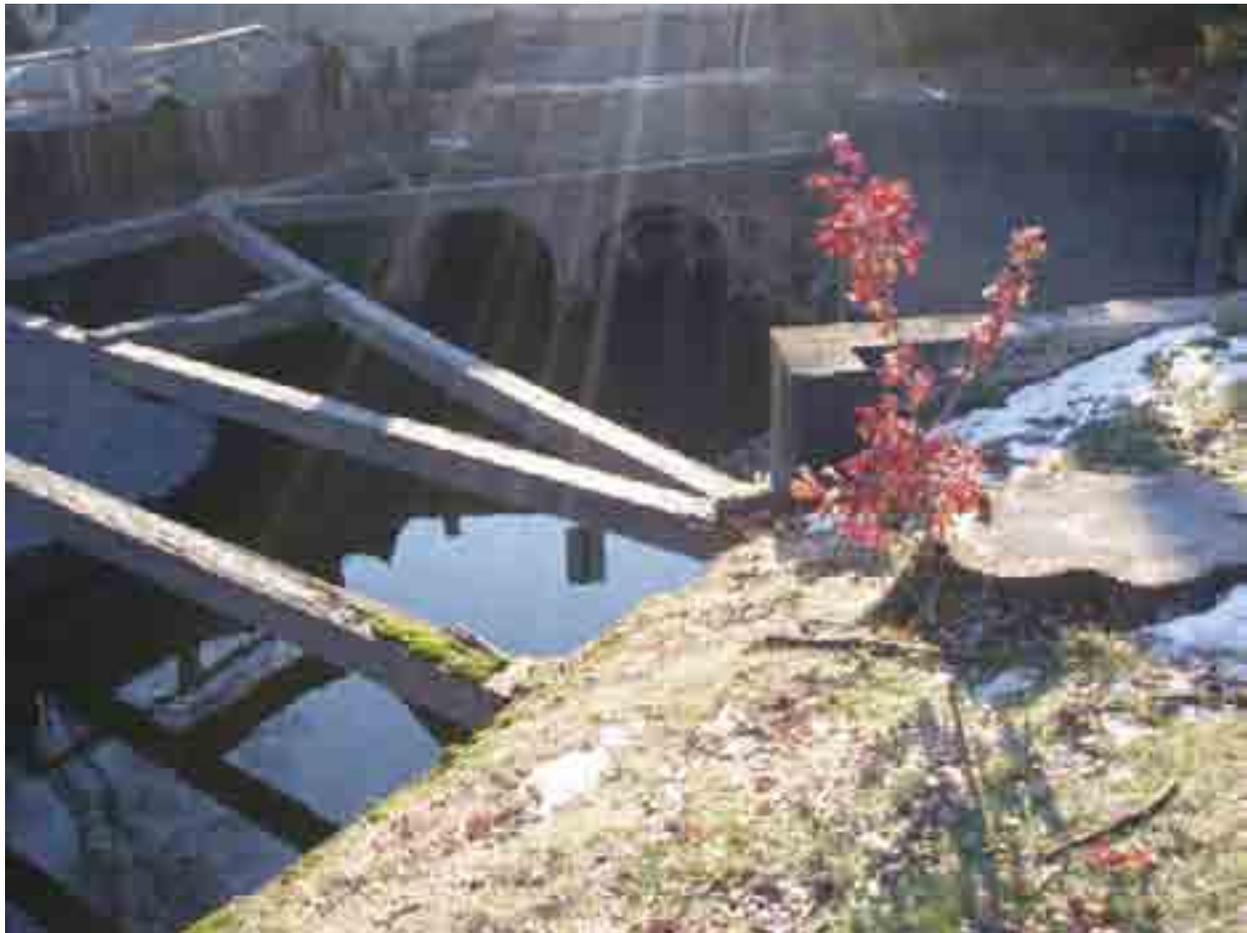
Photo 2 Description: In-flow at pump station

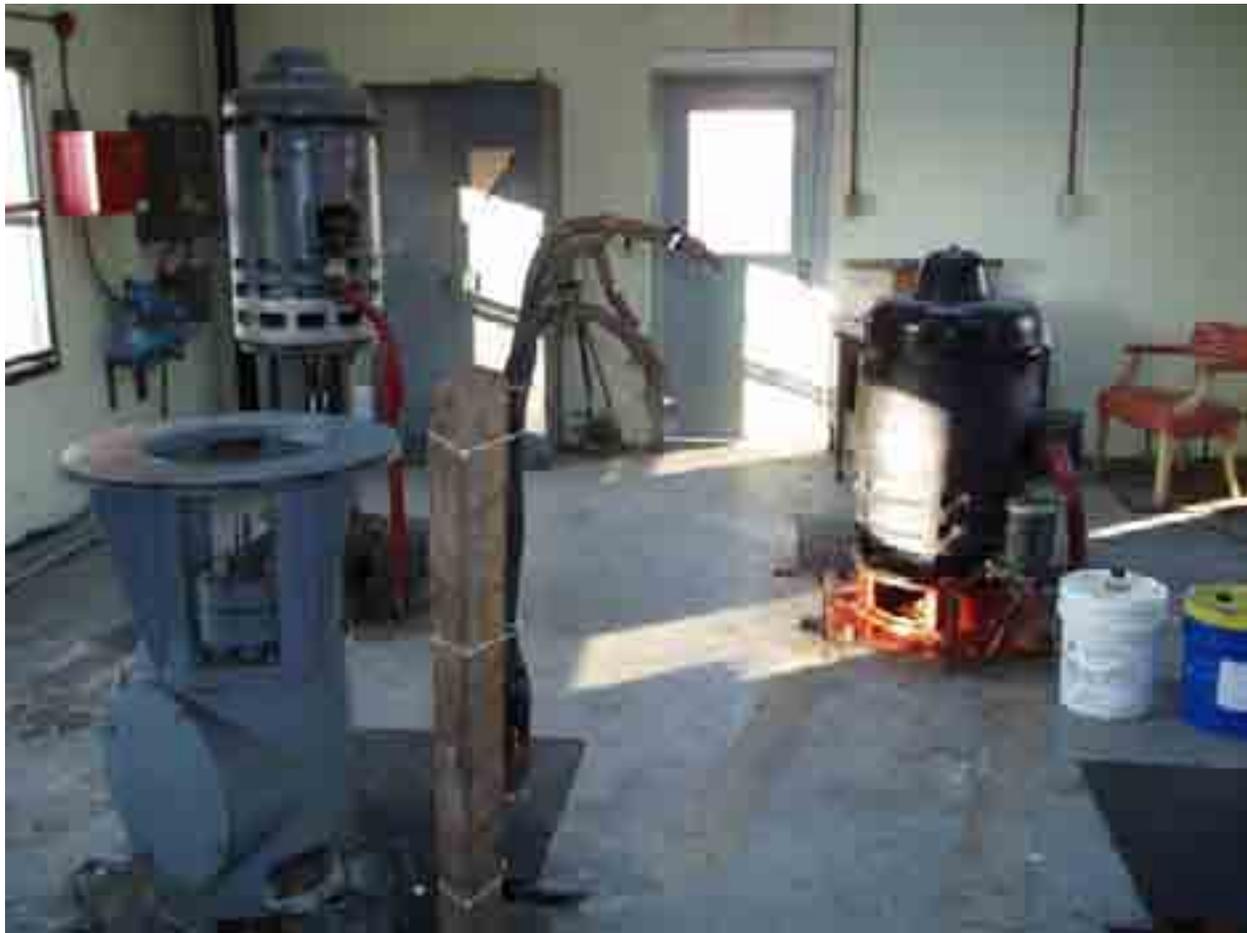
Photo 3 Description: View of pumps

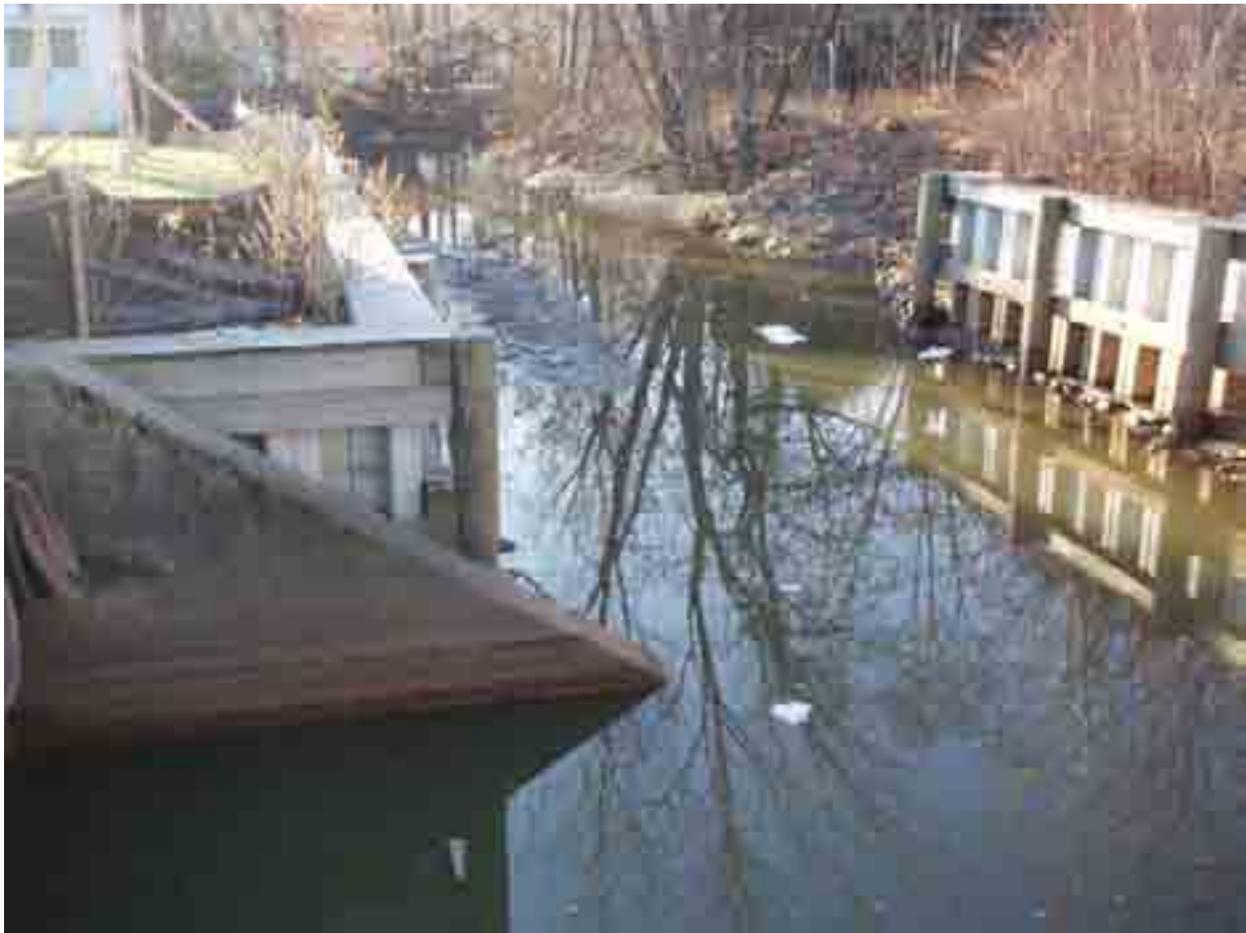
Photo 4 Description: Downstream view from the pump station

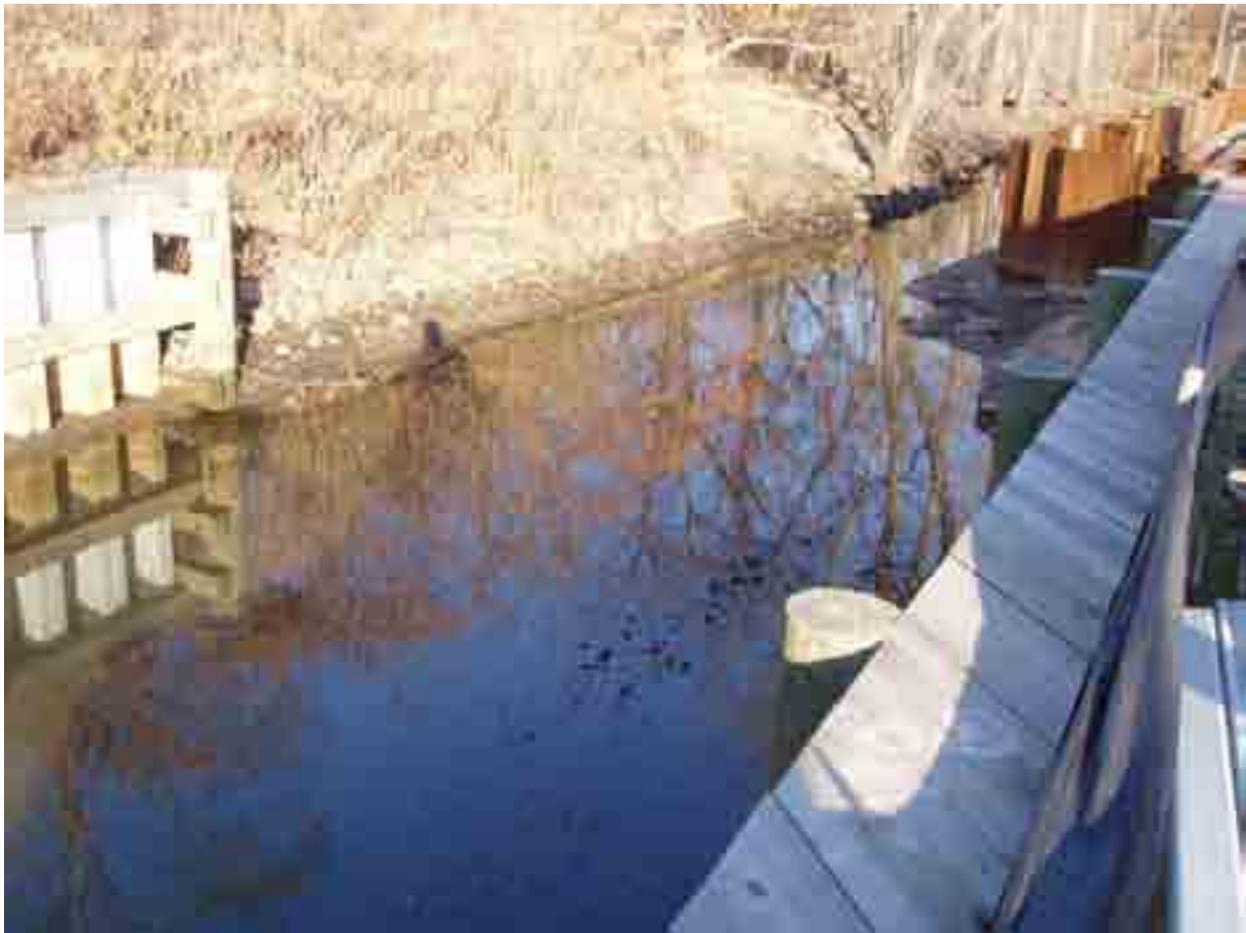
Photo 5 Description: Upstream view from the pump station
