# Hackensack Meadowlands Tide Gates Inspection Report

**The National Flood Insurance Program  
Community Rating System**

**The New Jersey Meadowlands Commission  
One DeKorte Park Plaza  
Lyndhurst, New Jersey**

**March 27, 2006**

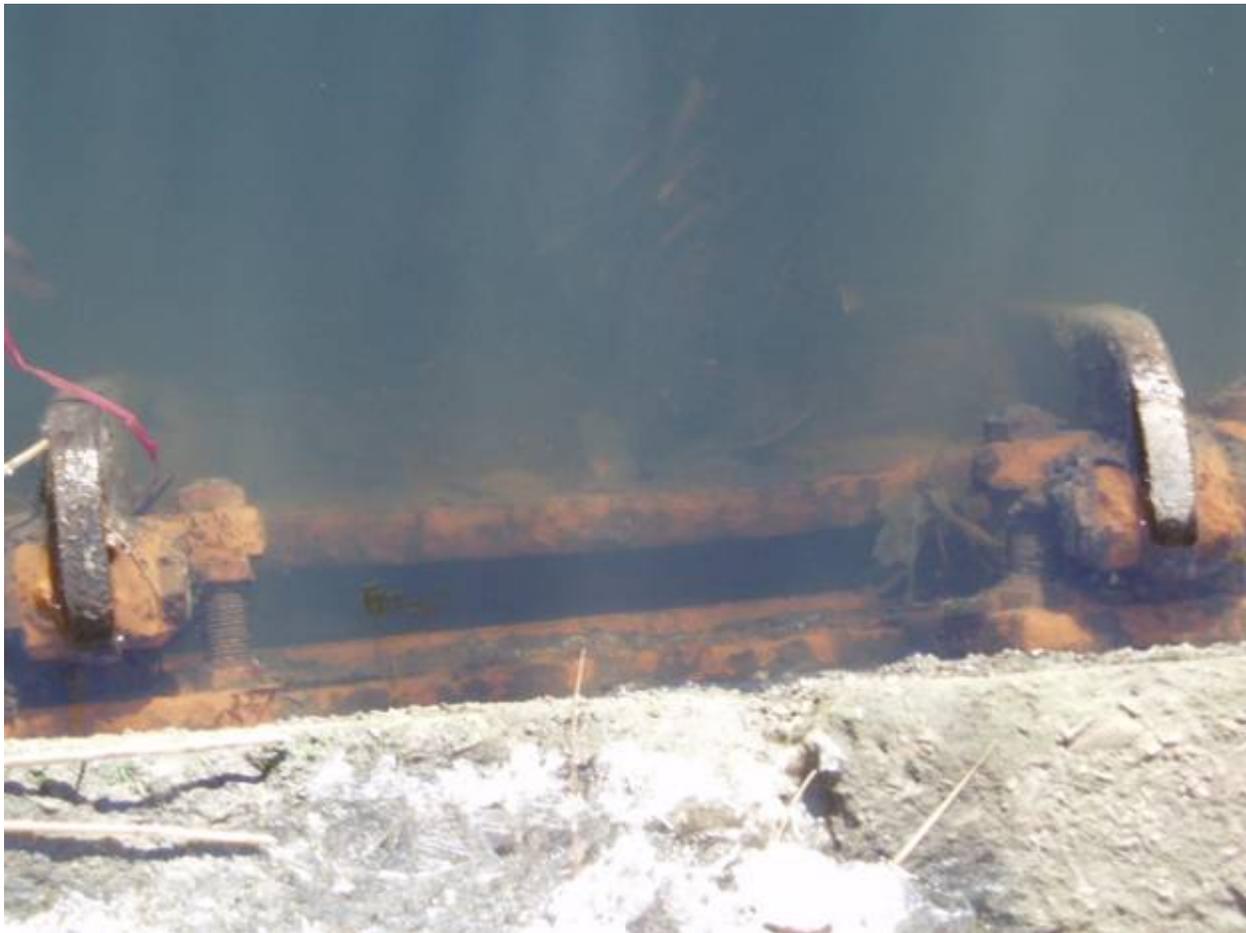
**Photo 1 Description: 1 steel flap gate**

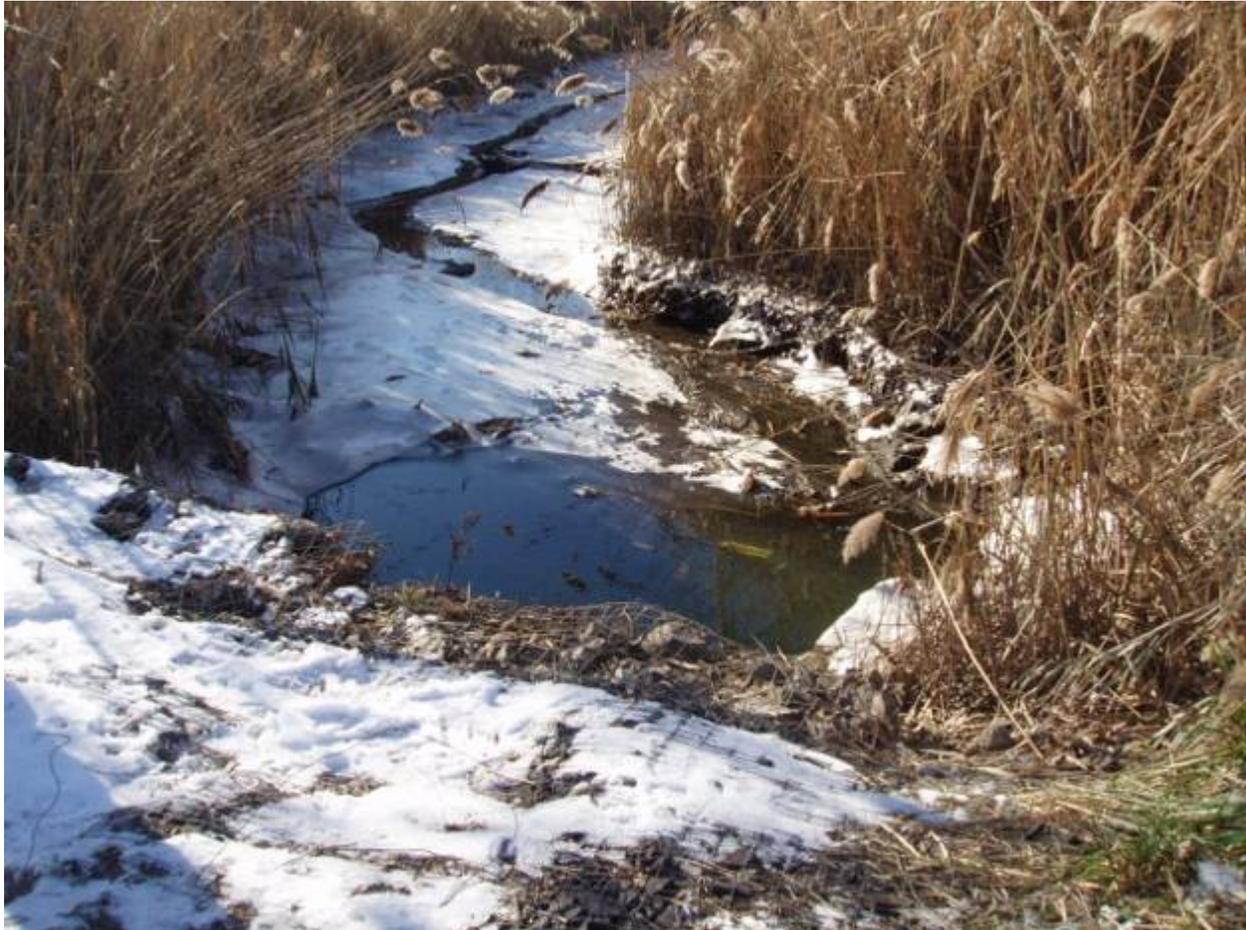
**Photo 2 Description: Downstream view from tide gate**

\* During low tide condition, the system was found to be non-functional. Please see attached low tide condition report.

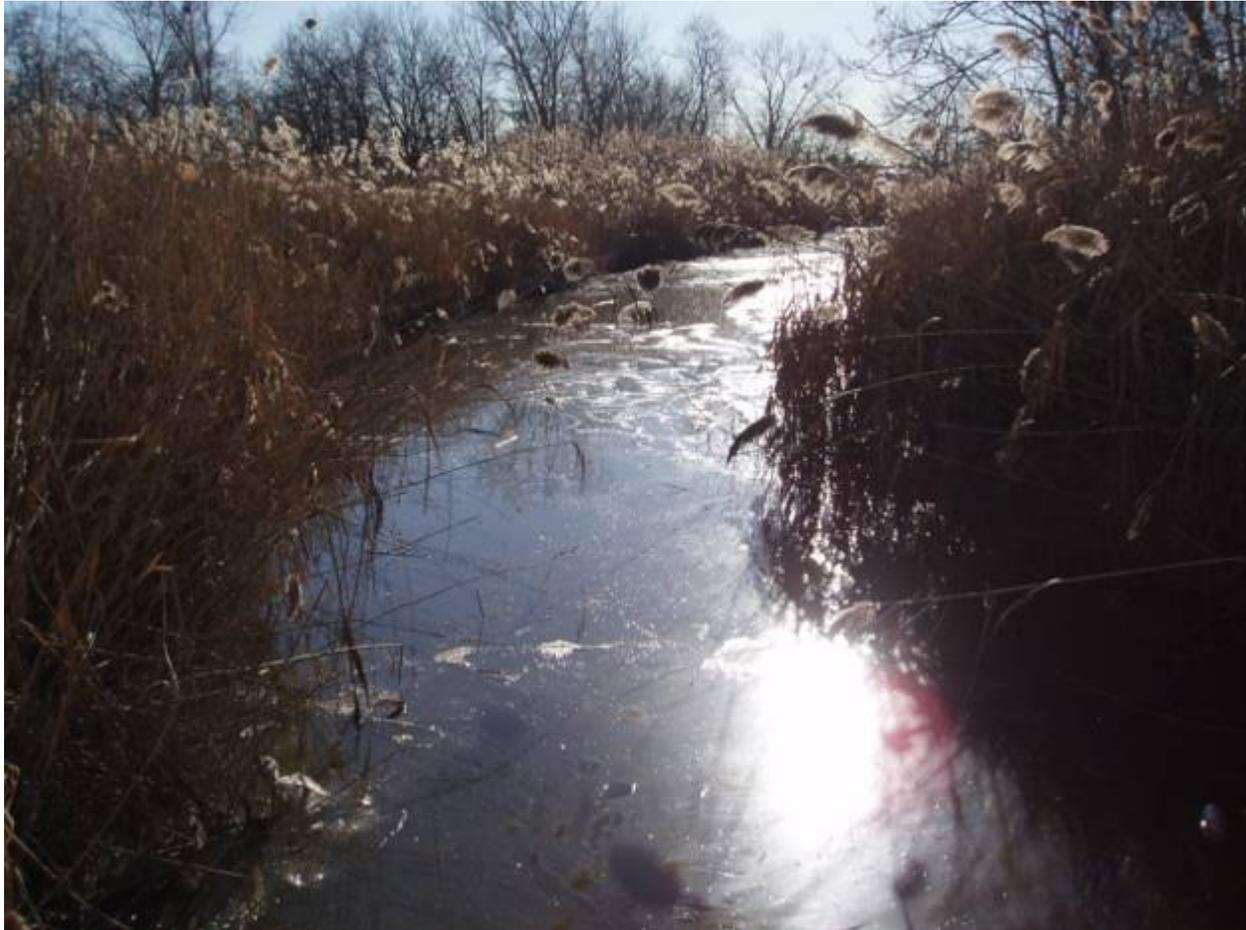
The gate appears to be working during high tide conditions. The storm sewer in the area need to be maintained regularly due to the build up of sedimentation.

**Photo 2 Description: Downstream view from tide gate**

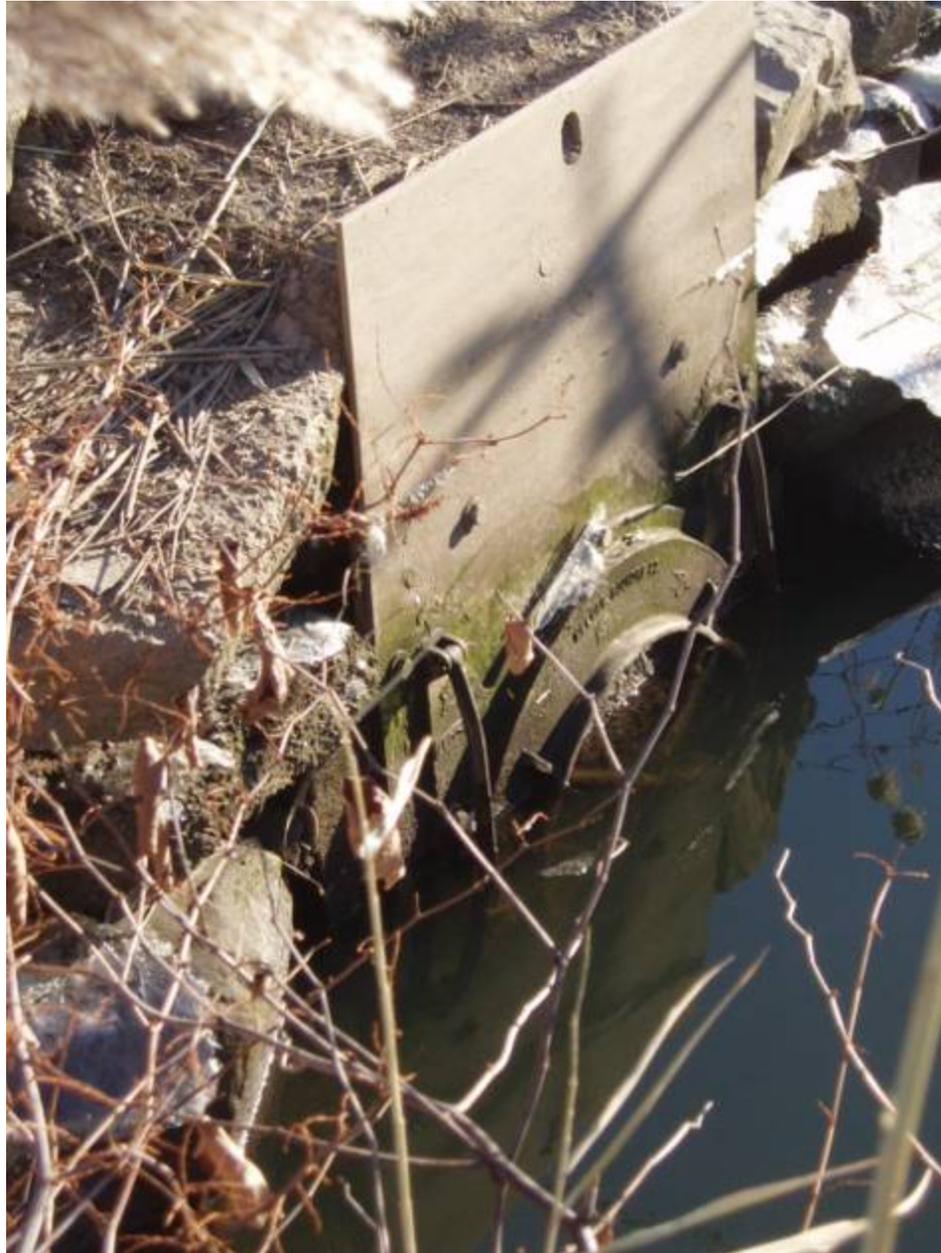
**Photo 1 Description: Metal flap gate**

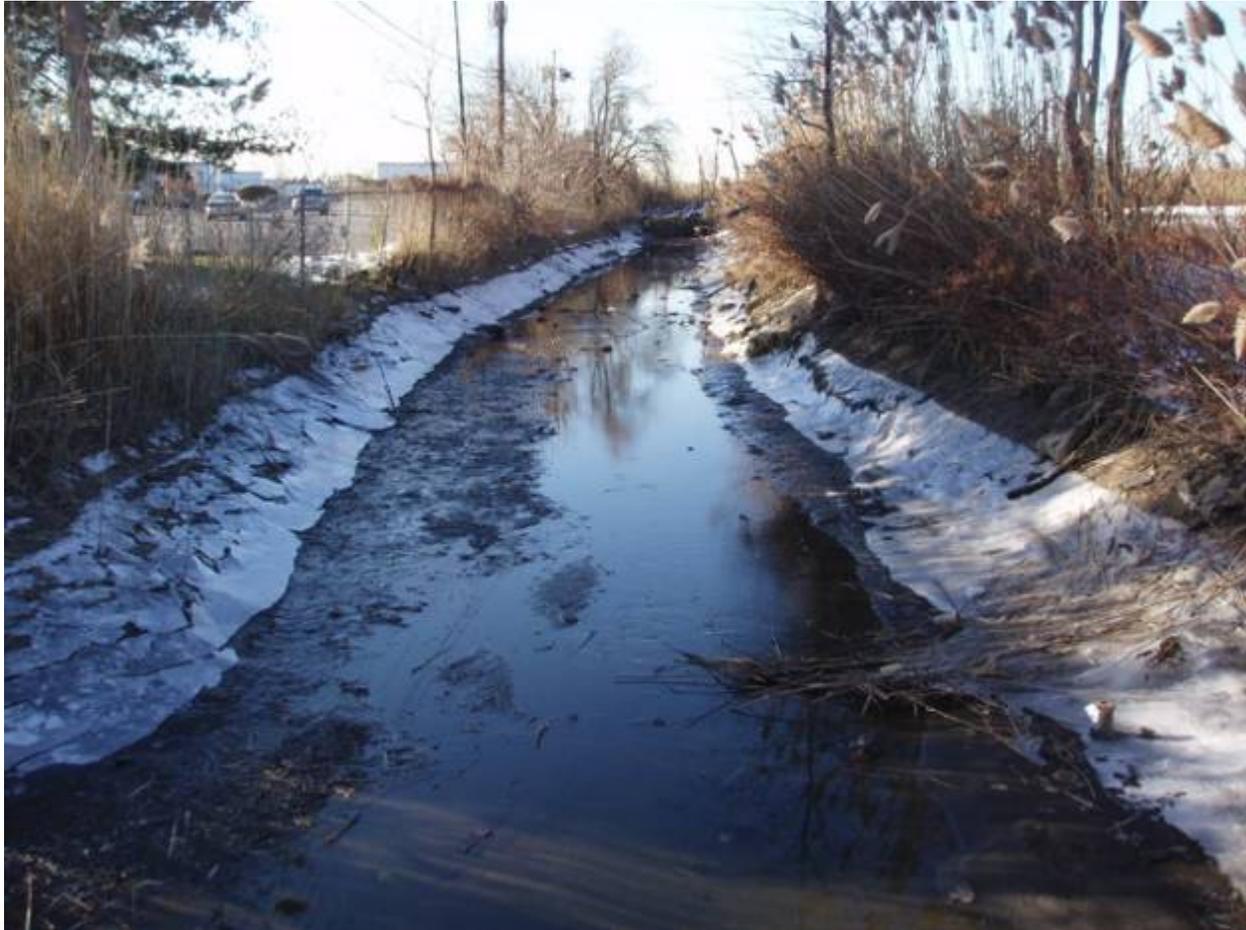
**Photo 2 Description: Downstream view from tide gate**

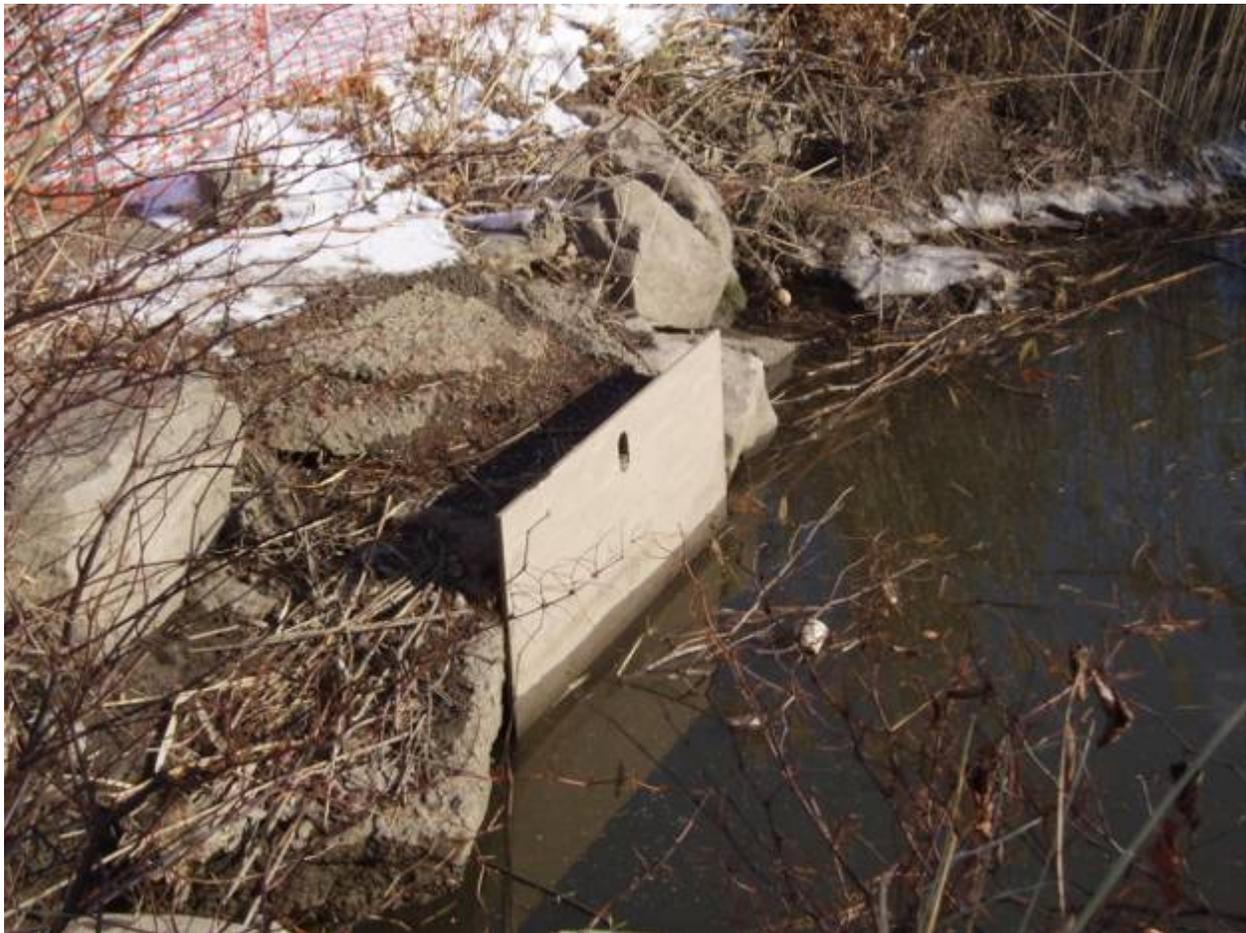
The tide gate appears to be working properly during high tide conditions.

**Photo 1 Description: Metal flap gate**

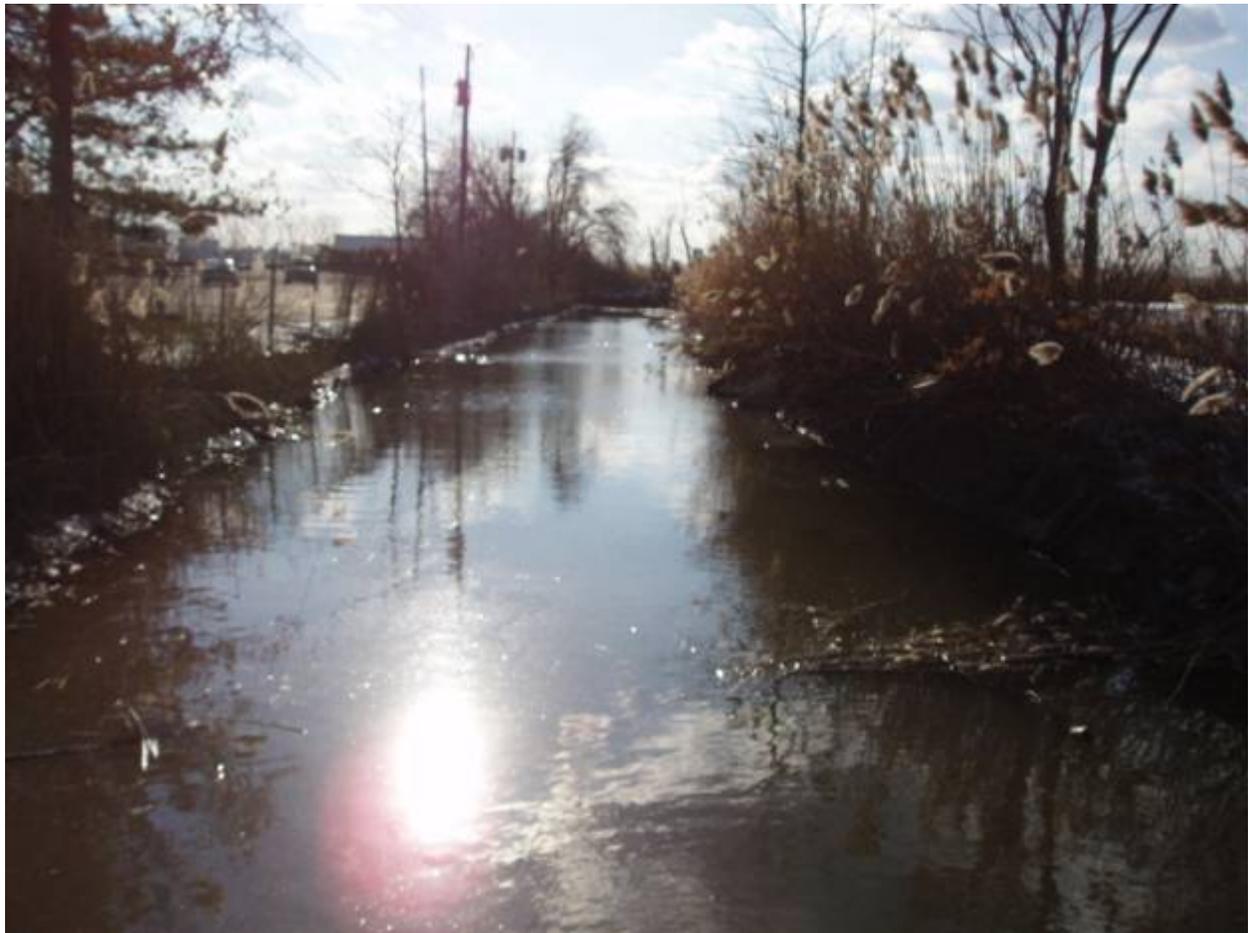
**Photo 2 Description:** Upstream view from tide gate

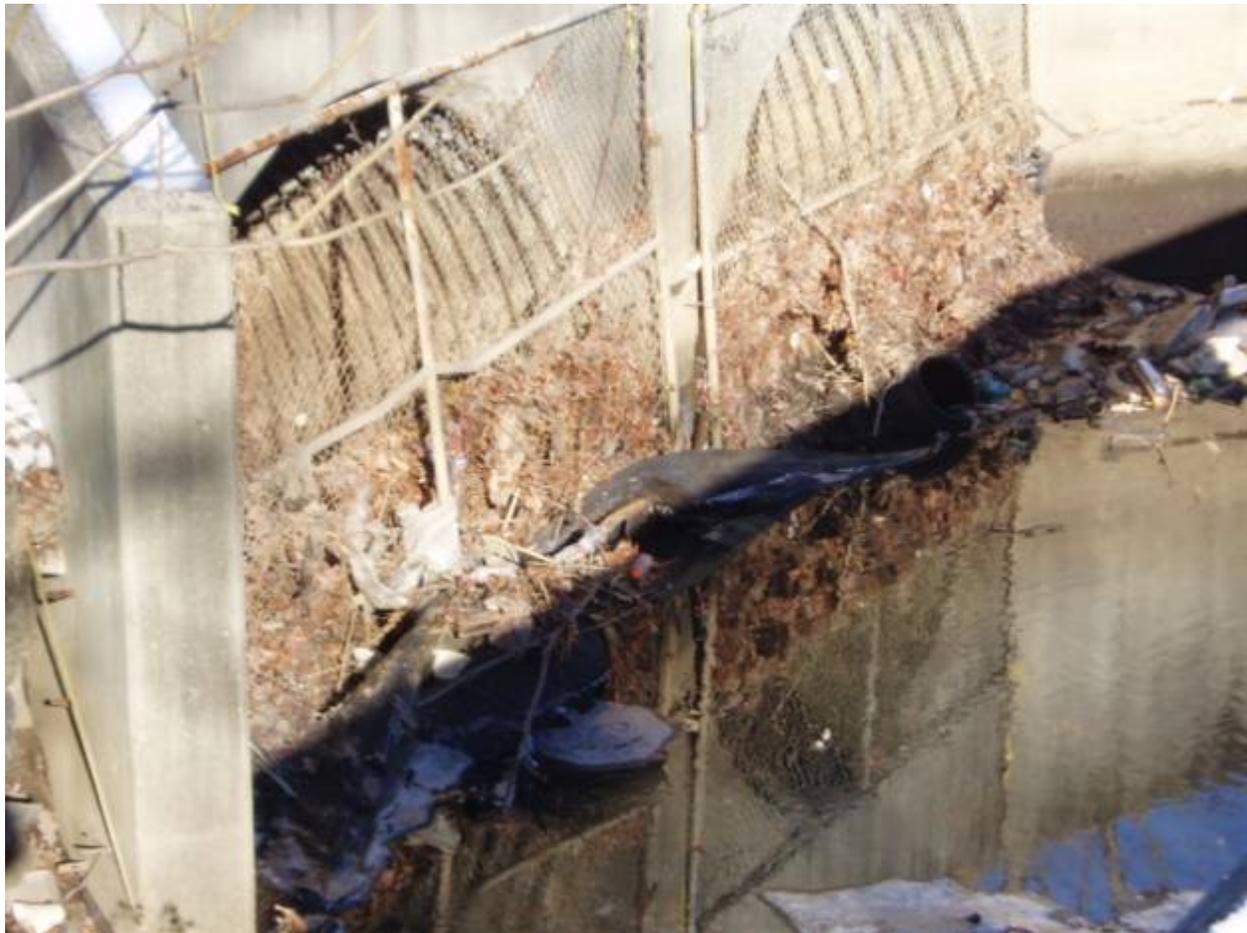
**Photo 2 Description:** Upstream end of the tide gates

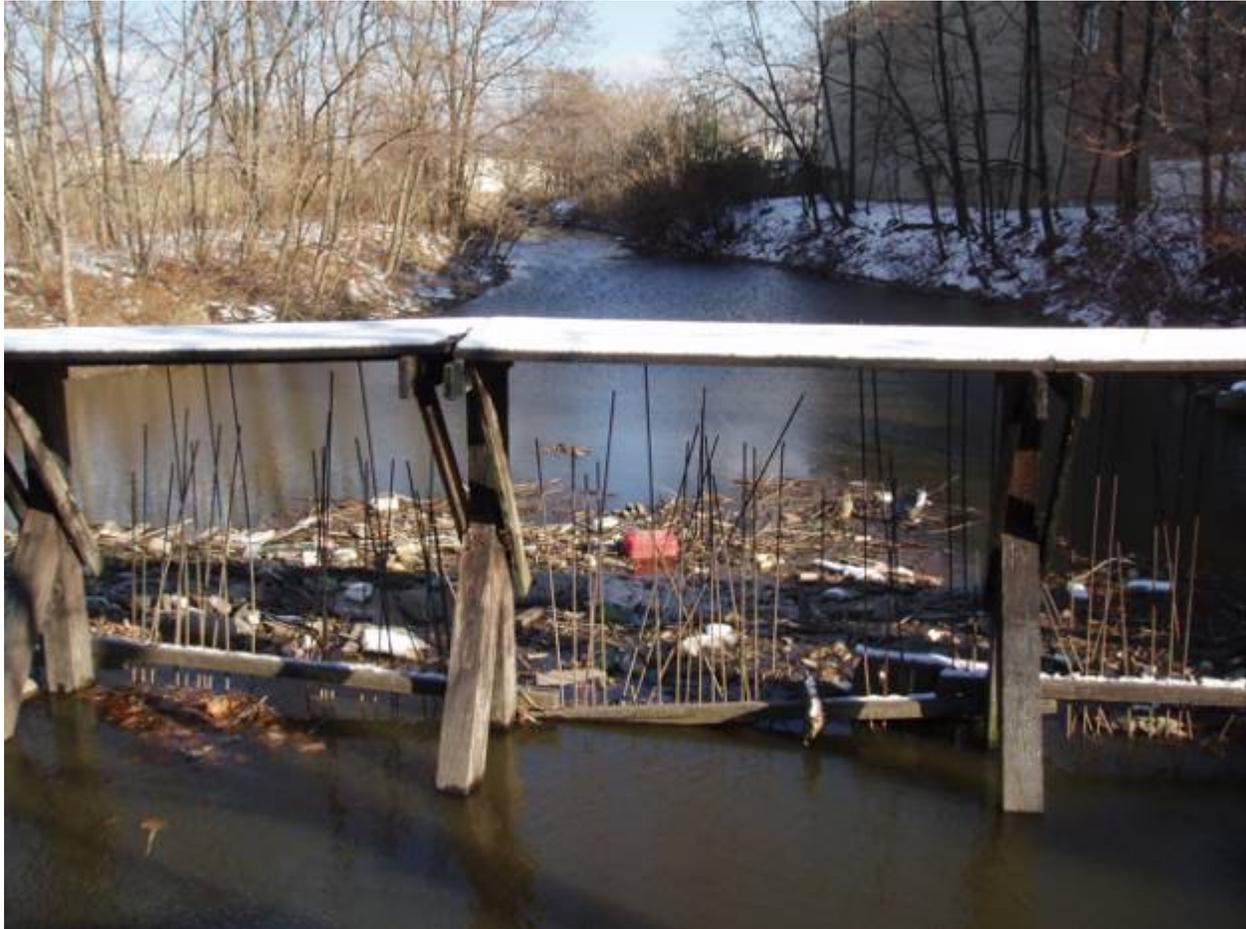
The tide gates are malfunctioning and not seating properly, specifically tide gates two and four. The water is entering through the gates and entering the upstream system during high tide conditions.

**Photo 2 Description: Upstream view from tide gates and view of the trash rack system**

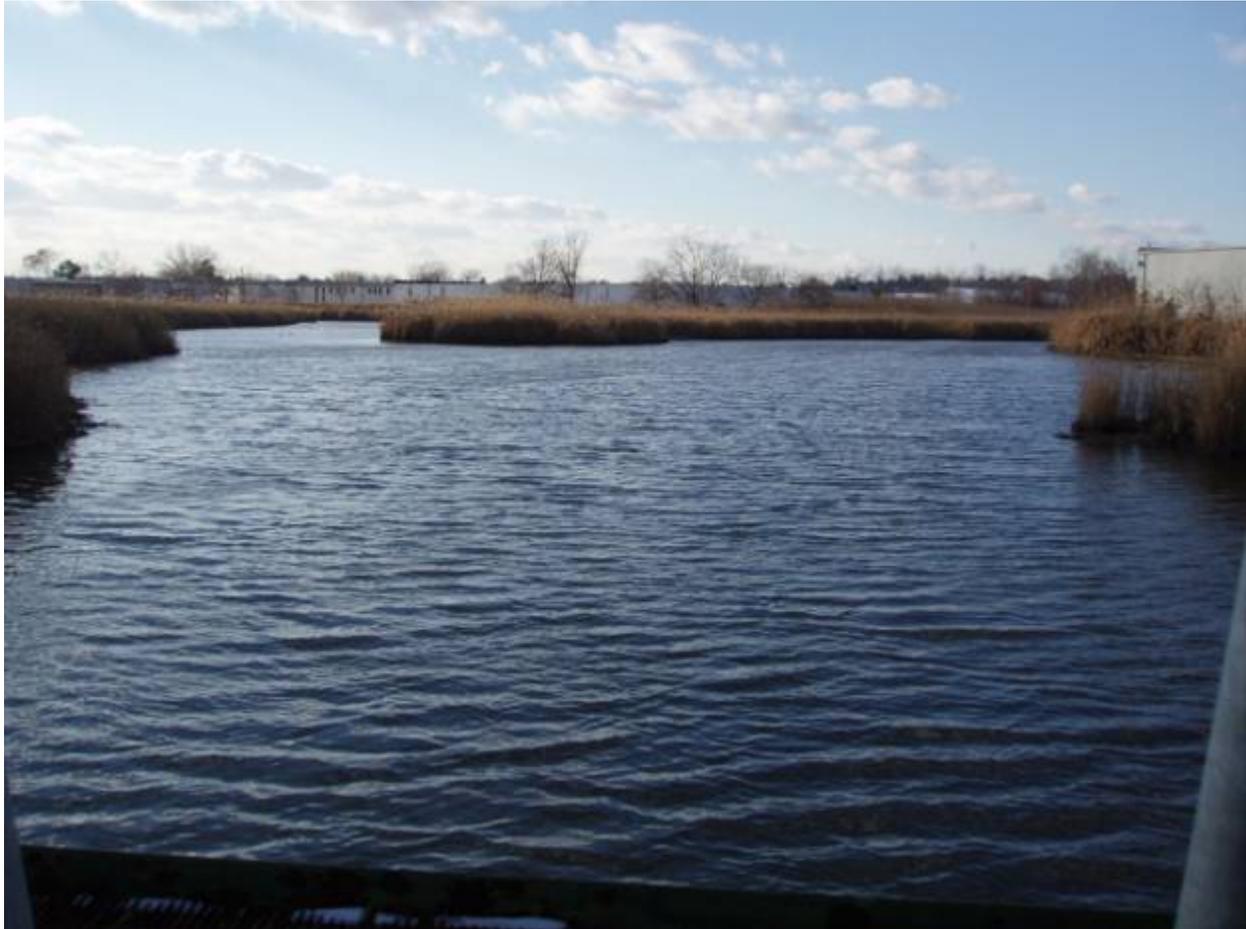
**Photo 3 Description: Downstream view from the tide gates**

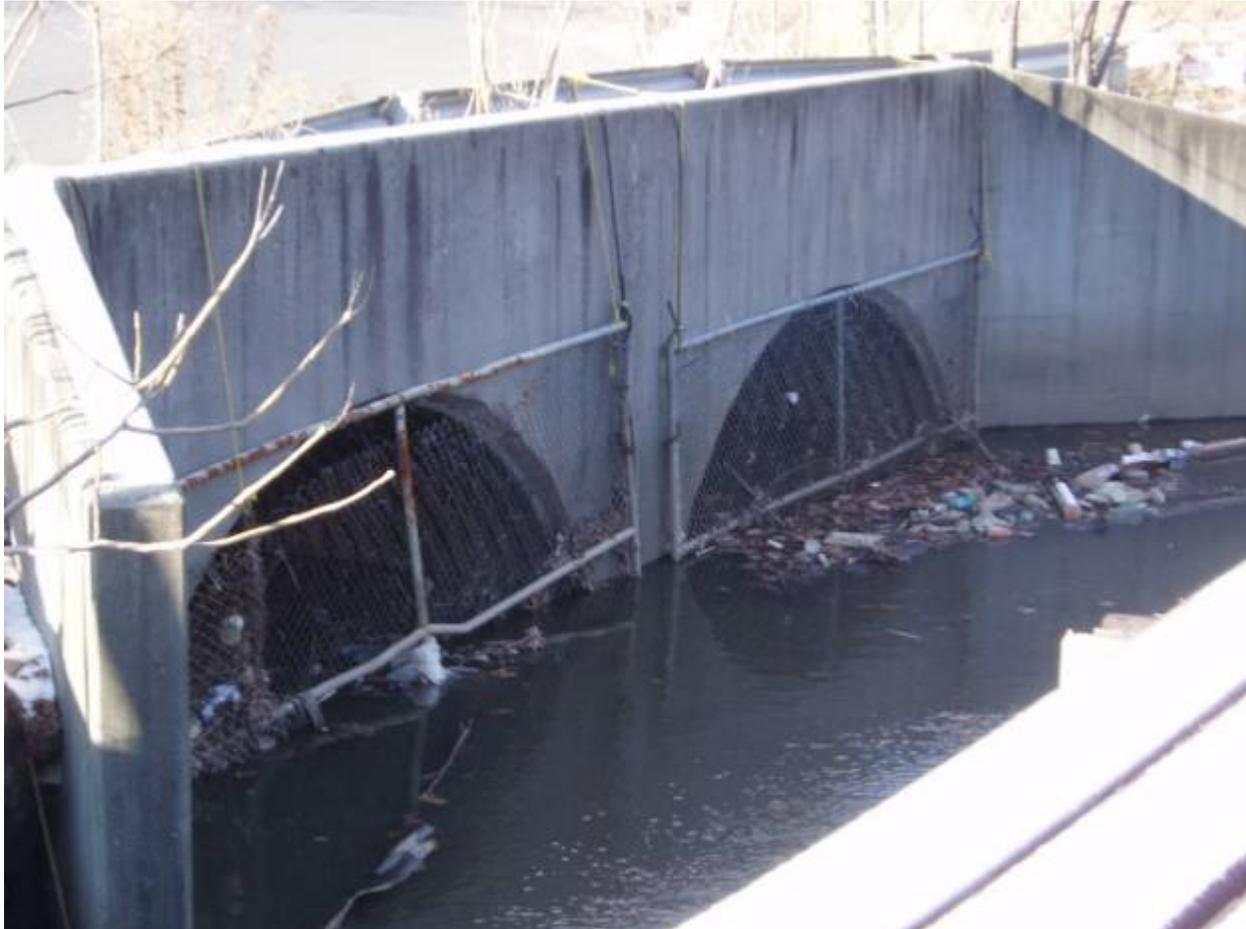
**Photo 4 Description: Upstream end of the tide gates**

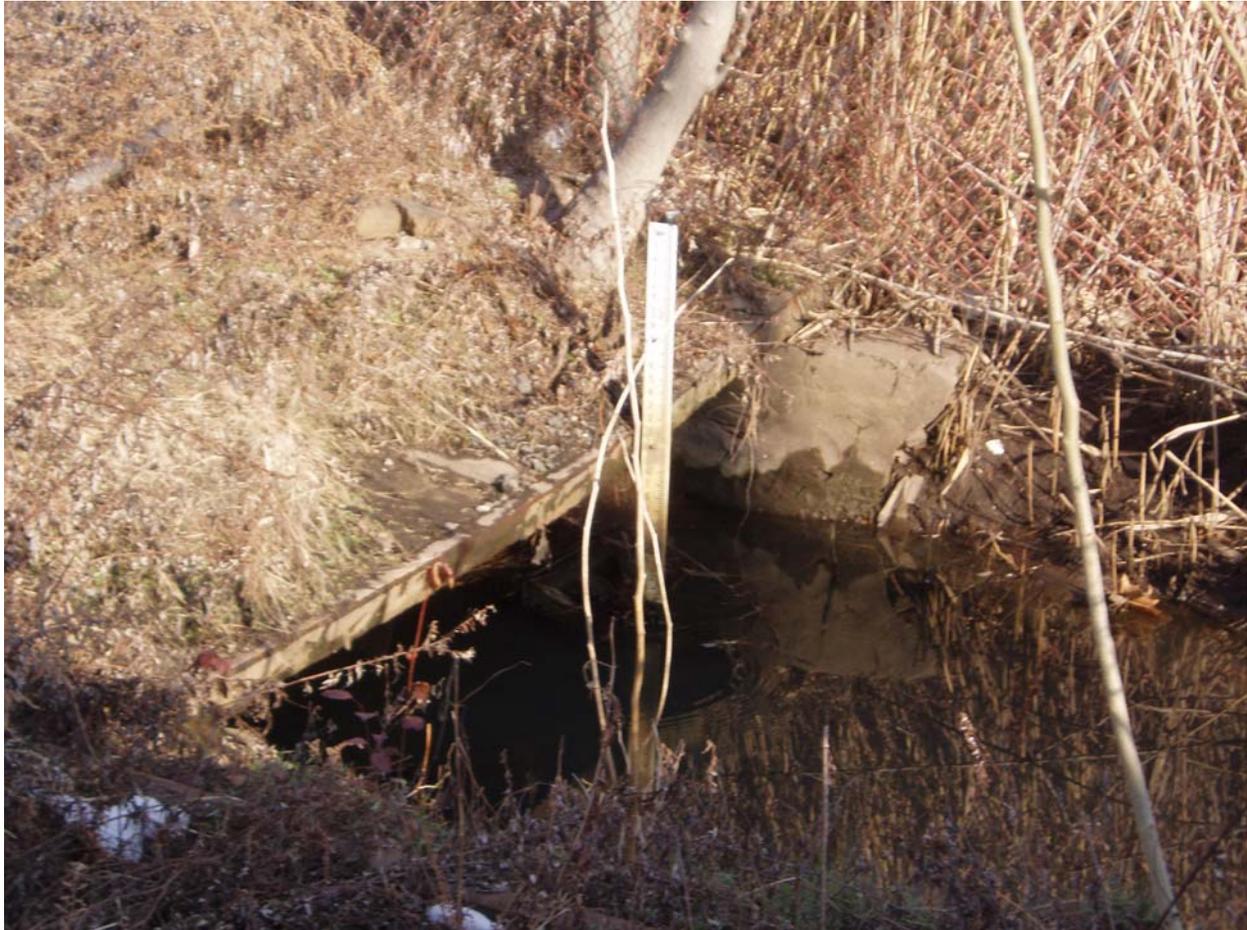
The tide gate located in the intersection of 13<sup>th</sup> Street and Division Street in Carlstadt was inspected on December 19, 2005 during low and high tide conditions. The water elevation in the vicinity of the tide gate did not change regardless of the tidal conditions. The tide gate is constantly submerged and cannot be inspected. After a detailed analysis of the topographic data and aerial mapping, NJMC has determined tidal water cannot reach the tide gate, and therefore, it is recommended that the J.P. Smith Tide Gate no longer be inspected.

**Photo 1 Description: Existing tide gate structure shown**

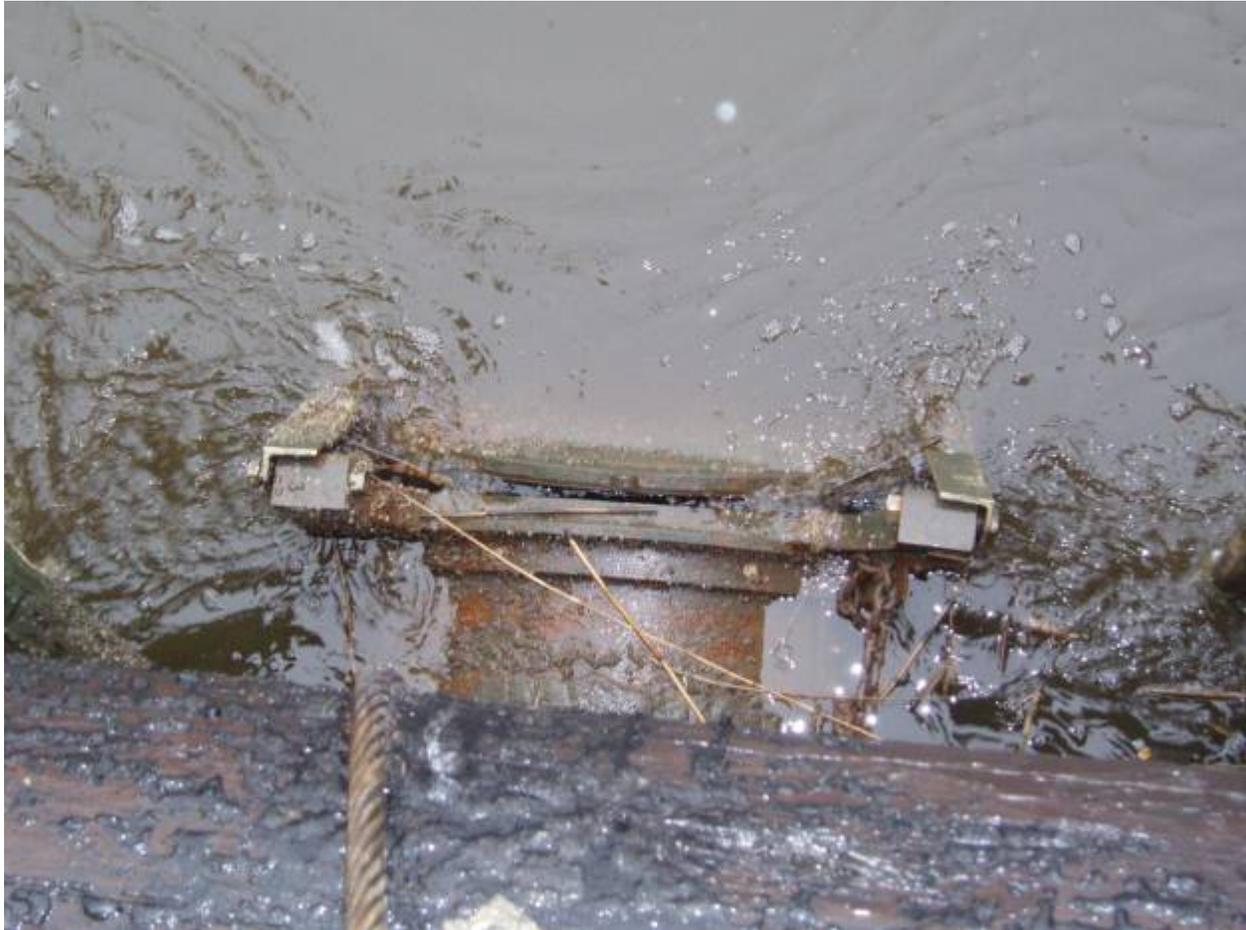
**Photo 1 Description: Tide gate shown in the open position**

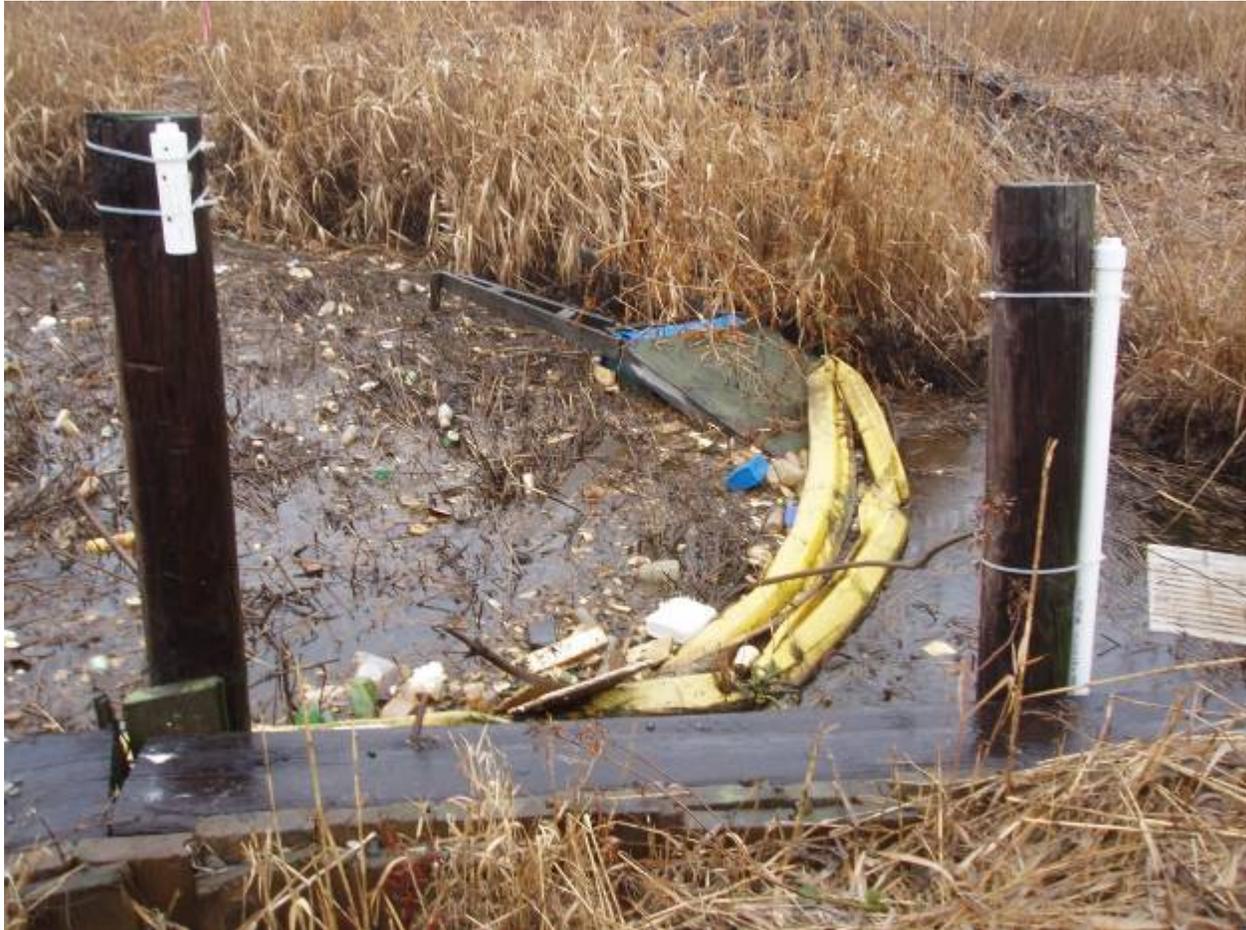
**Photo 2 Description: View of trash rack on upstream side of the tide gate**

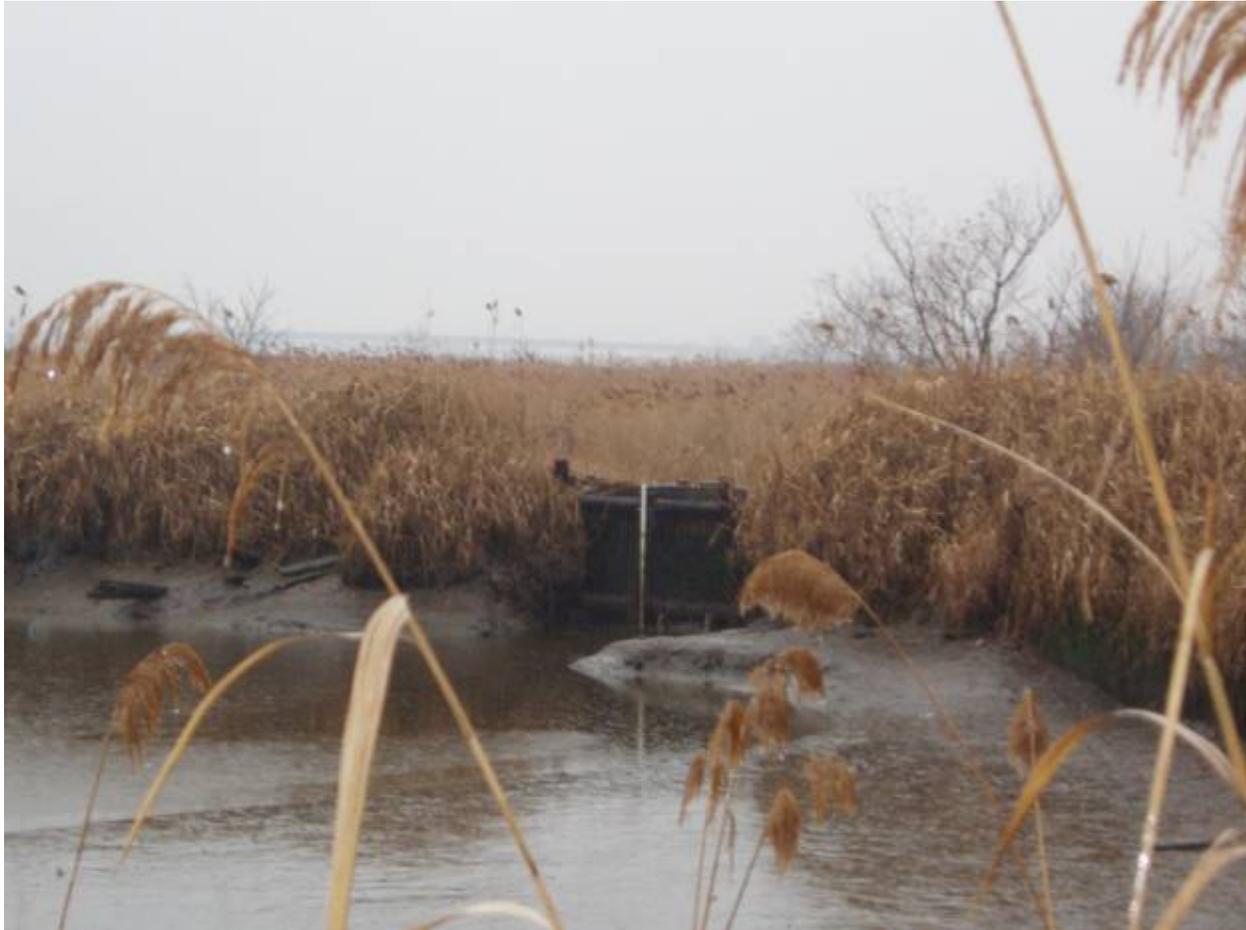
**Photo 3 Description: View of tide gate structure**

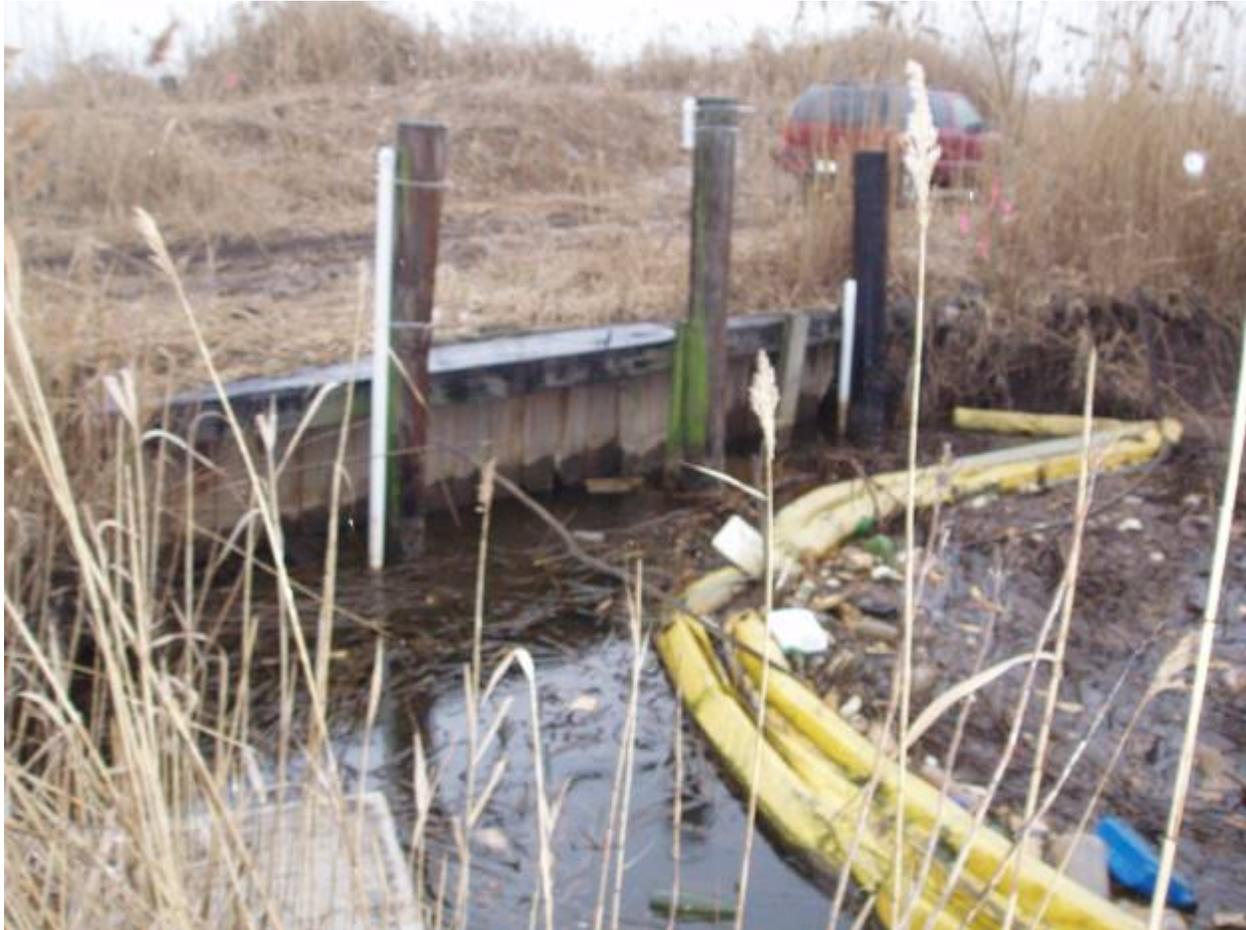
The tide gate appears to be working properly during high tide conditions.

**Photo 1 Description: Trash rack system**

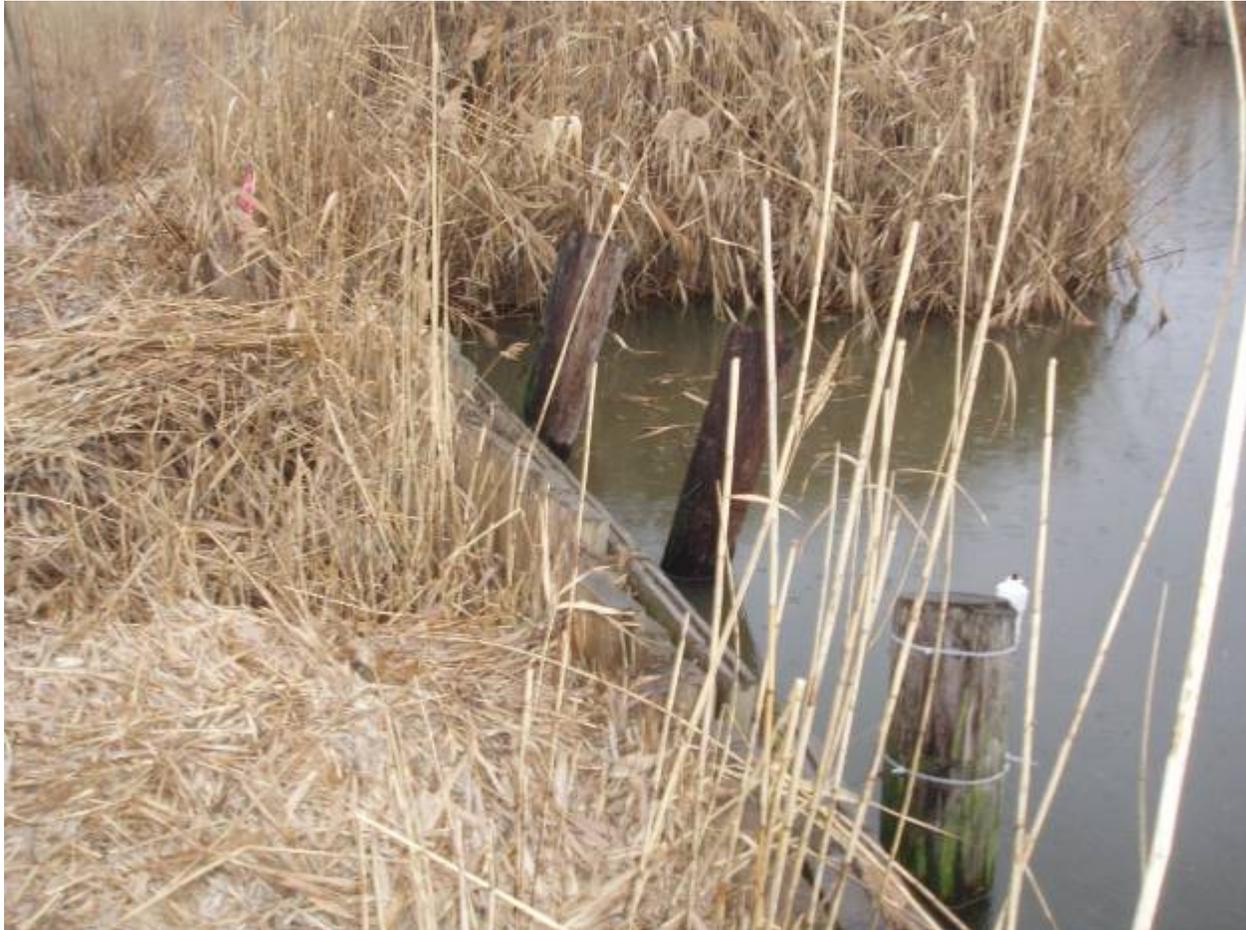
**Photo 2 Description: Tide gate headwall**

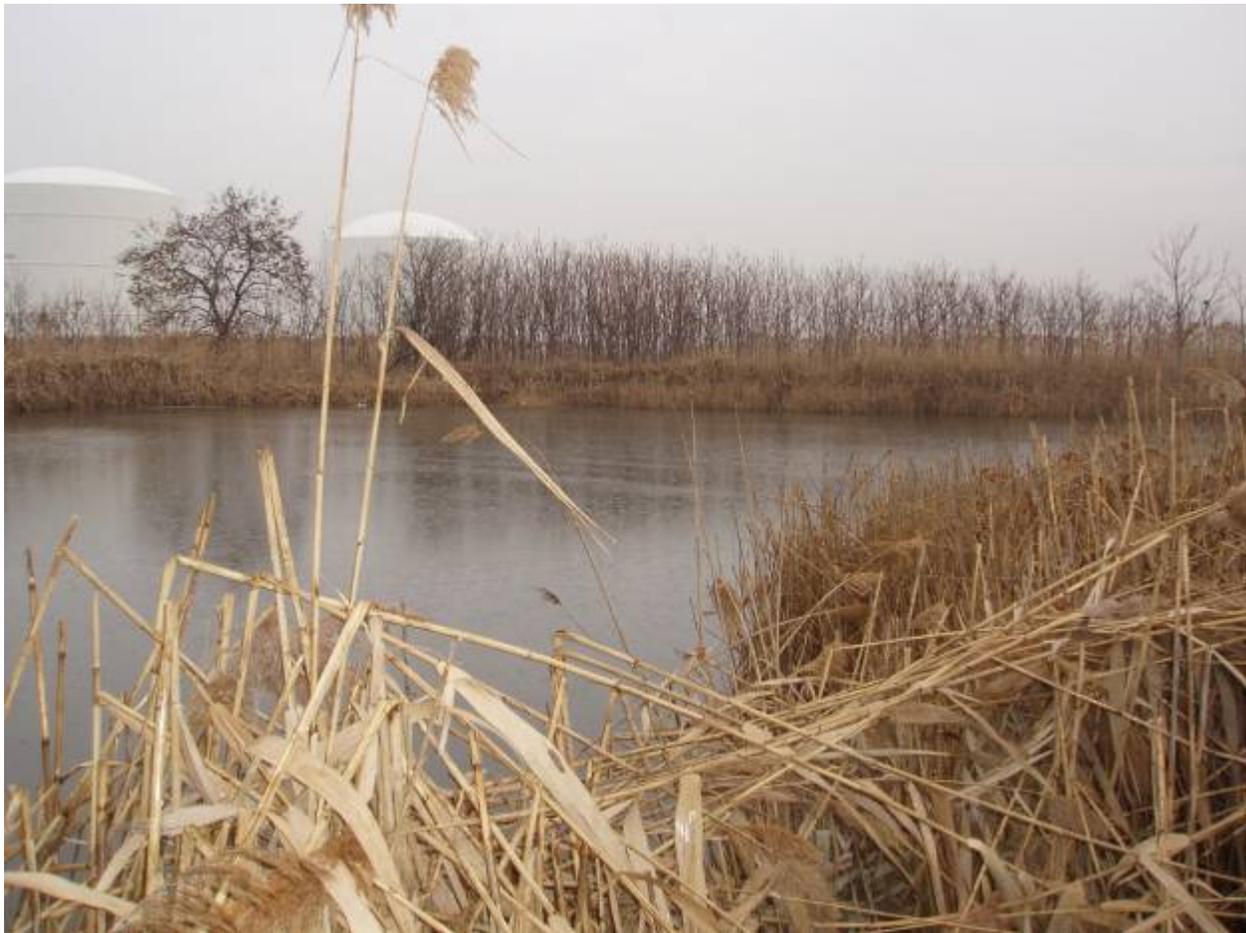
**Photo 3 Description: Downstream of the tide gate**

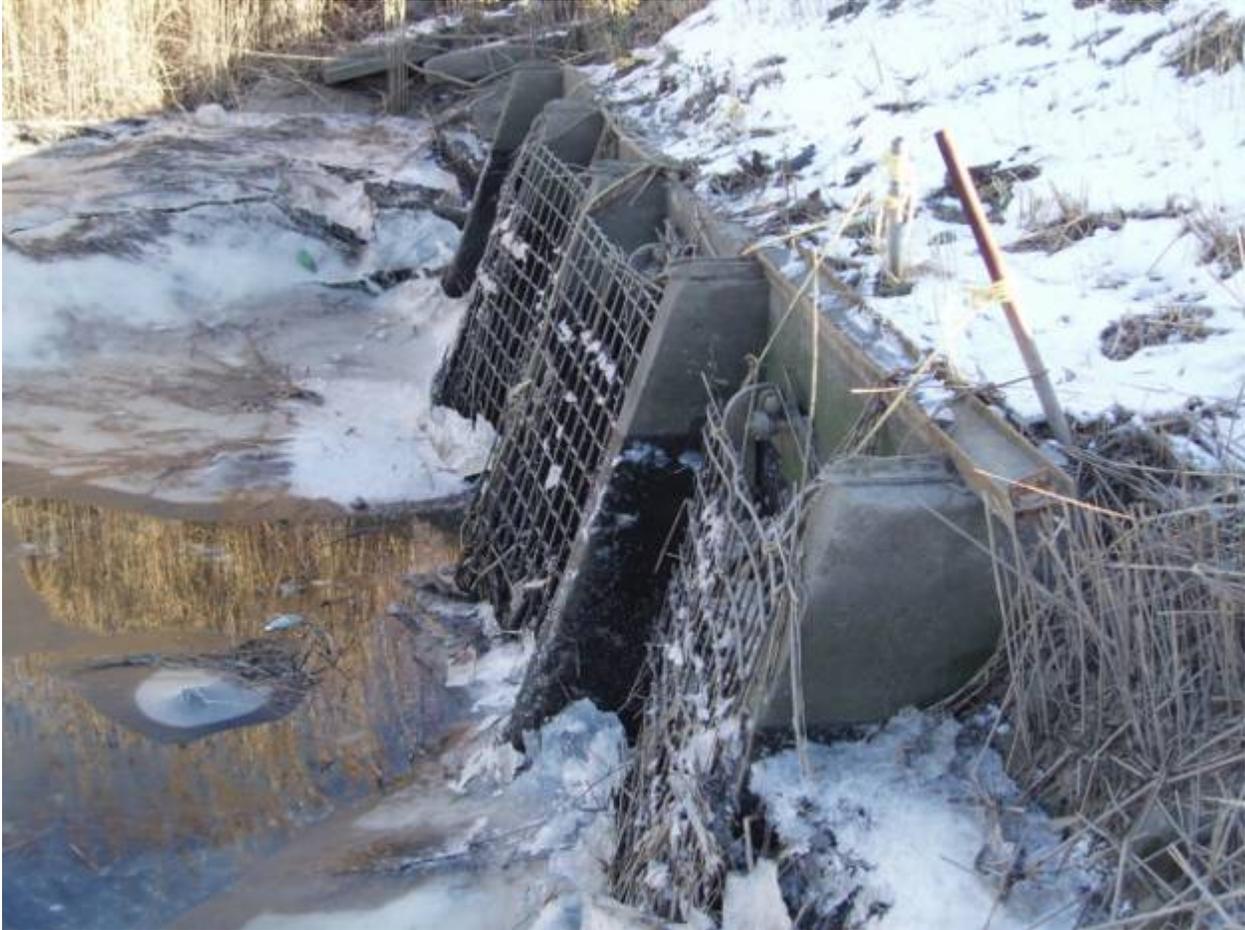
**Photo 1 Description: 4 metal flap gates**
