# Hackensack Meadowlands Tide Gates Inspection Report

**The National Flood Insurance Program  
Community Rating System**

**The New Jersey Meadowlands Commission  
One DeKorte Park Plaza  
Lyndhurst, New Jersey**

**March 27, 2006**

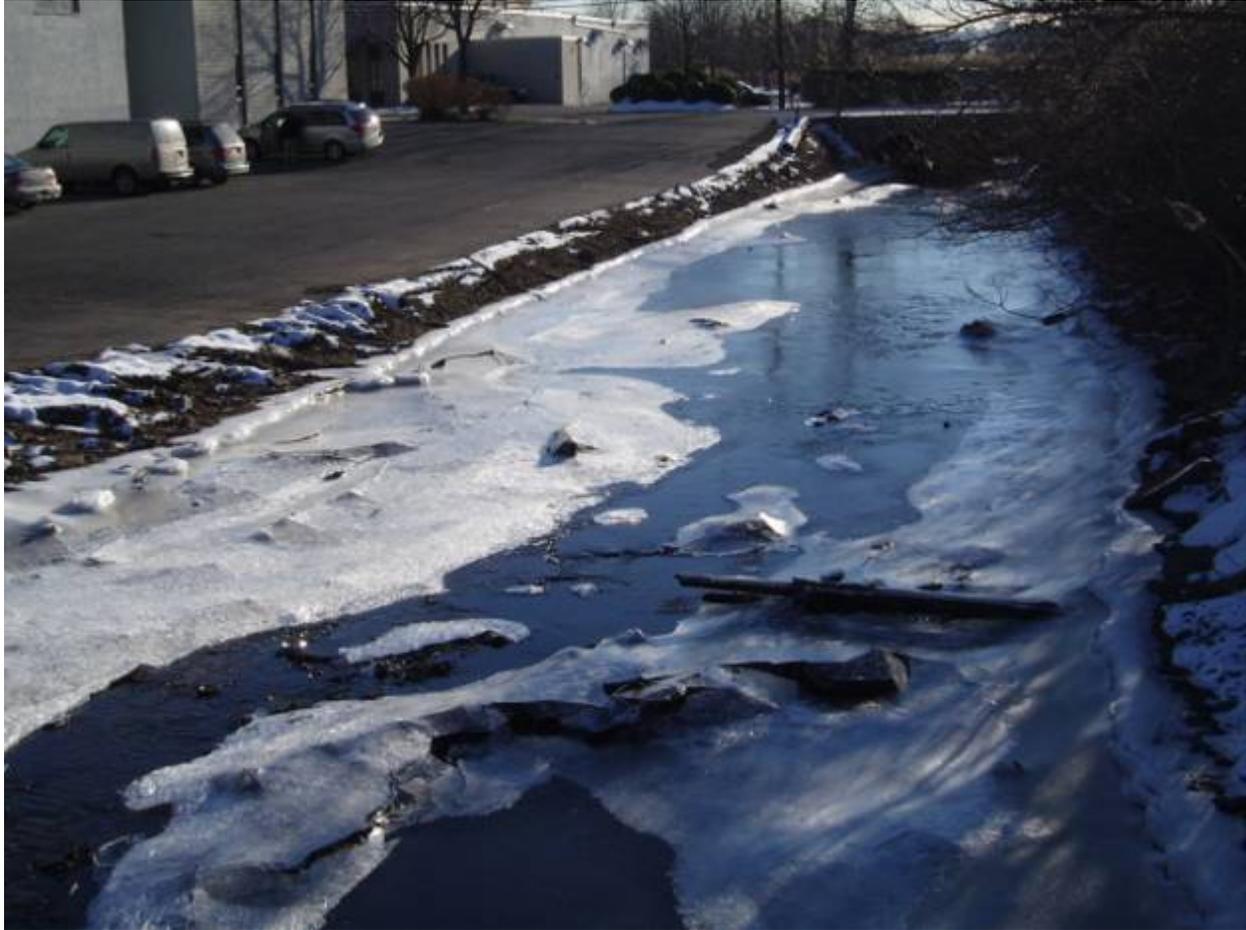
**Photo 2 Description: Upstream view from gates**

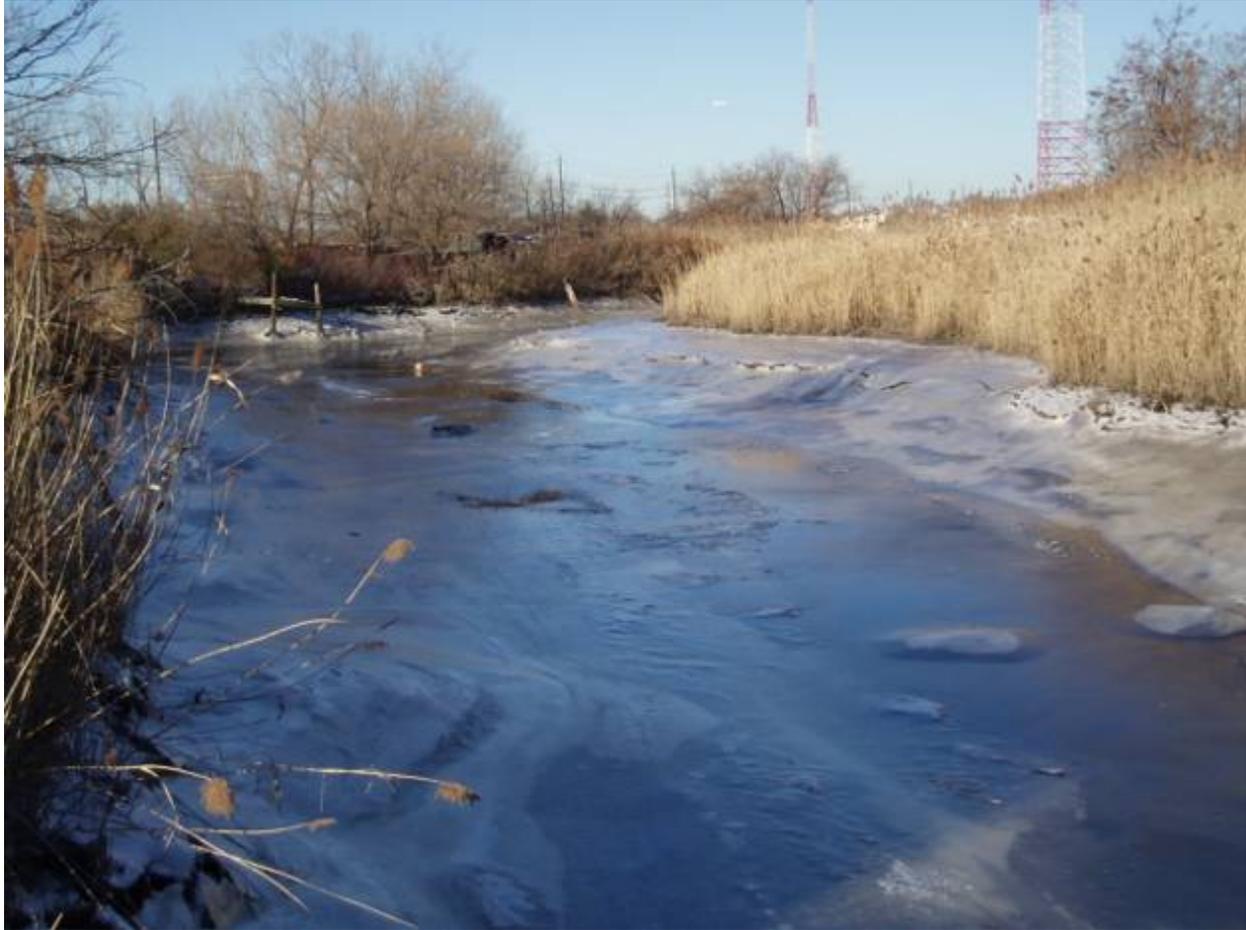
**Photo 3 Description: Downstream view from gates**

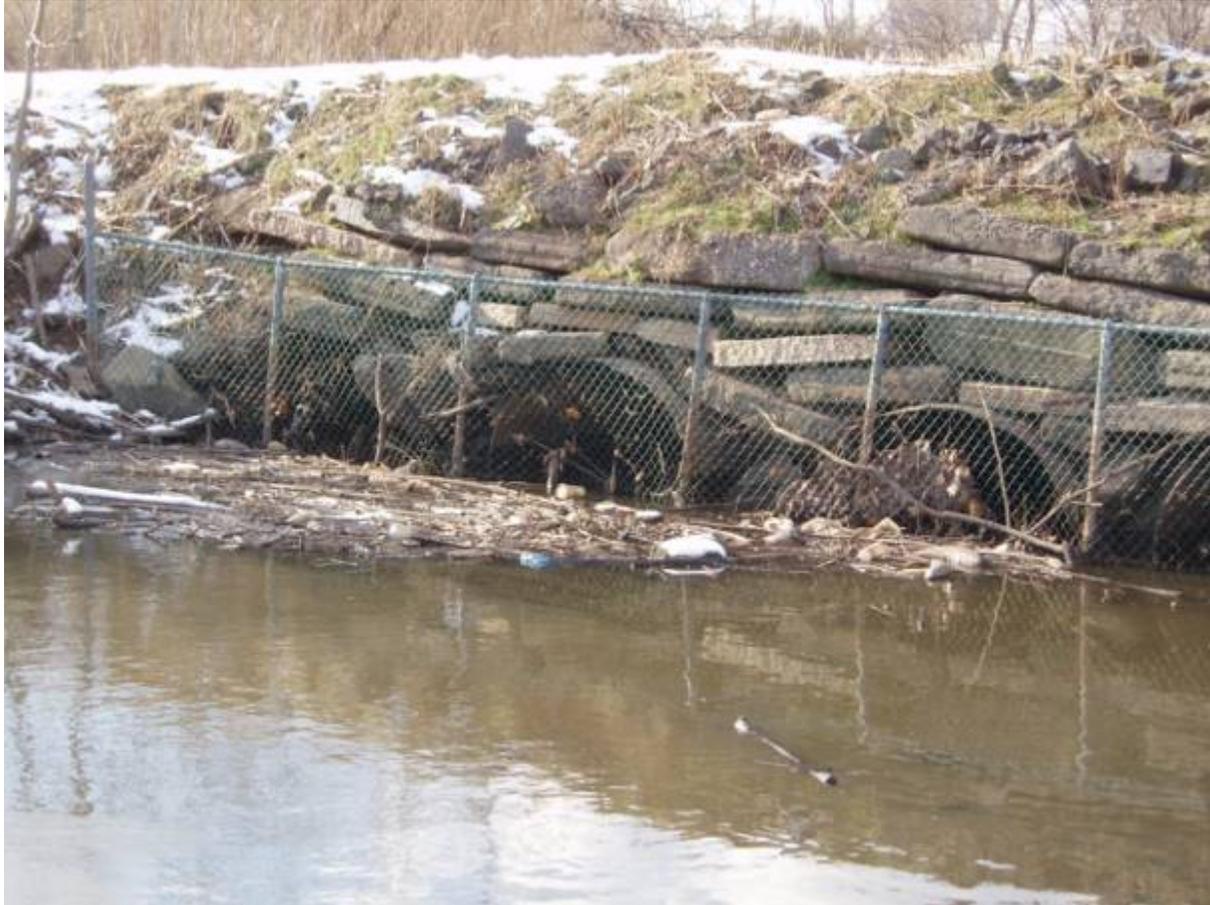
**Photo 1 Description:** Trash rack on upstream side of the tide gates

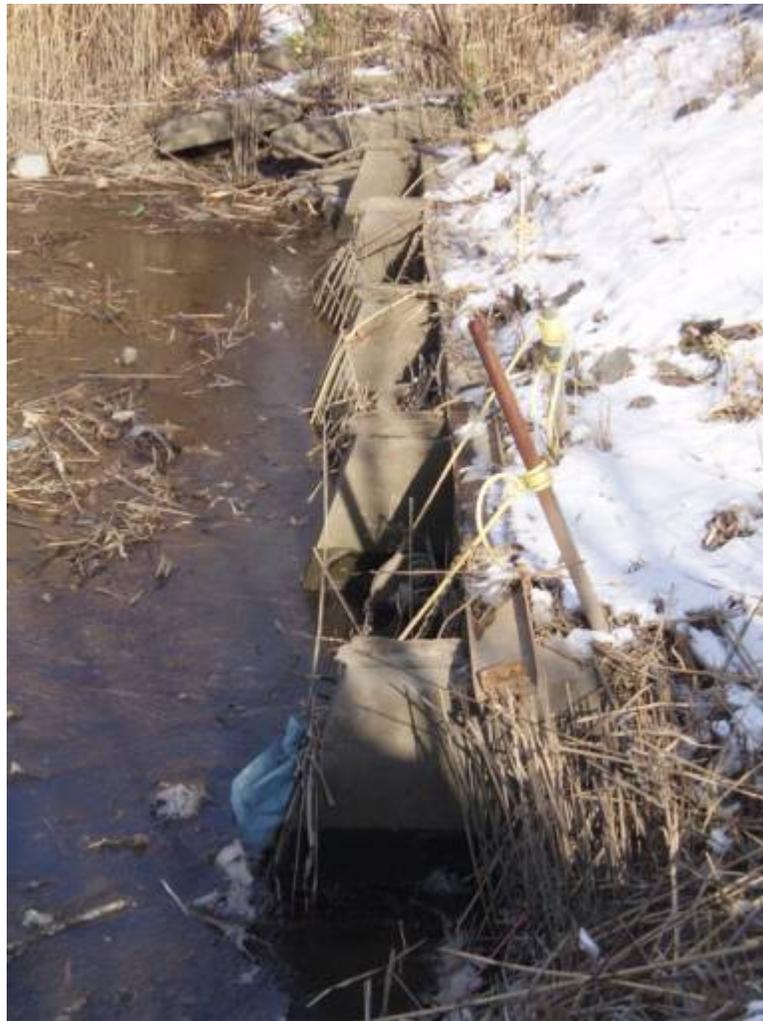
The tide gates do not seat properly during high tide conditions and a small amount of water continues to seep through and into the upstream system.

**Photo 2 Description: 4 metal flap gates**

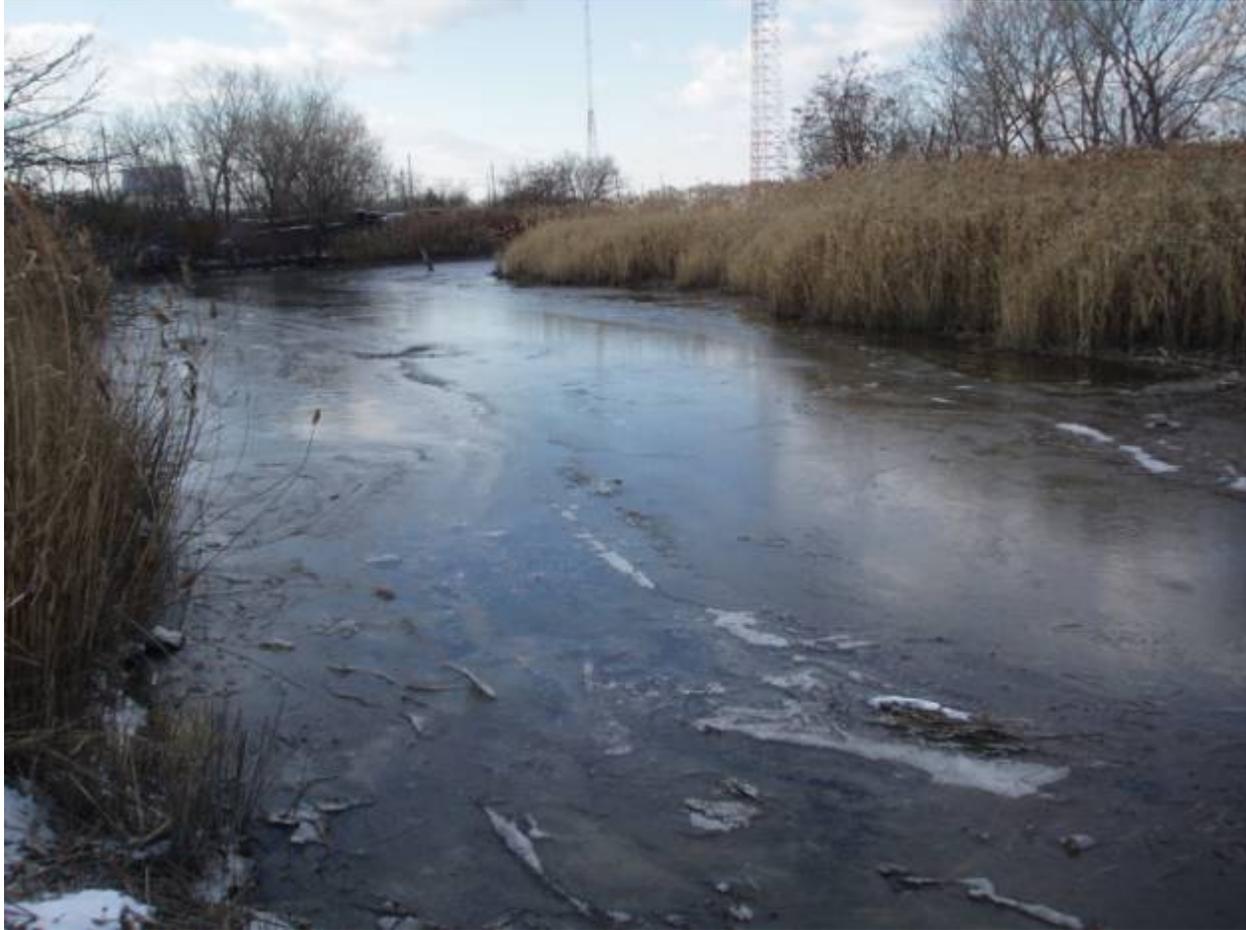
**Photo 3 Description: Downstream view from the tide gates**

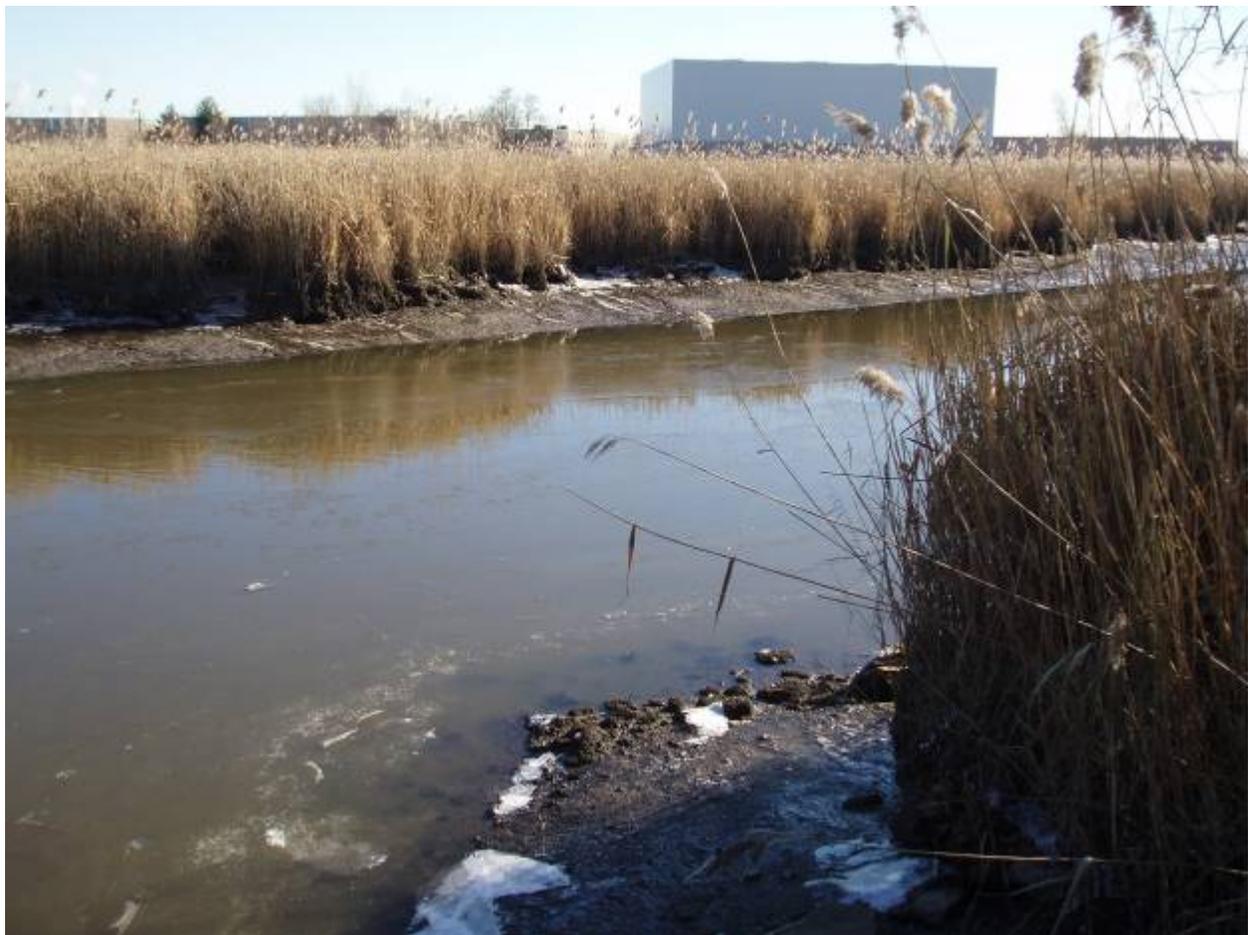
**Photo 2 Description: Downstream view from the tide gate**

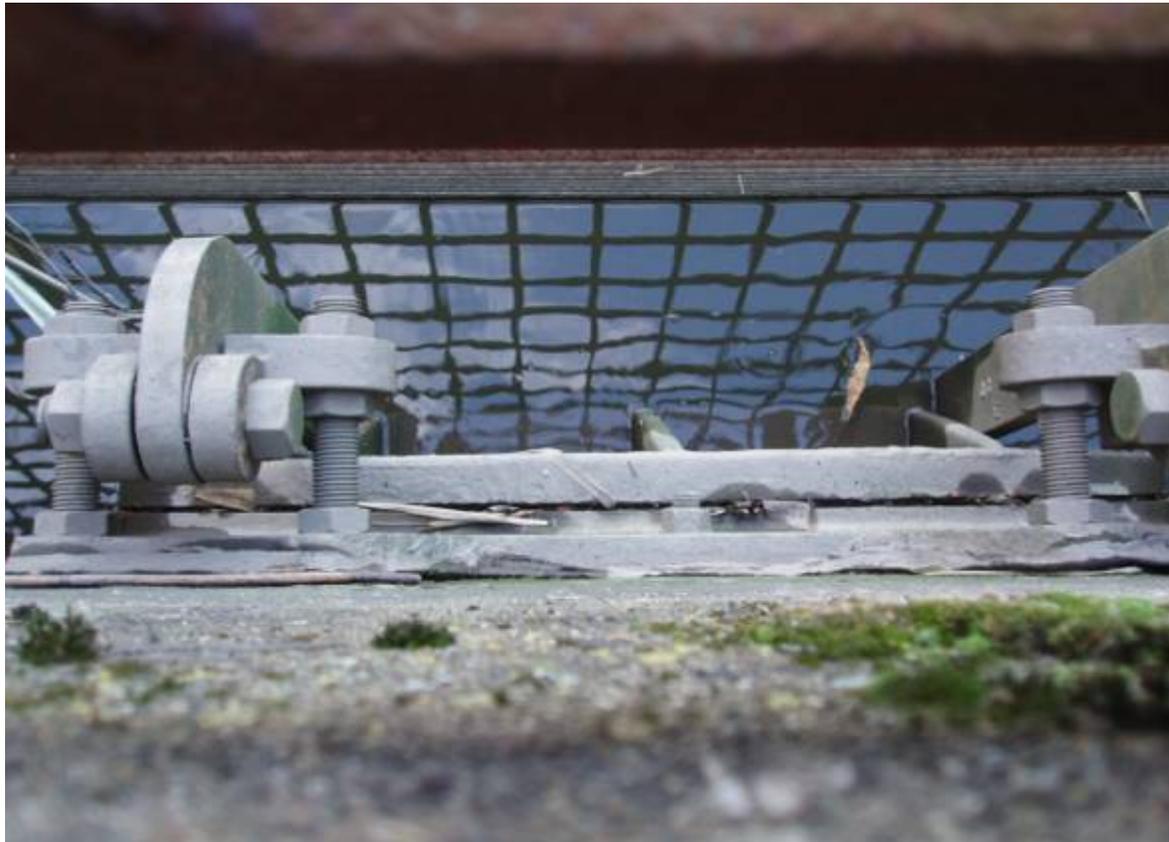
**Photo 1 Description: Metal flap gate**

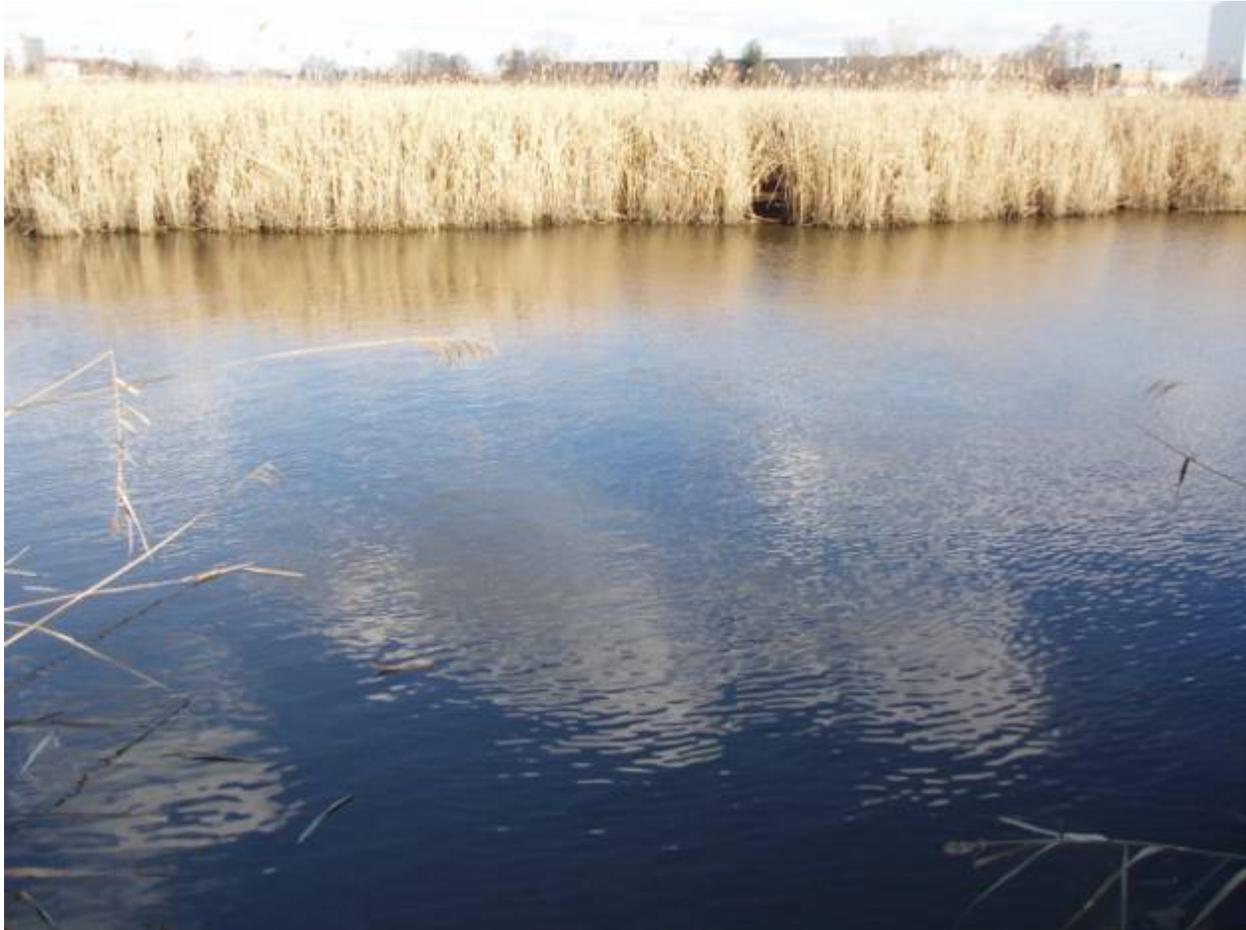
**Photo 2 Description: Downstream view from the tide gate**

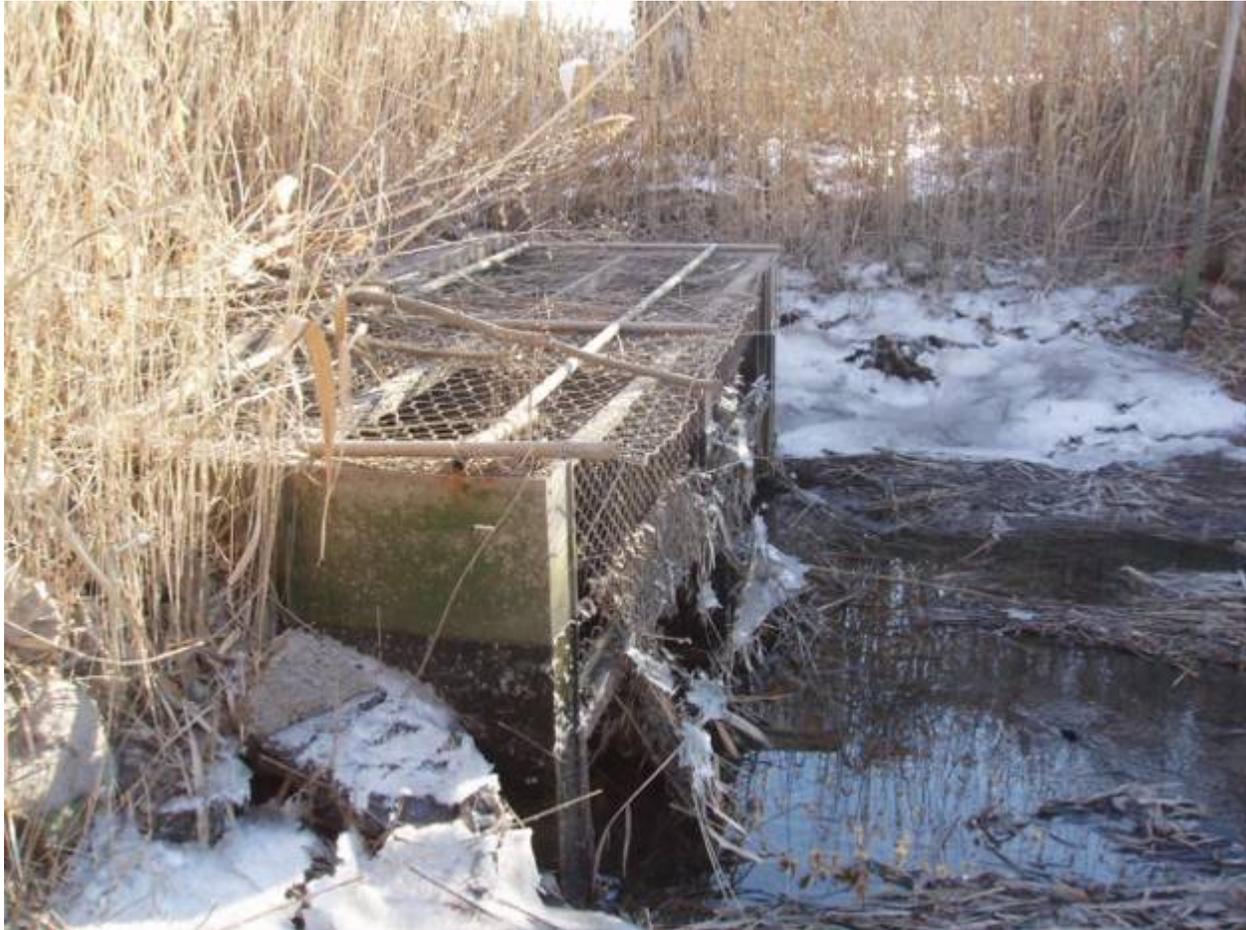
**Photo 1 Description: Tide gate structure**

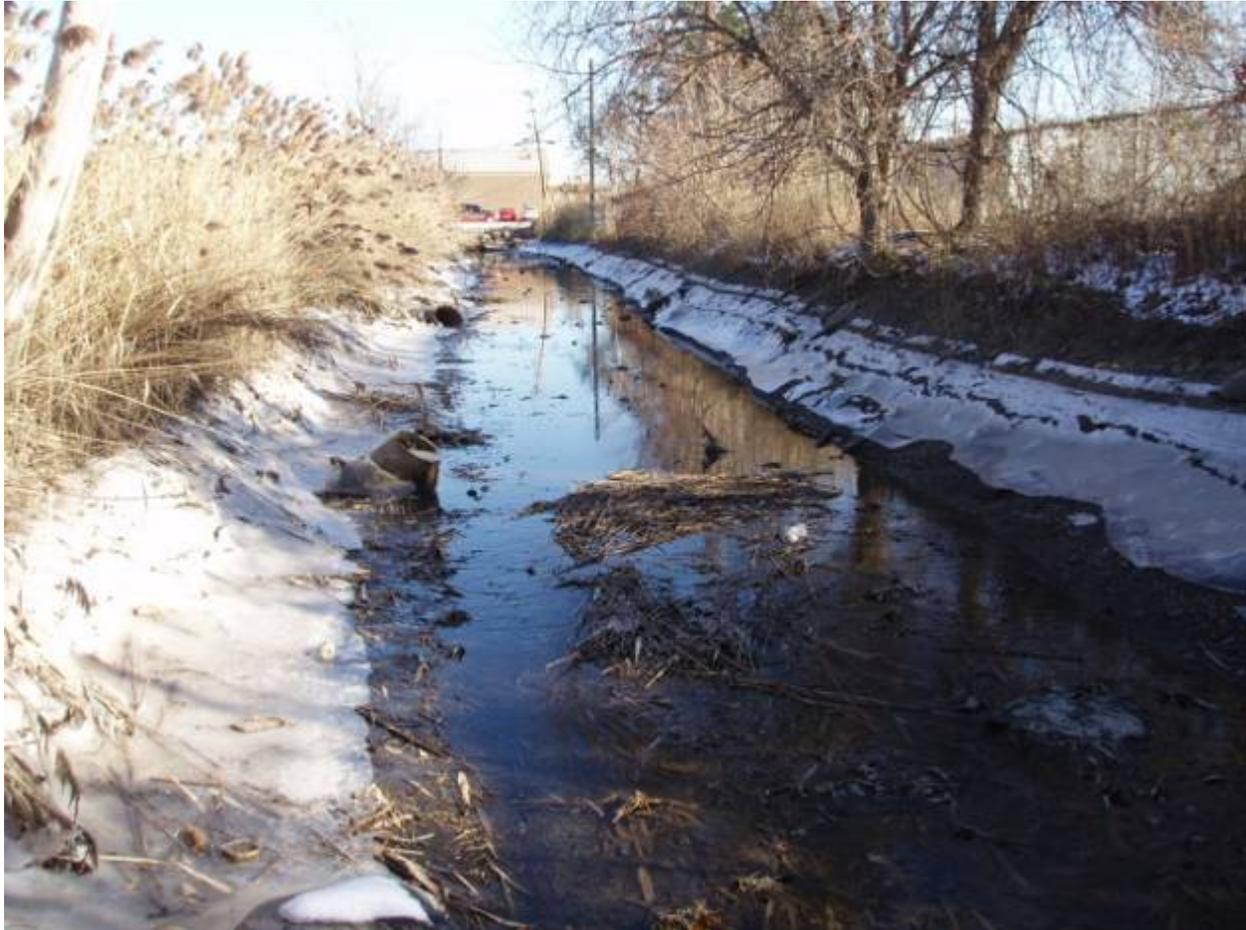
**Photo 2 Description:** Upstream view from tide gates

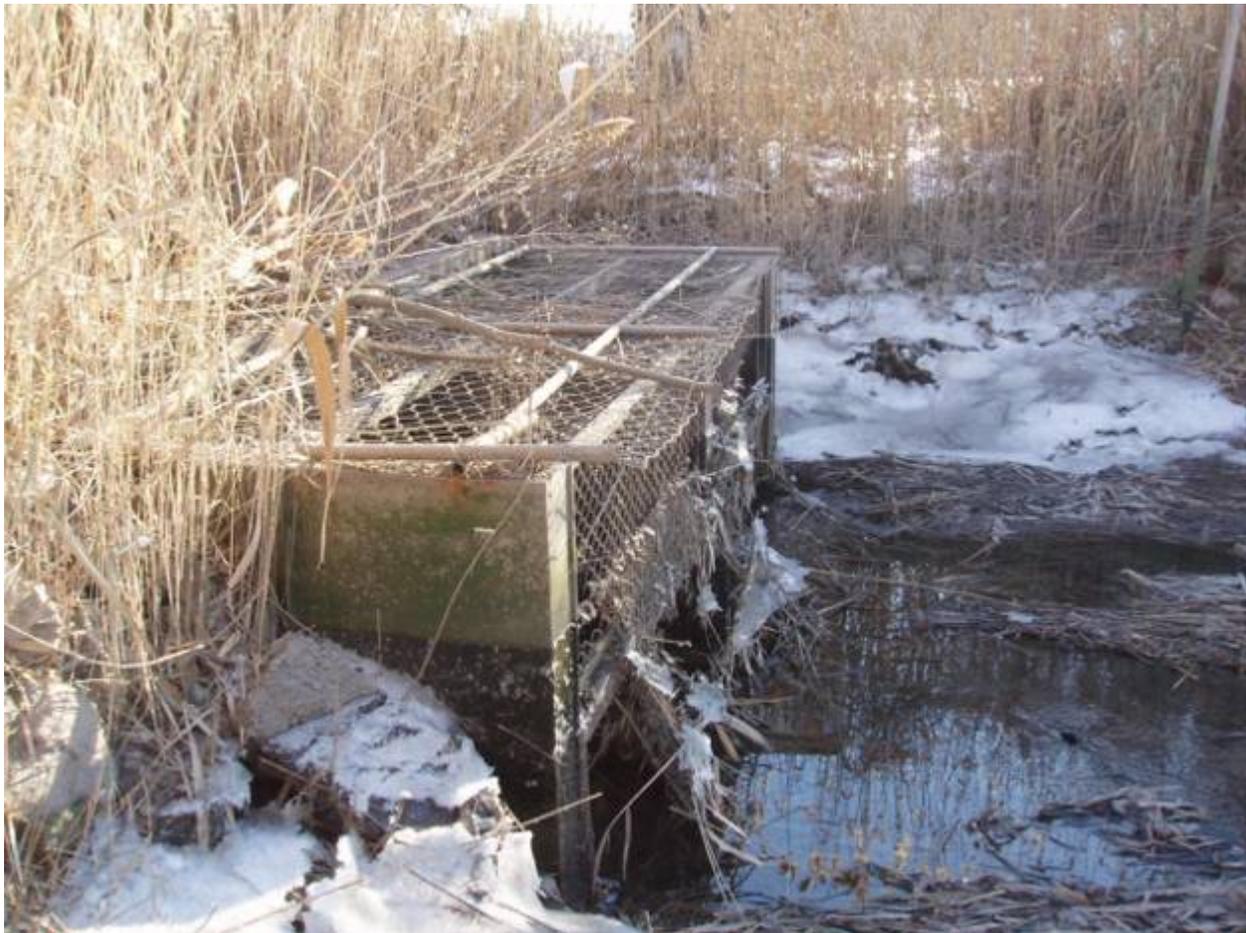
The tide gates are not seating properly and debris has accumulated in front of the tide gates. A feasibility study will be initiated in 2006 to investigate the overall functionality of the tide gates and the need for repairs and/or replacement.

**Photo 1 Description: Tide gate structure**

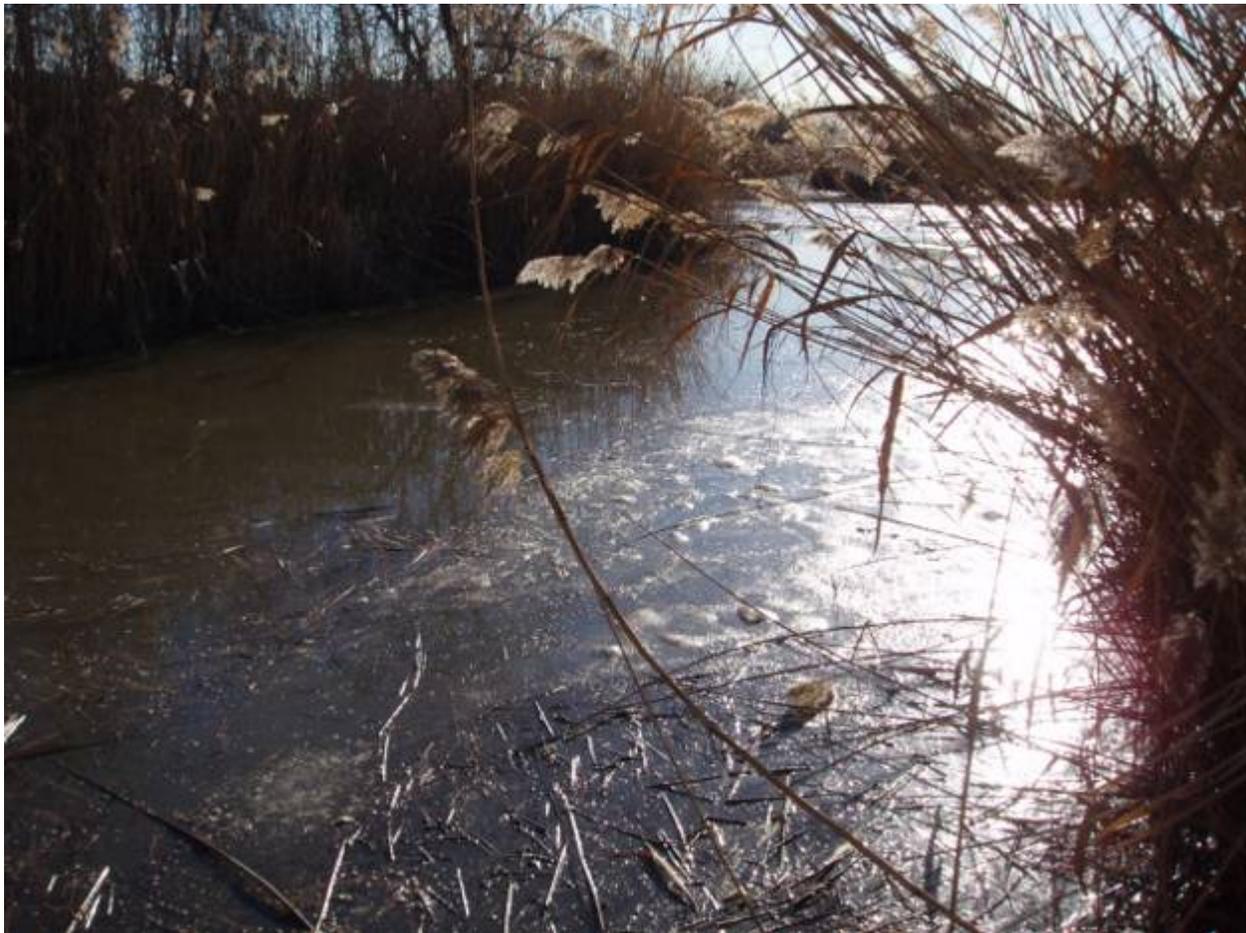
**Photo 2 Description: Downstream view from the tide gates**

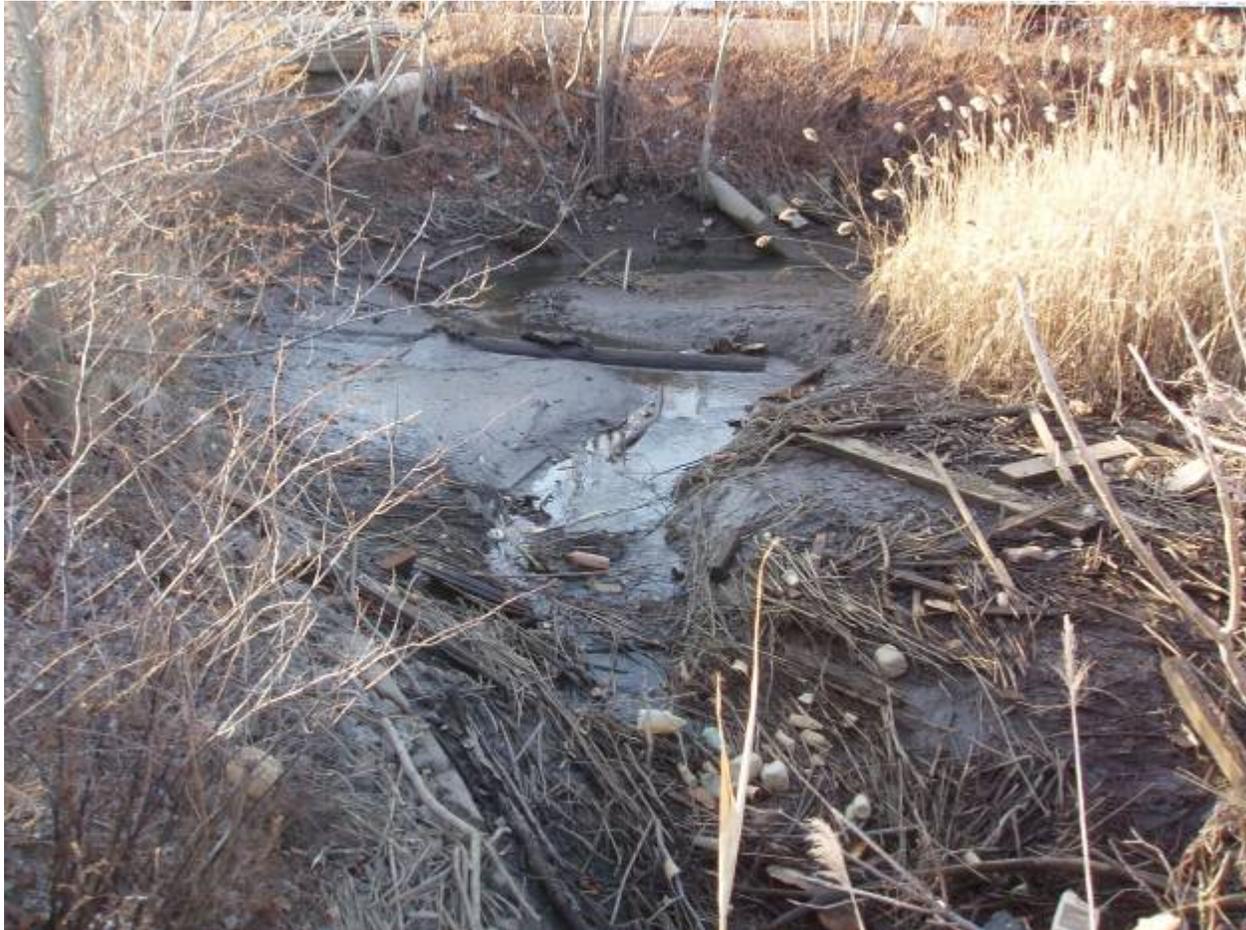
**Photo 2 Description:** Upstream view from the tide gate

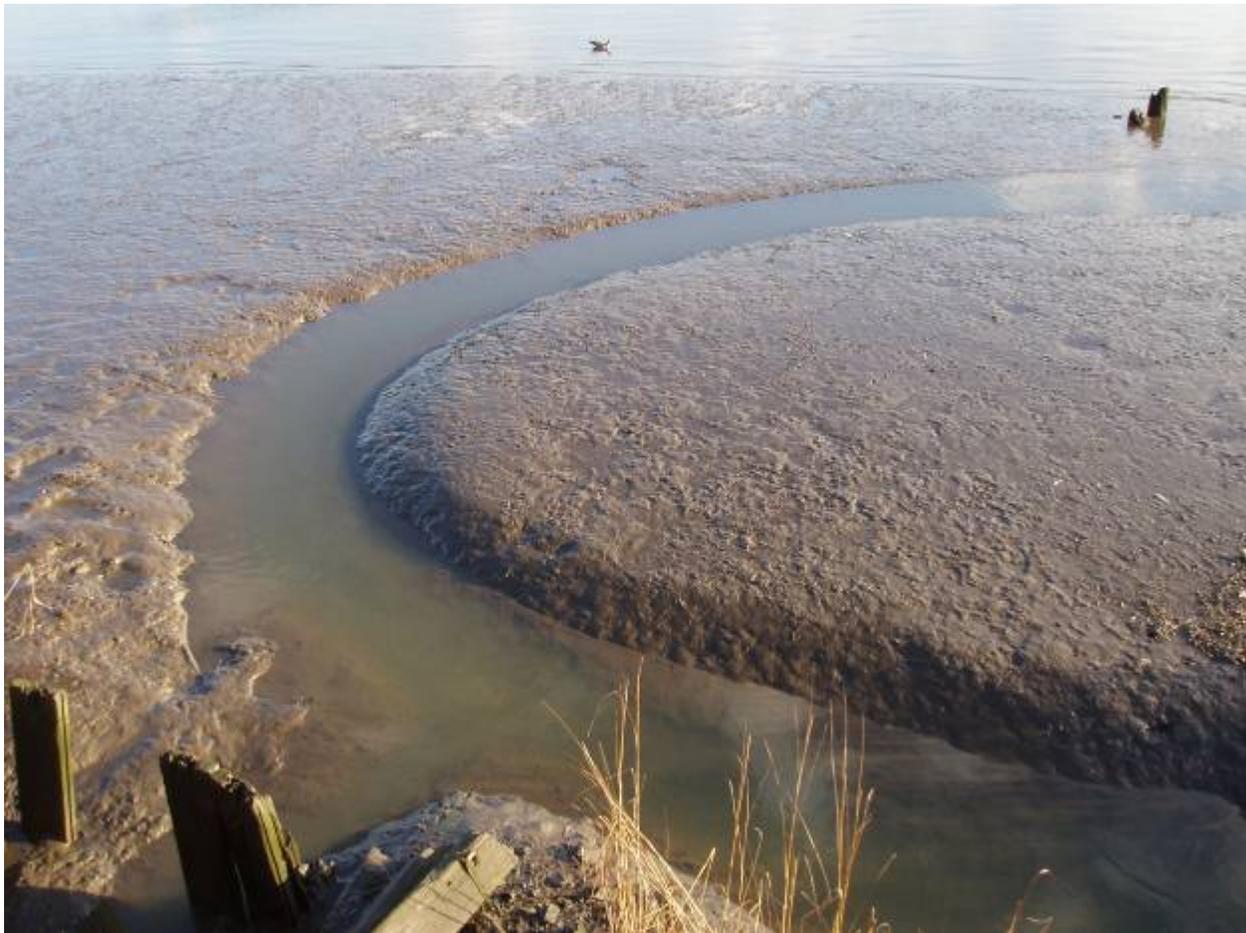
**Photo 3 Description: Downstream view from the tide gate**

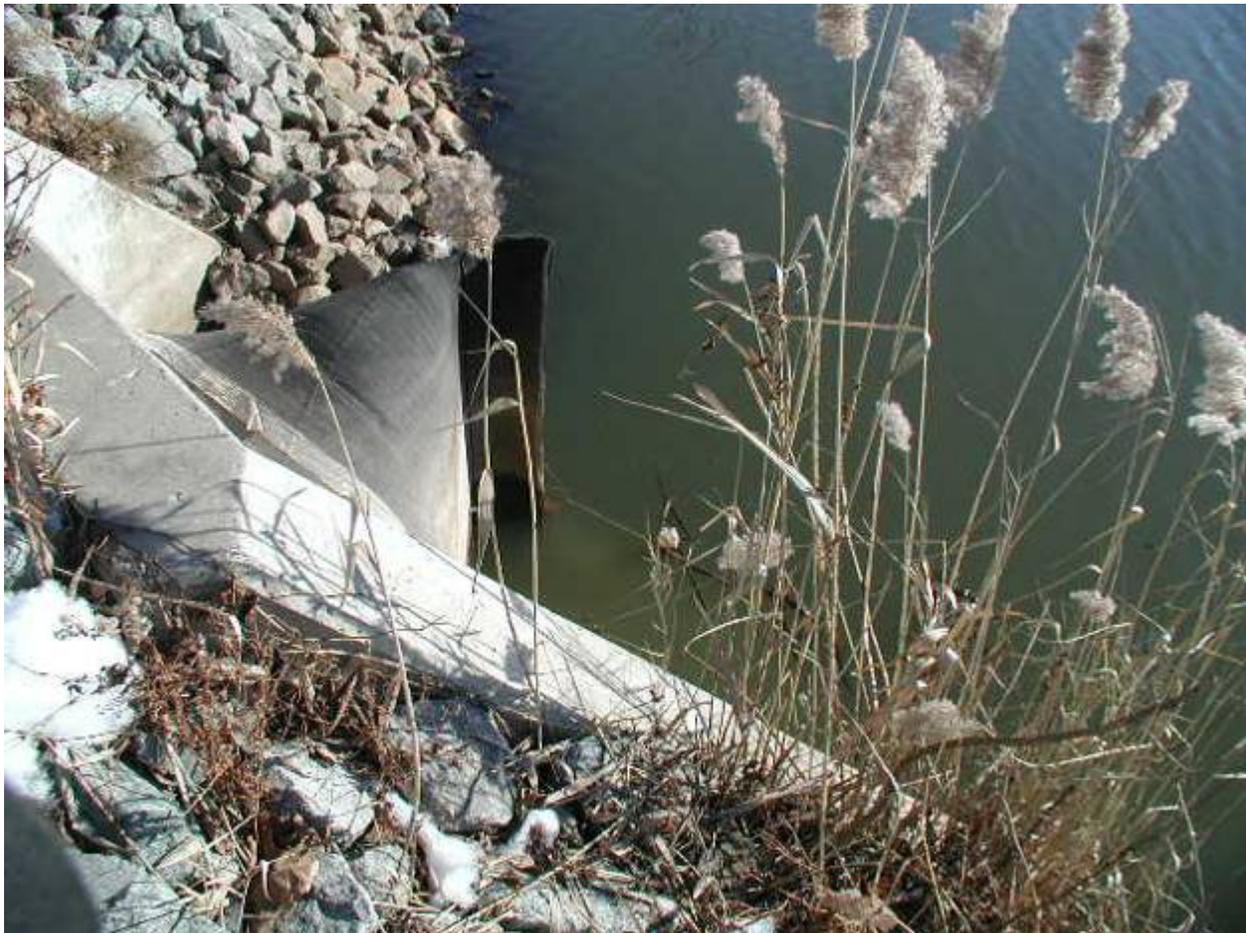
**Photo 1 Description: Tideflex™ check valve structure**

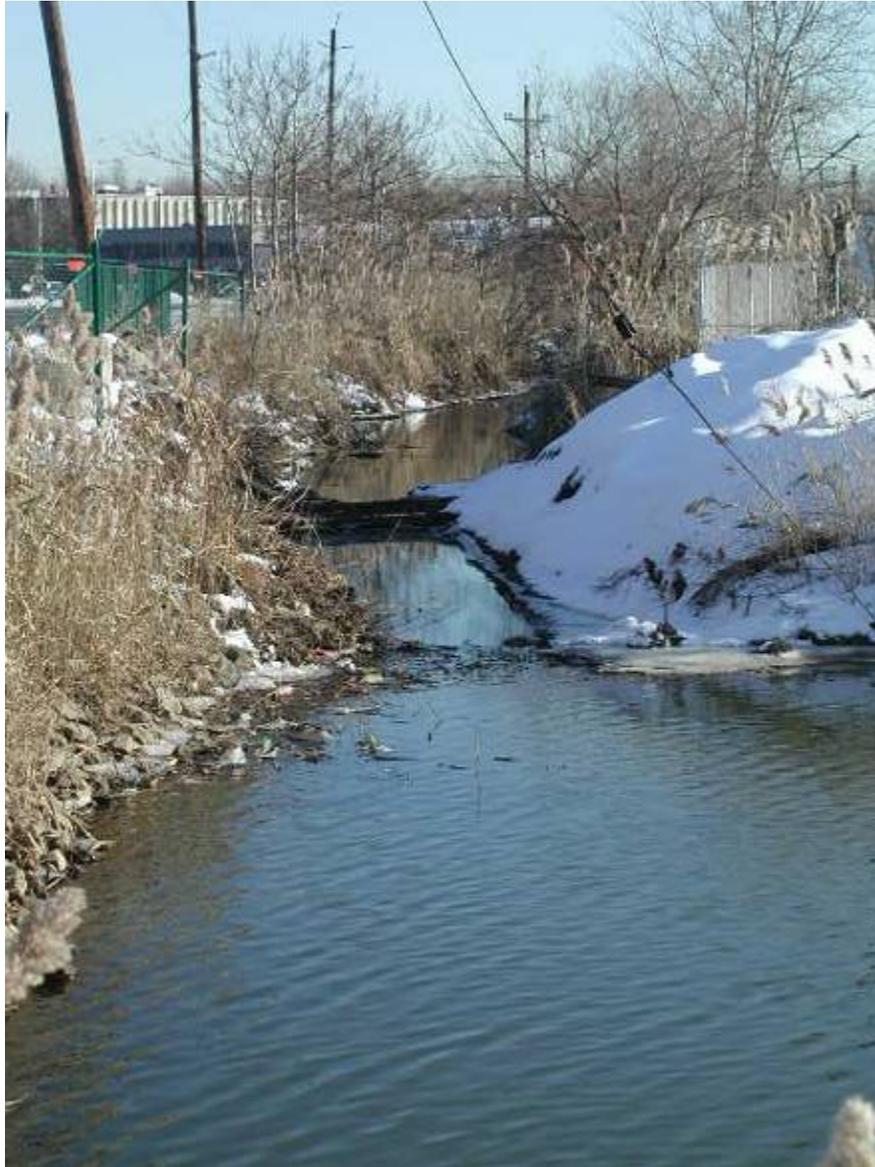
**Photo 2 Description: Downstream view from tide gate**

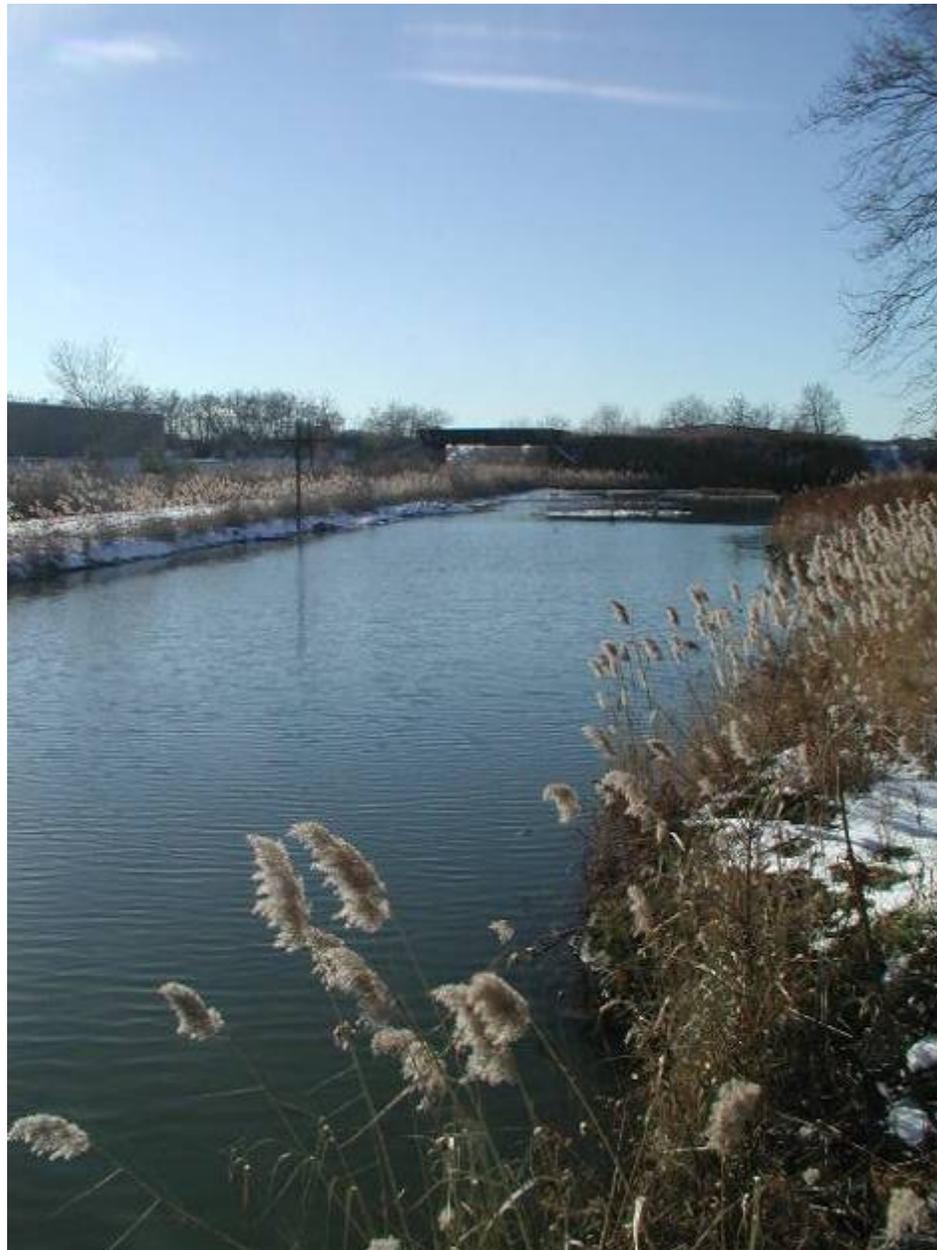
**Photo 3 Description:** Downstream detention basin located at the tide gate outfall

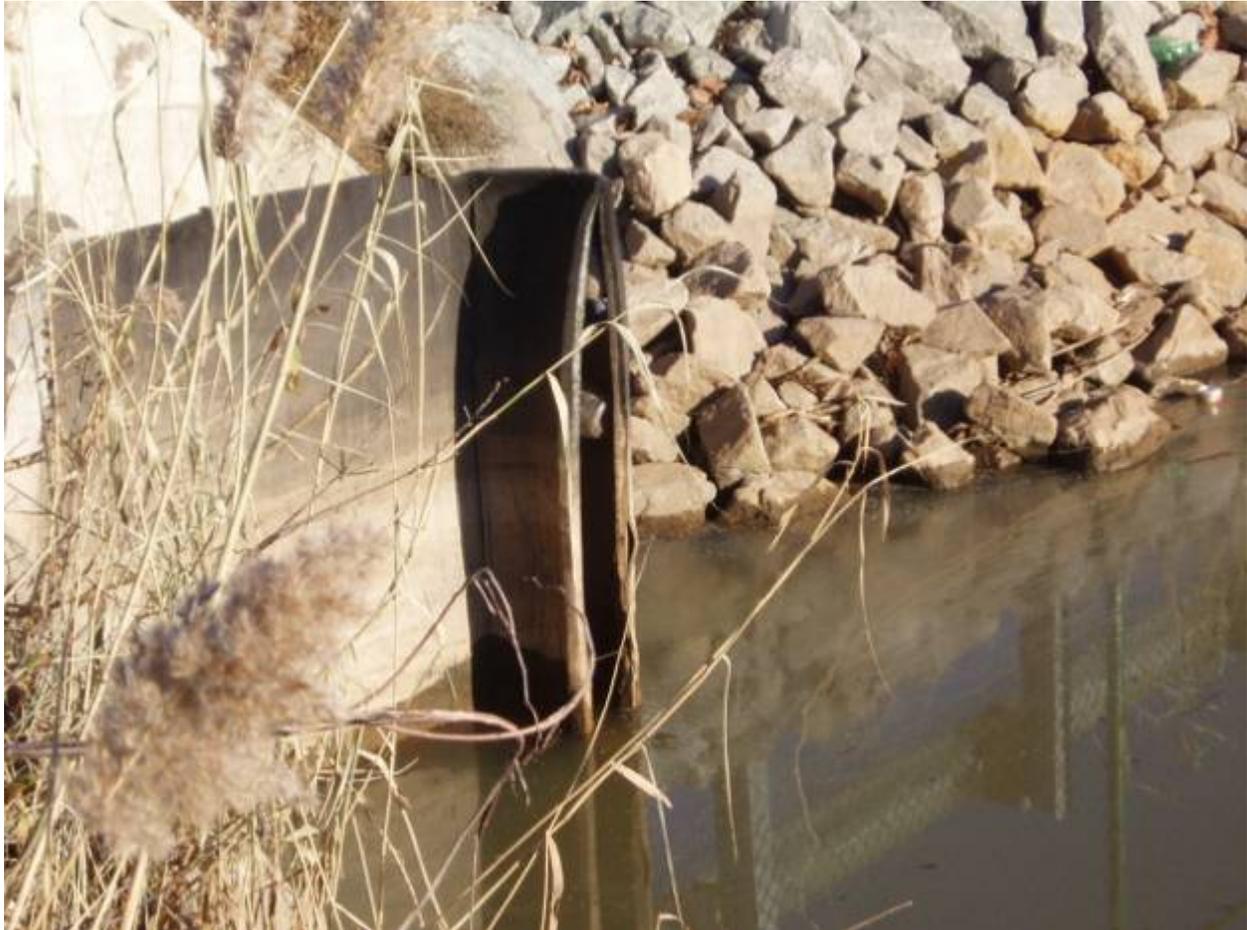
**Photo 1 Description: Tideflex™ check valve structure**

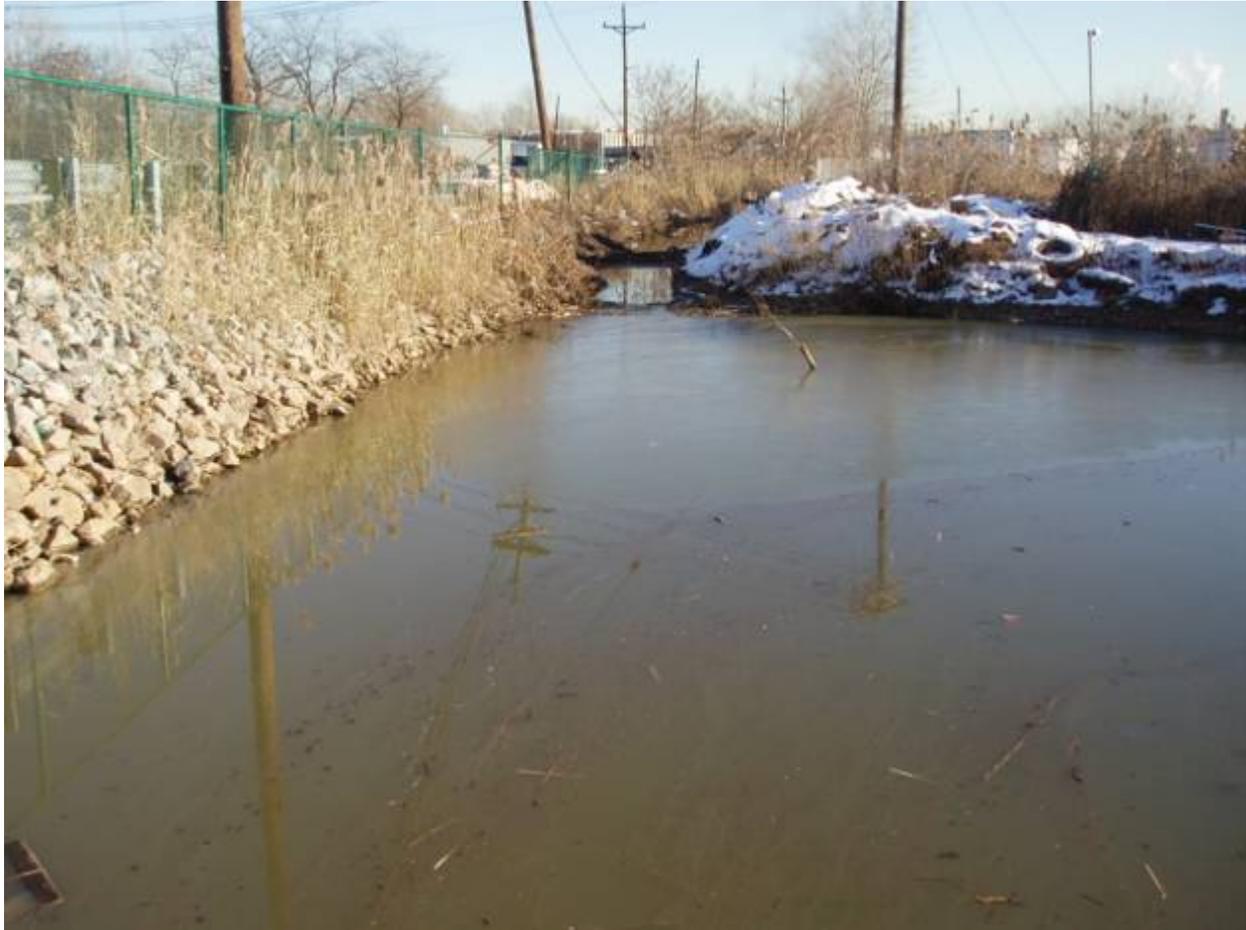
**Photo 2 Description: Downstream view from tide gate**

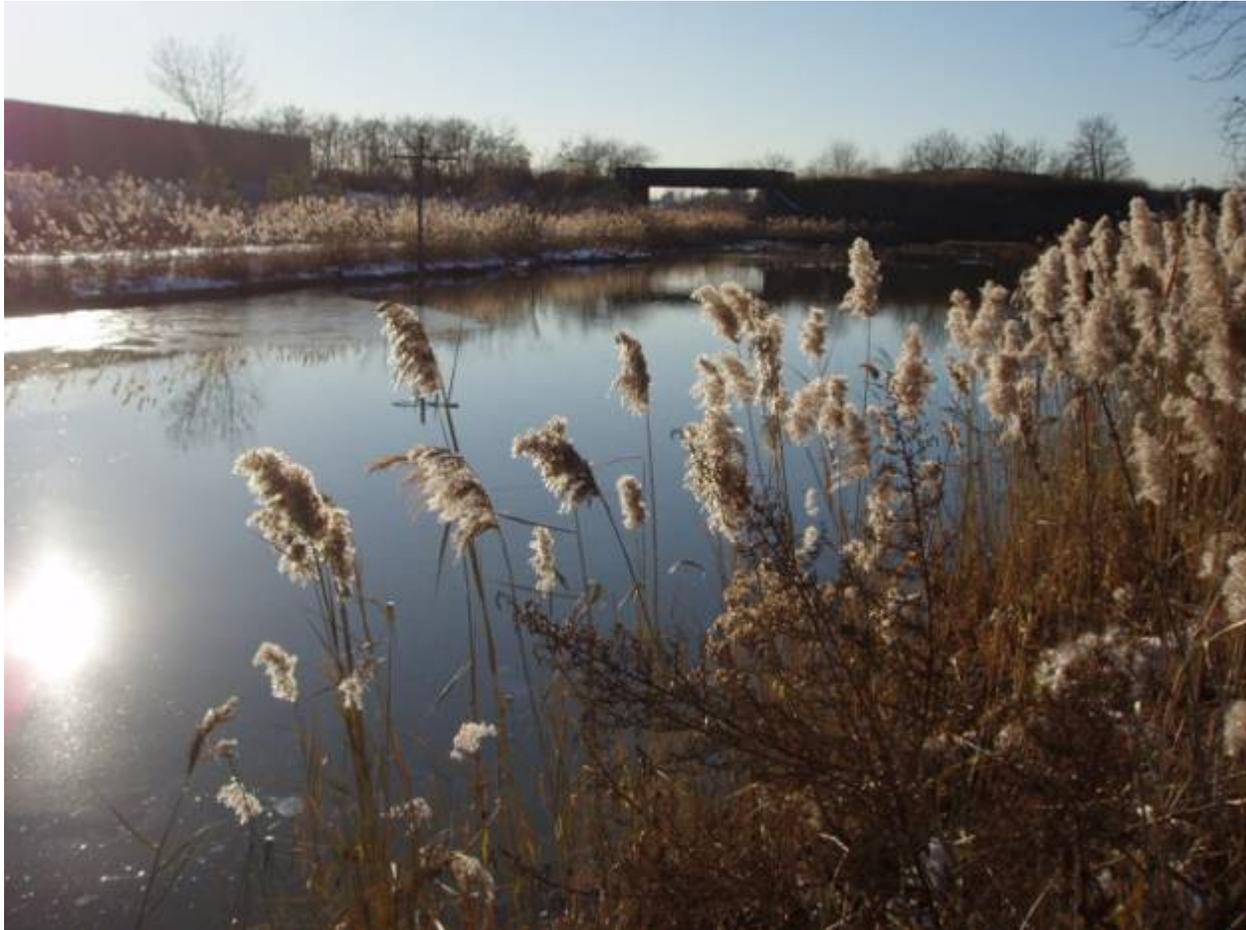
**Photo 3 Description:** Downstream detention basin located at the outfall of the tide gate
