# Hackensack Meadowlands Tide Gates Inspection Report

**The National Flood Insurance Program  
Community Rating System**

**The New Jersey Meadowlands Commission  
One DeKorte Park Plaza  
Lyndhurst, New Jersey**

**March 27, 2006**

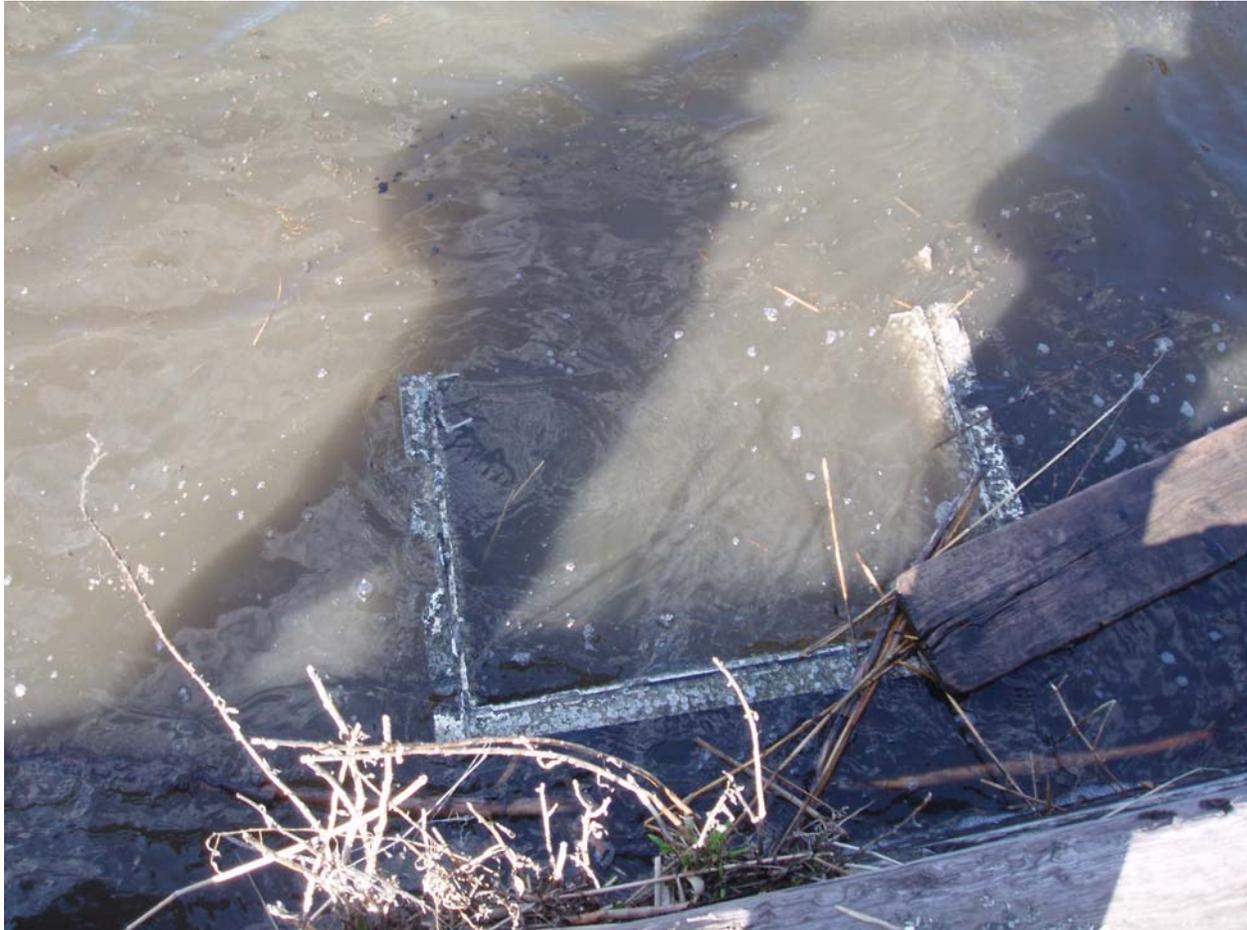
Three existing tide gates were found but the tide gate structures did not appear to be functional. The pump station is abandoned and without electrical service. Flow of water between the Hackensack River and the marsh across the dike might be seeping through the old tide gate structures. No signs or indications were found to prove the dike has been breached in the past.

**Photo 1 Description: View of old tide gate structure**

No interim maintenance is required because the Cayuga Dike system has deteriorated into a dilapidated state. An analysis of the Cayuga Dike system will be required to determine if the system is needed for flood control mitigation and should be repaired.

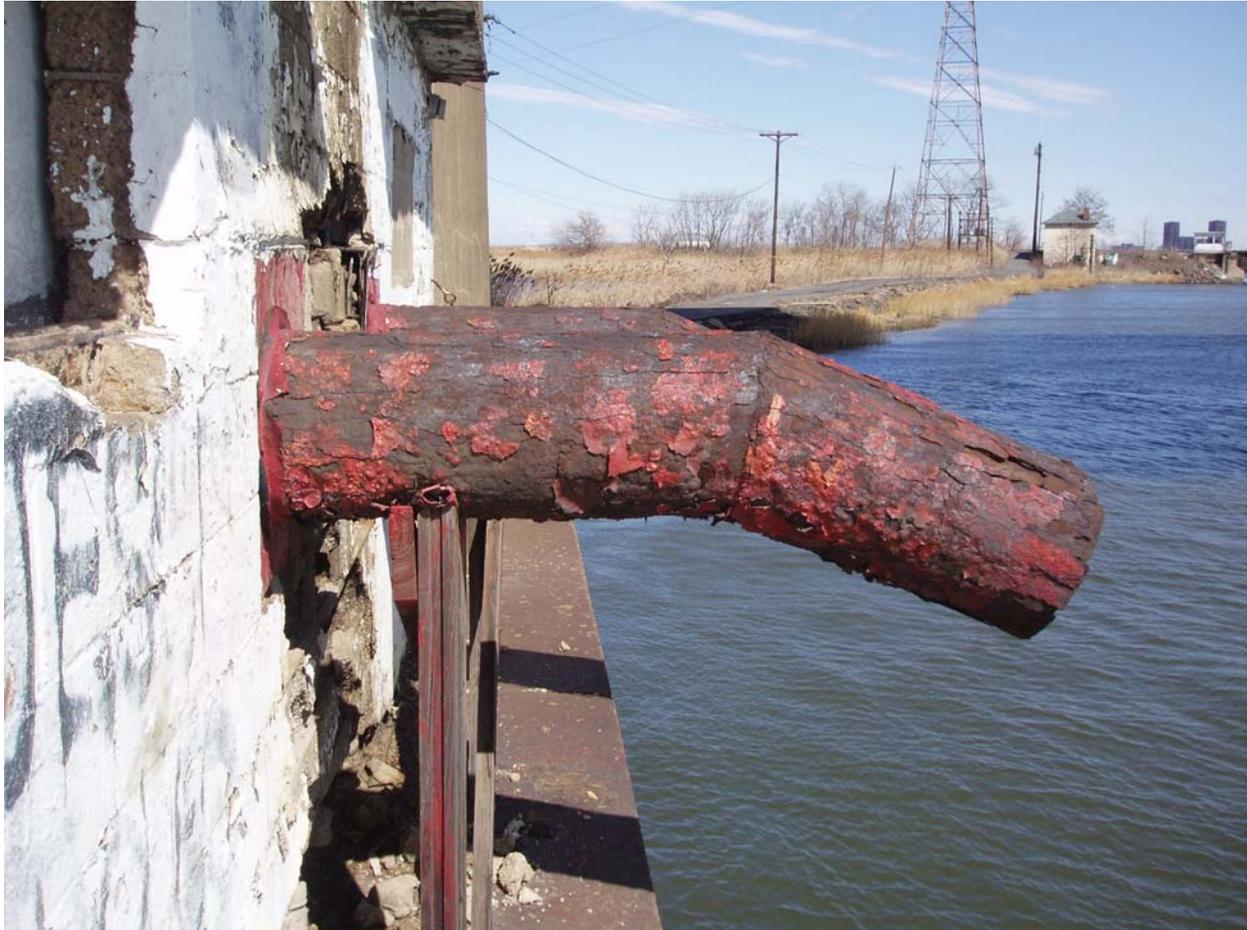
**Photo 3 Description: View of discharge pipes from pump station to Hackensack River**

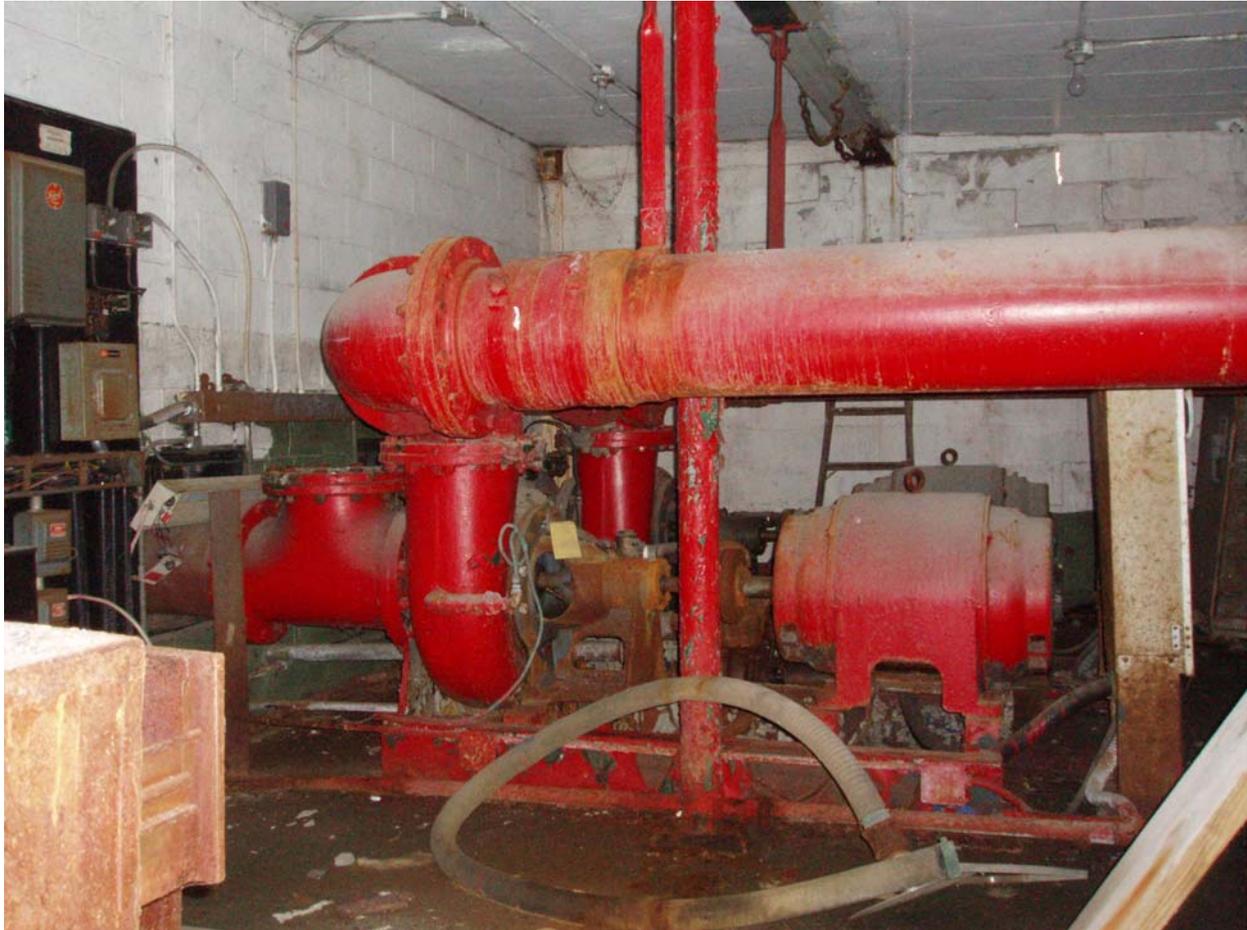
**Photo 4 Description: Looking inside of the Cayuga Dike Pump Station**

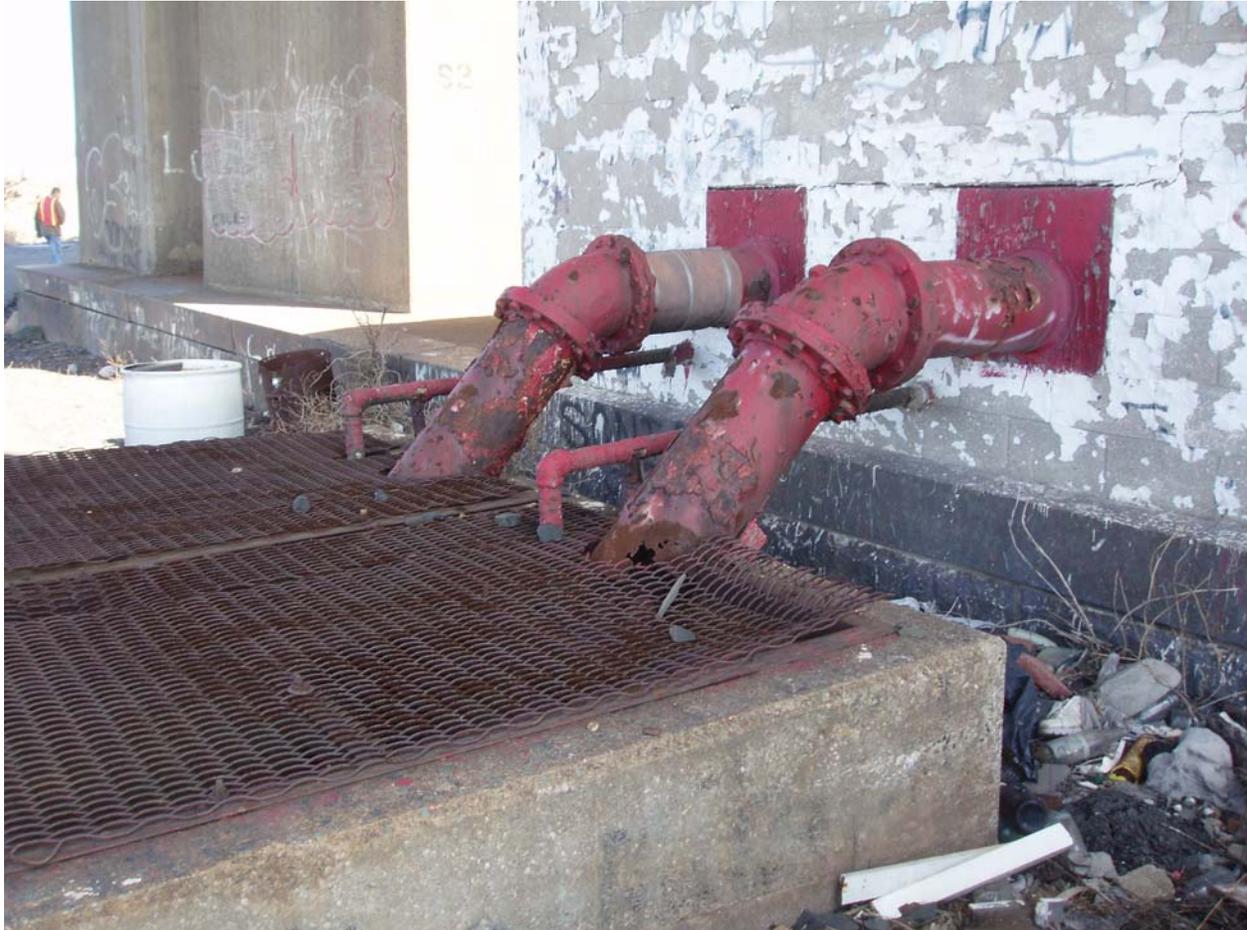
**Photo 5 Description: View of Cayuga Dike Pump Station's intake structure**

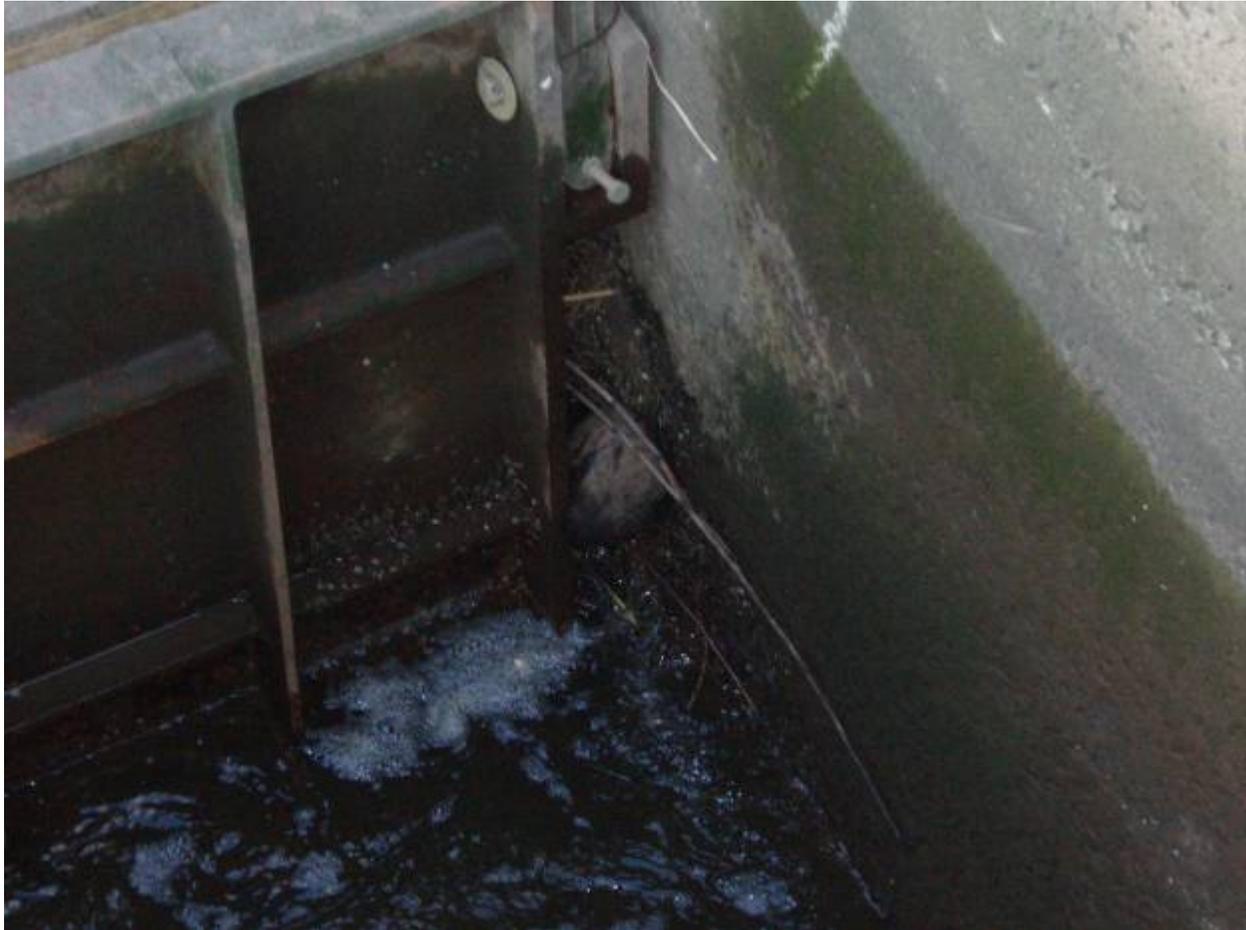
**Photo 2 Description: Debris (rock) shown lodged in-between the gate keeping it ajar**

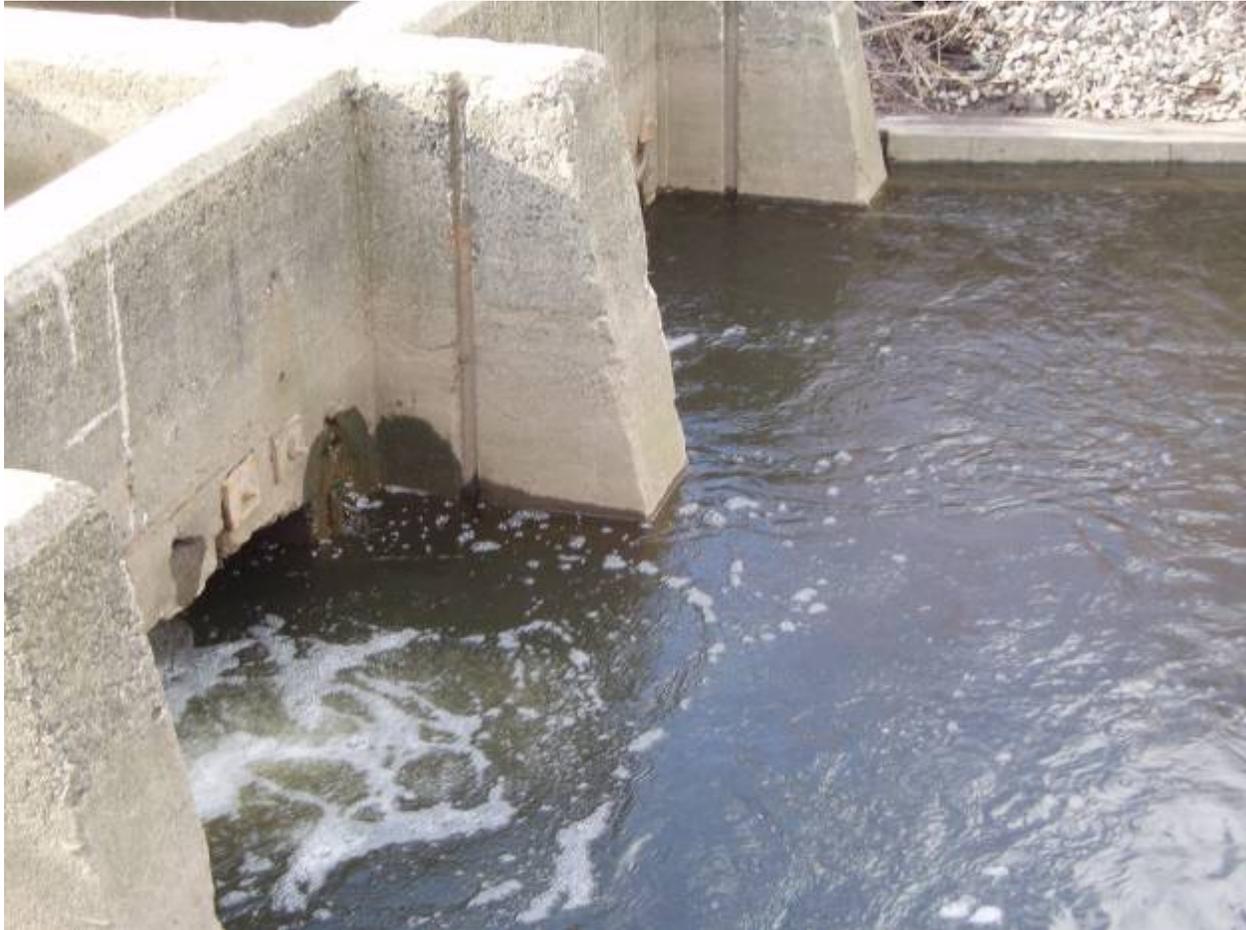
The tide gates are not functioning properly. Water is seeping through during high tide conditions due to the tide gates not seating properly.

**Photo 1 Description:** Notice water (bubbles) traveling upstream of the tide gate during high tide conditions

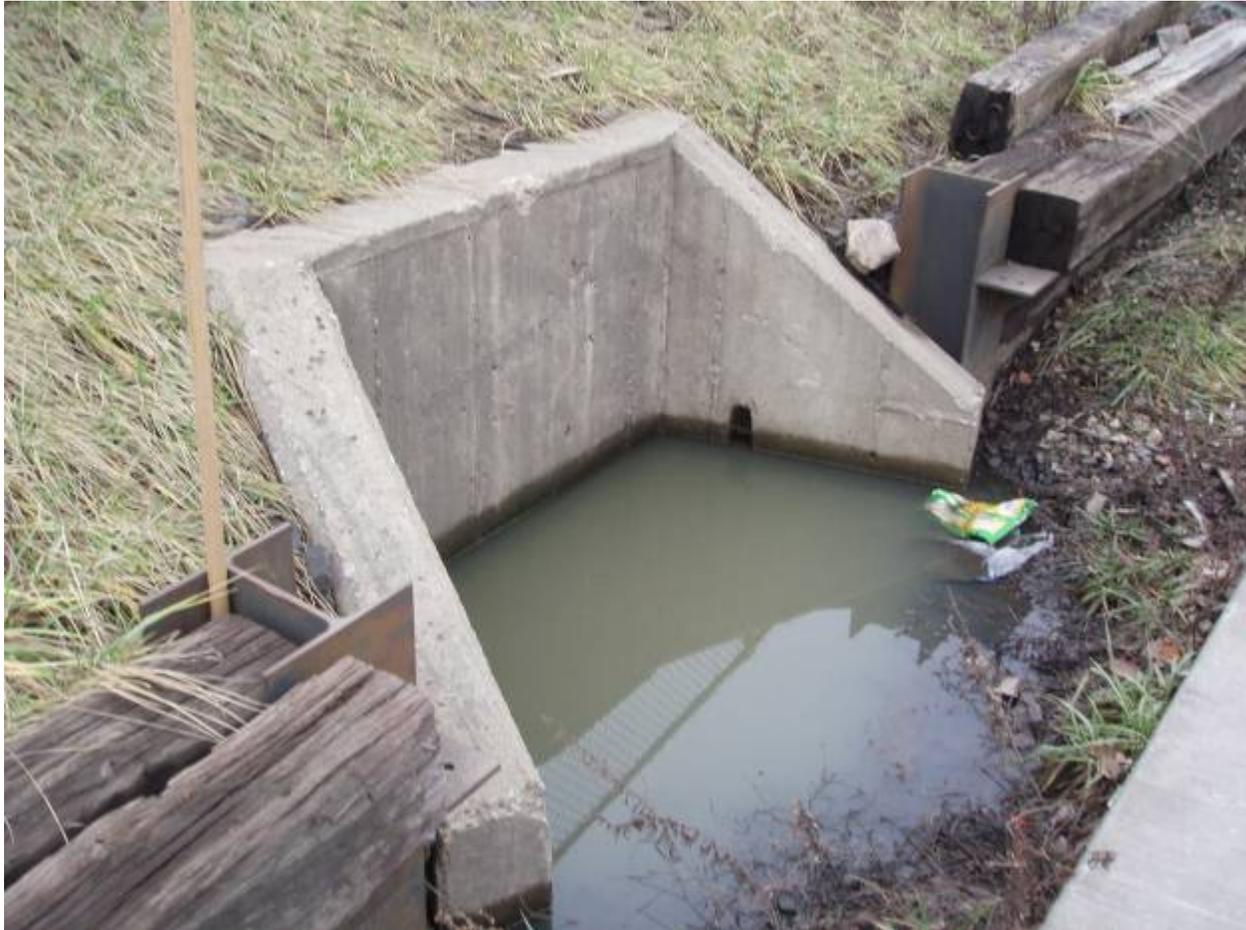
Headwalls were found during the inspection. The tide gate can not be found due to stagnant water around the structures.

**Photo 1 Description: Location of possible submersed tide gate**

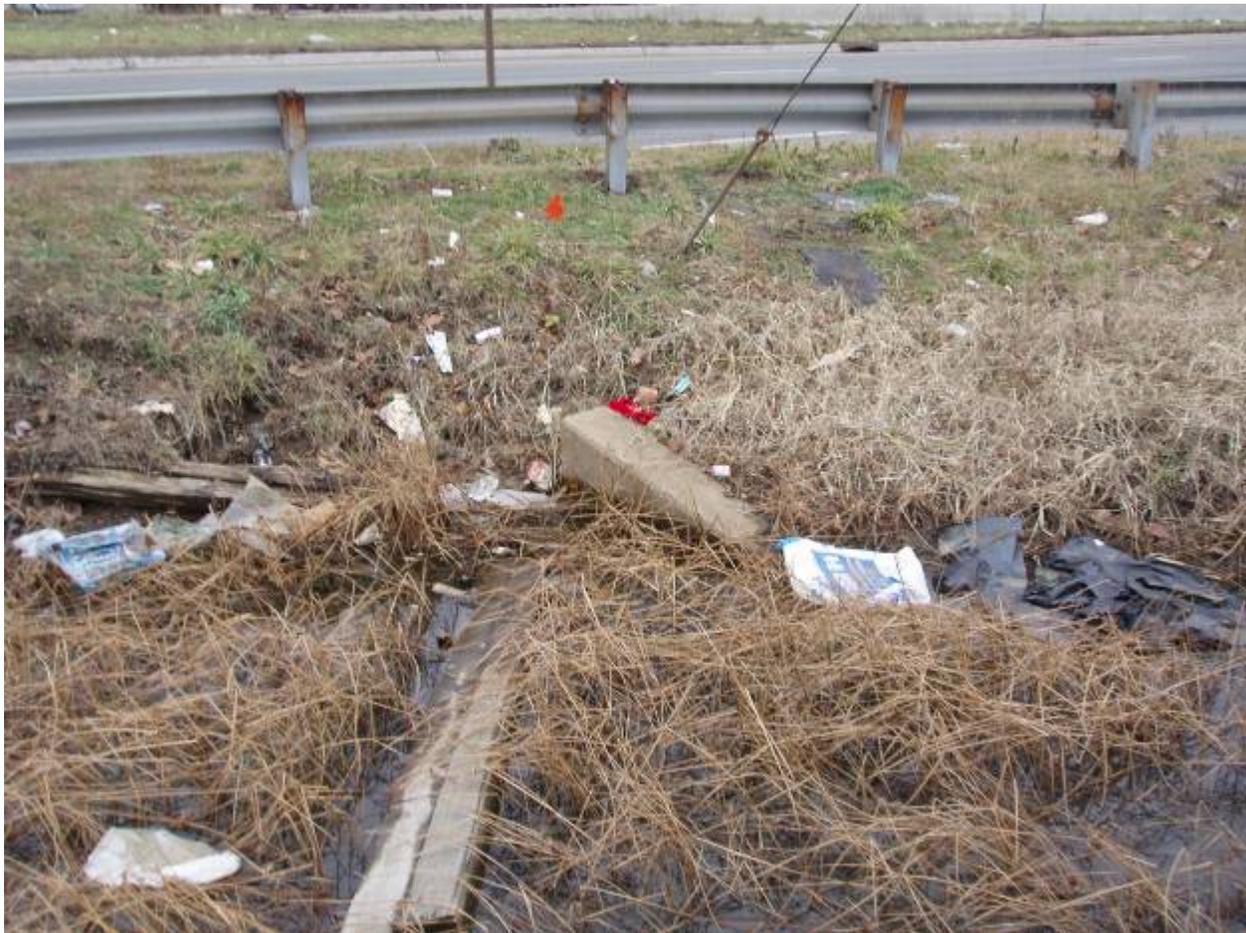
**Photo 2 Description: Possible location of a old tide gate**

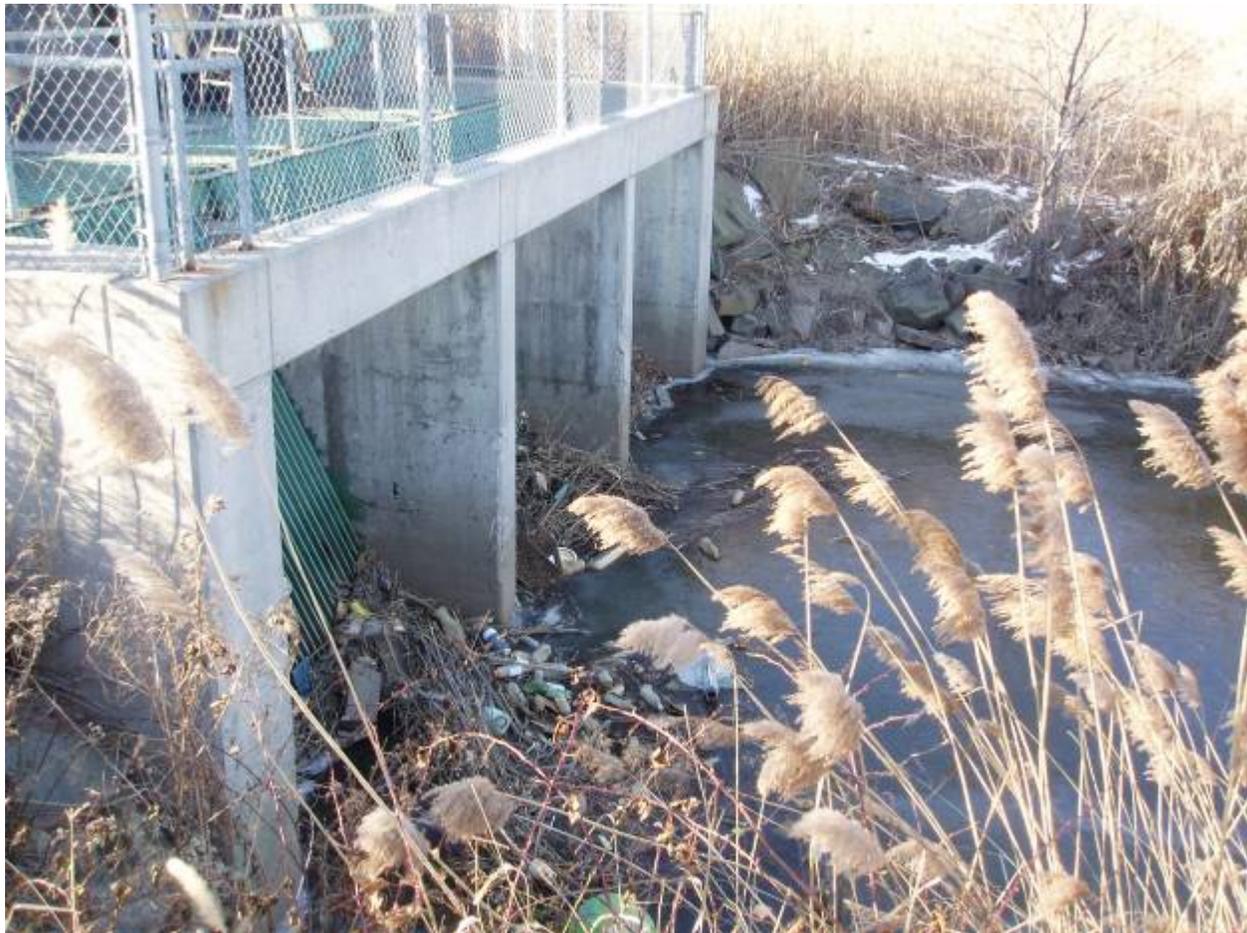
**Photo 1 Description: View of trash racks at in-take structure**

Drainage ditch needs to be cleaned out. The gates need cleaning and repairs made. Gates are timber and in the future may need to be replaced. A trash rack system also needs to be installed to keep debris out of the tide gates. The metal access walkway appears to be deteriorating and needs to be cleaned and repainted.

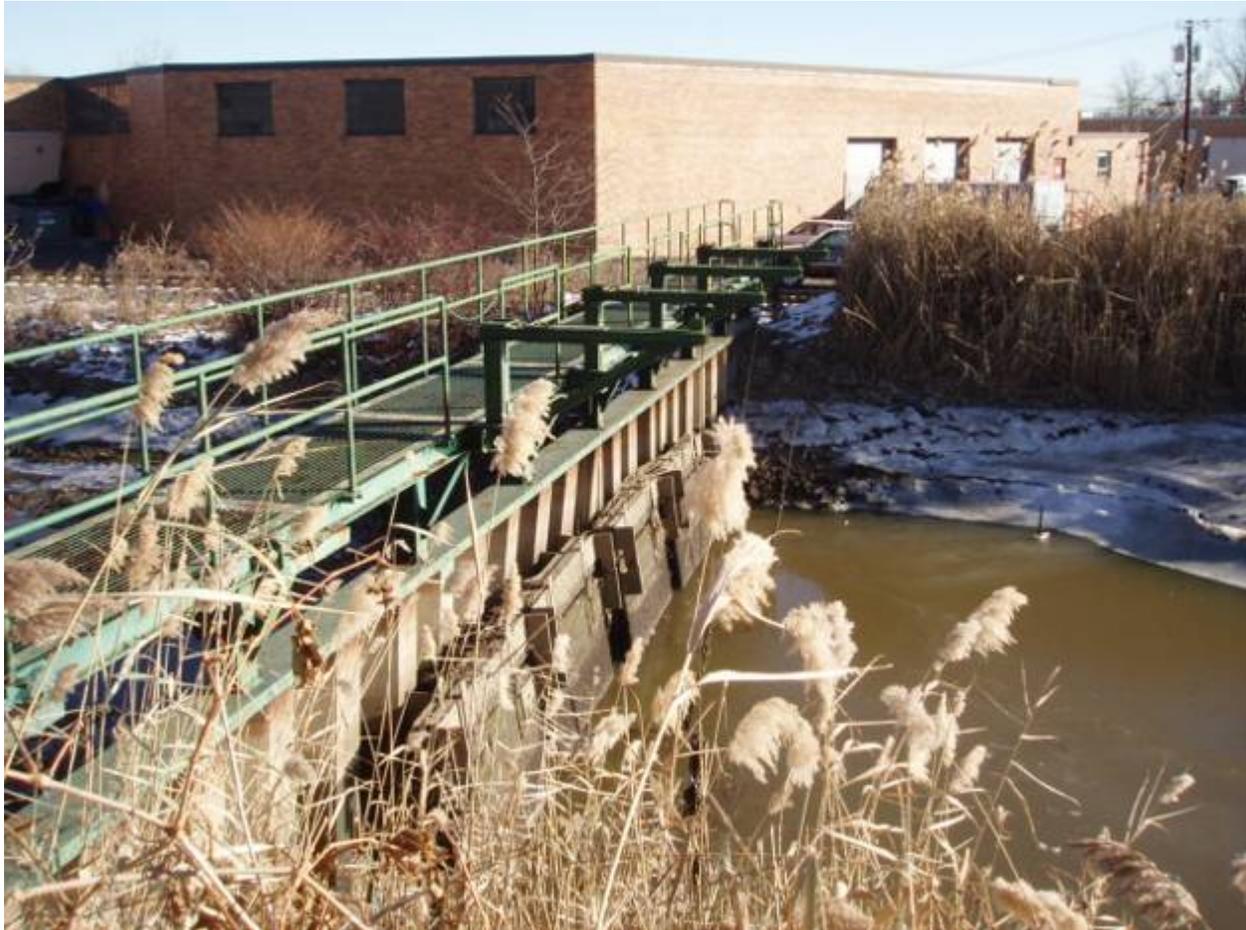
**Photo 1 Description: 4 timber tide gates**

Tide gates are not seating properly. Maintenance needs to be performed on the gates. The gates foundation is also being undermined

Routine cleaning will help keep the gates operating properly. Gates may need to be replaced with metal flap gates in the future, currently they are timber. A trash rack system would also help to alleviate the collection of debris.

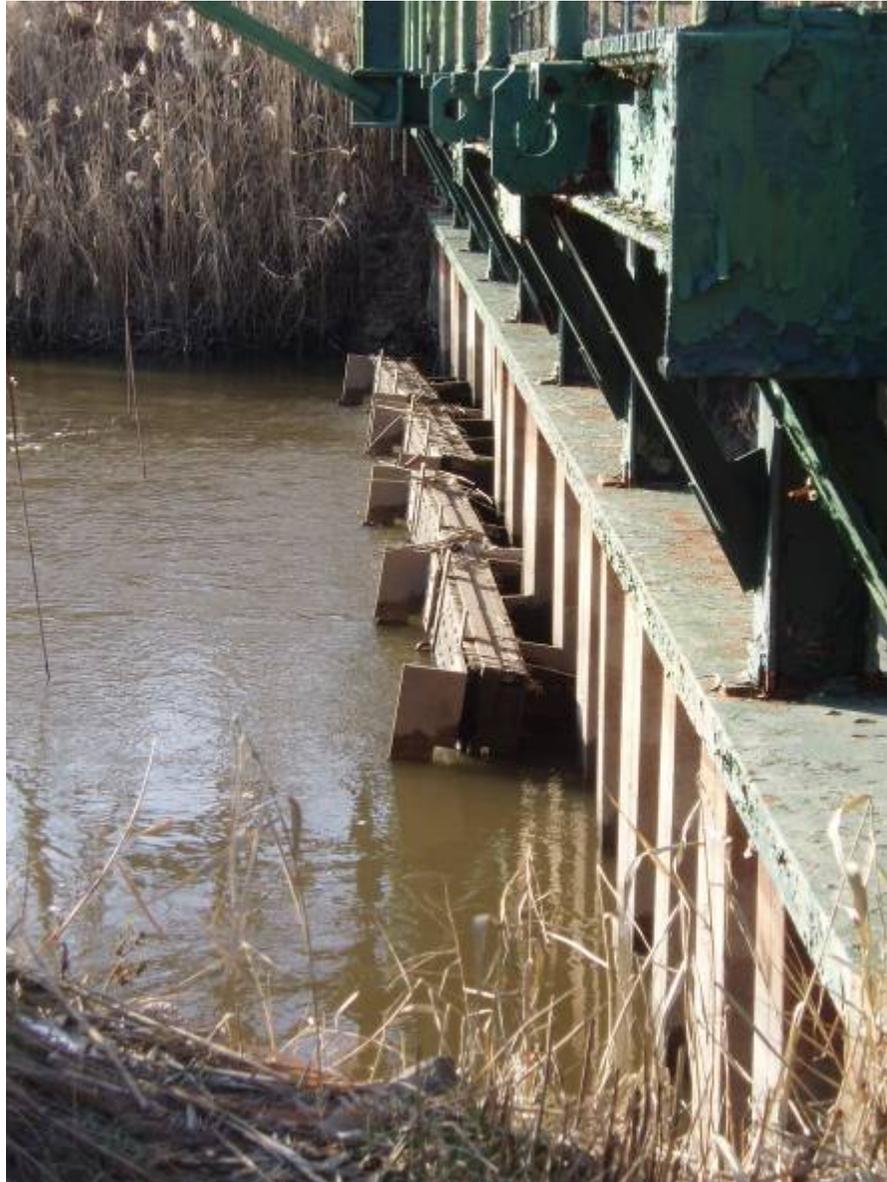
**Photo 1 Description: 4 timber tide gates**

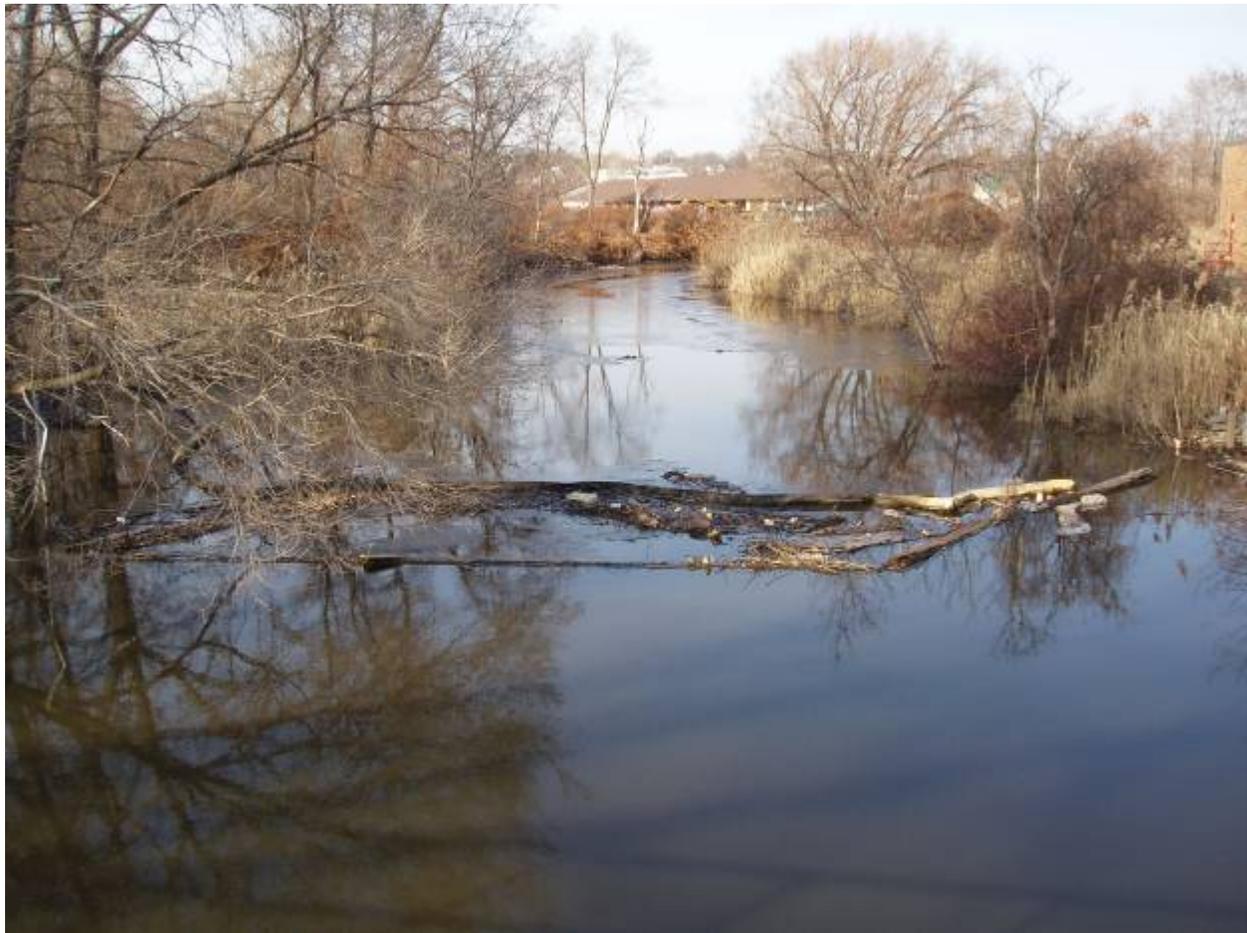
**Photo 2 Description: Upstream view of trash rack system**

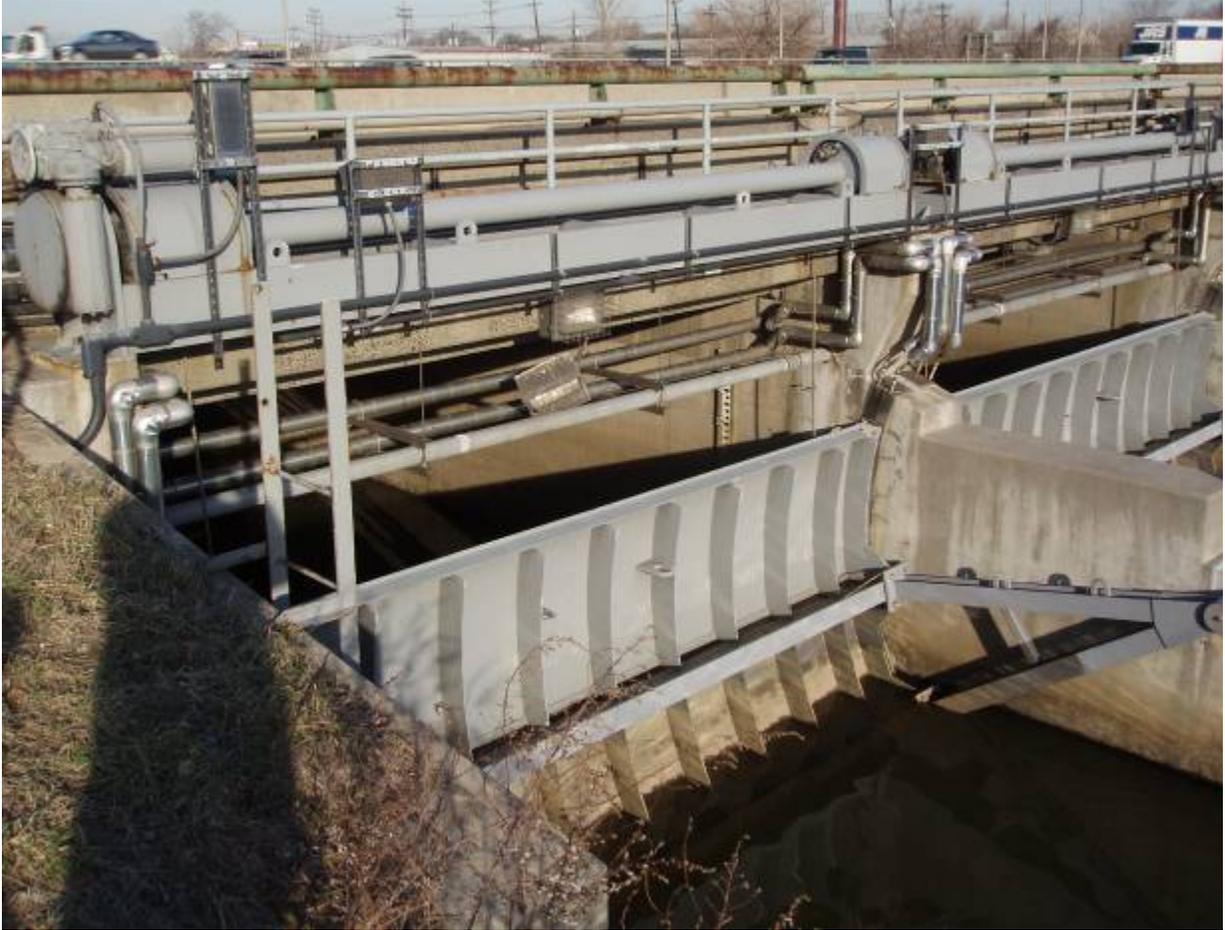
**Photo 3 Description: View of bascule tide gate**

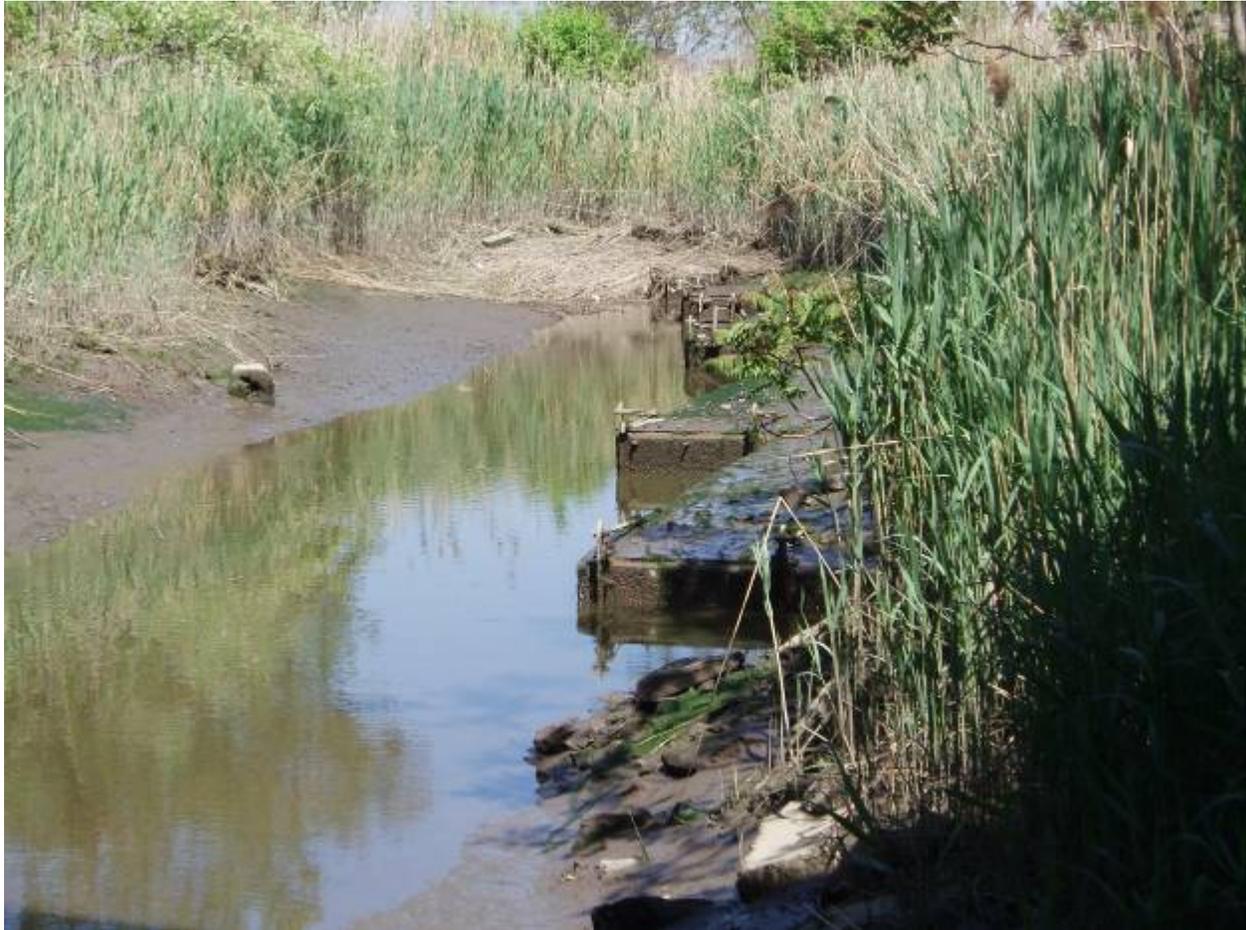
**Photo 1 Description: View of tide gates**

Water continues to seep through the gates and enter the upstream system. Of the five original designed 3 foot pipes, only three are functional and they are partially silted with their flap gates in varying degrees of damage. Two of the flap gates (culvert no. 4 and 5) have been welded closed.

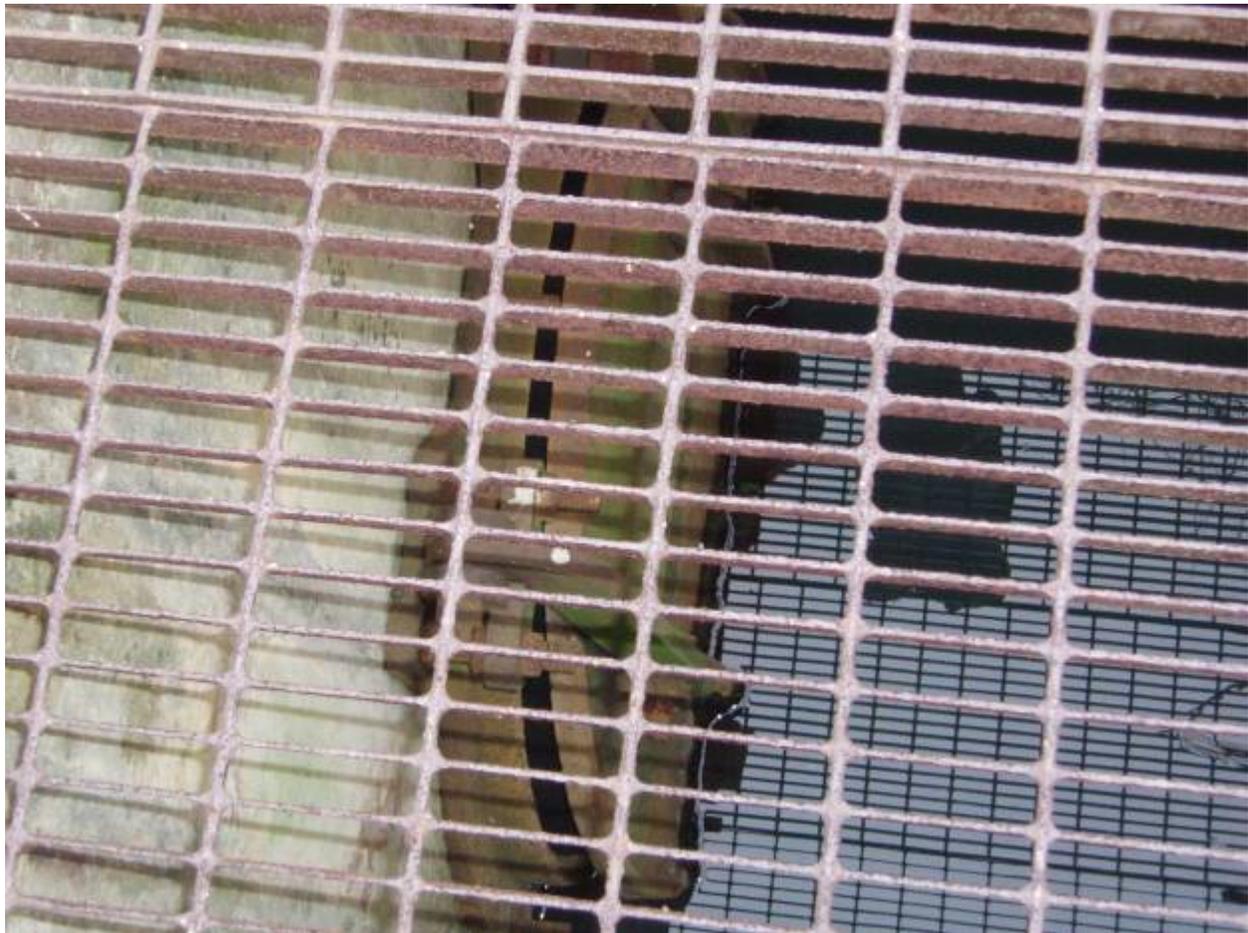
**Photo 2 Description: First 48-inch metal flap gate**

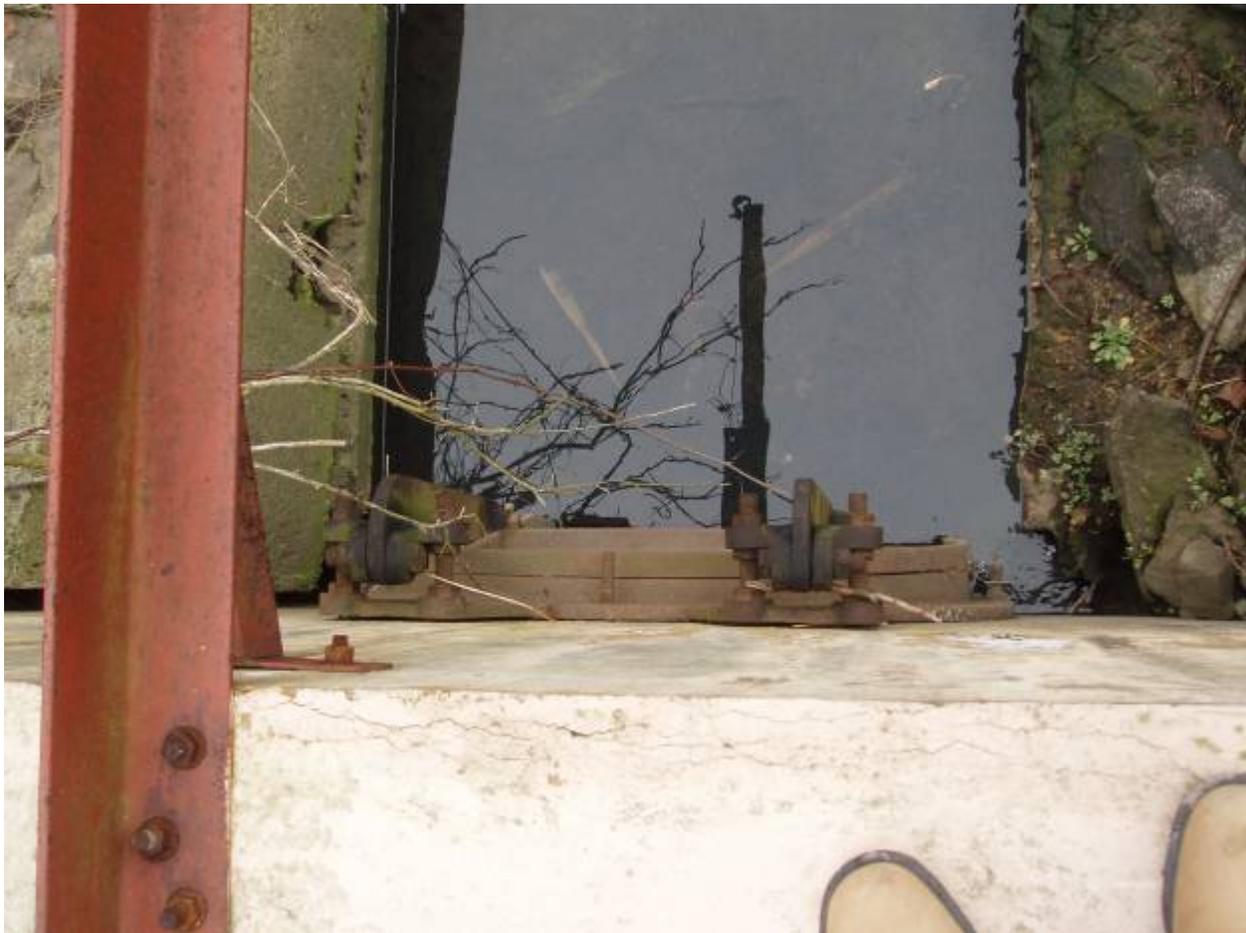
**Photo 3 Description: Second 48-inch metal flap gate**

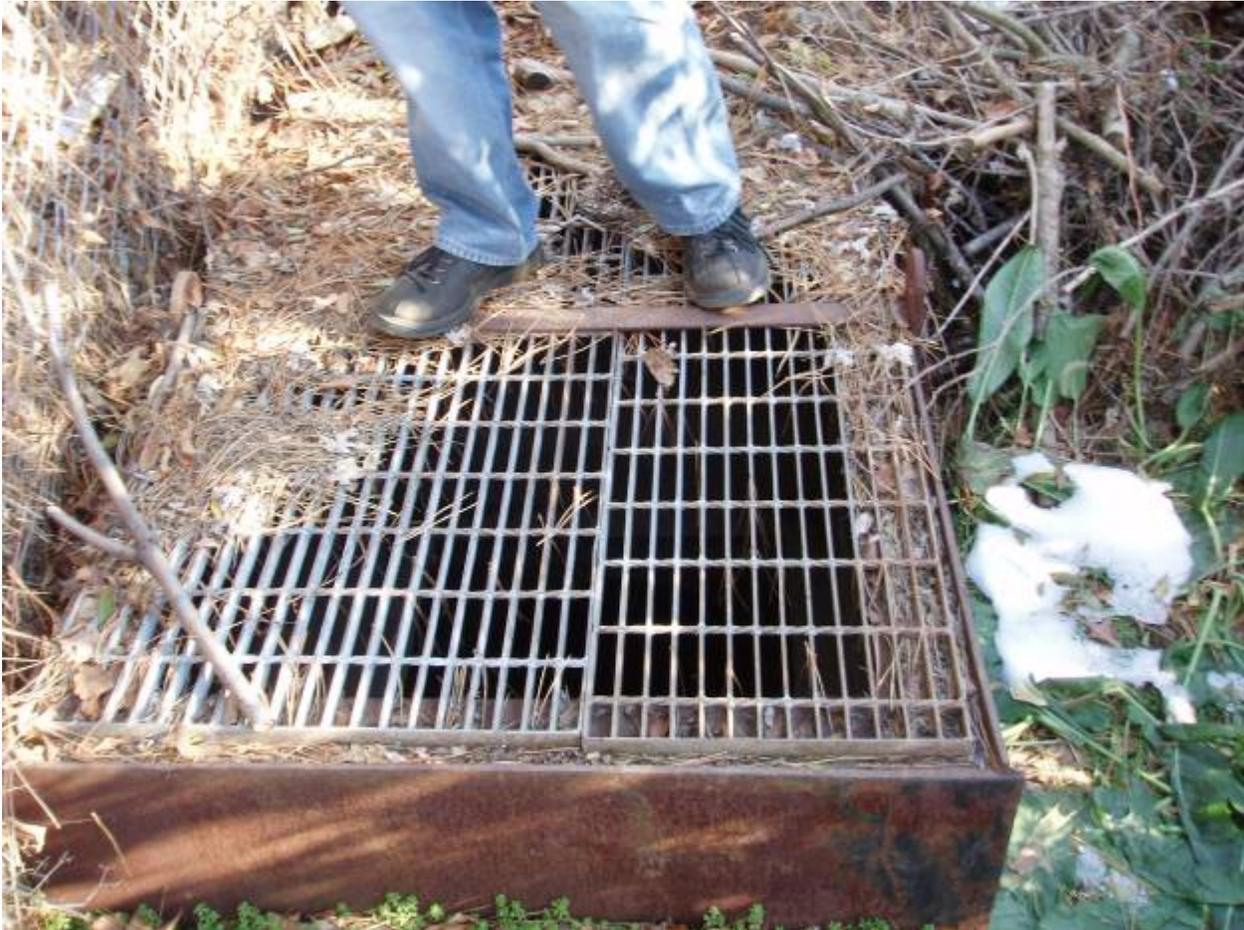
**Photo 3 Description: View of tide gate chamber**

Gated access needs to be added at this location. The chamber in which the gates are housed needs to be cleaned out and repaired.

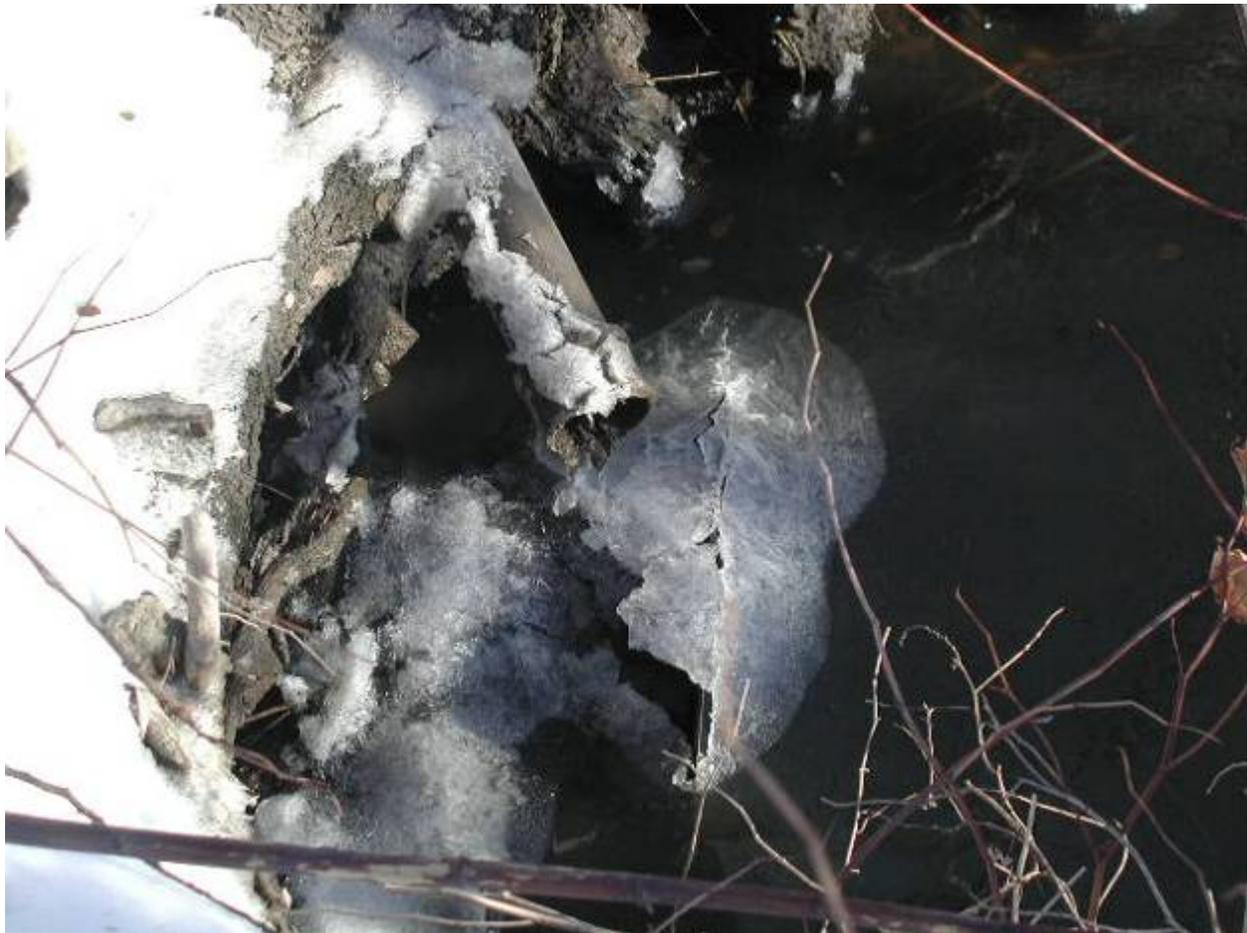
**Photo 1 Description: Tide gate structure shown during ice conditions**

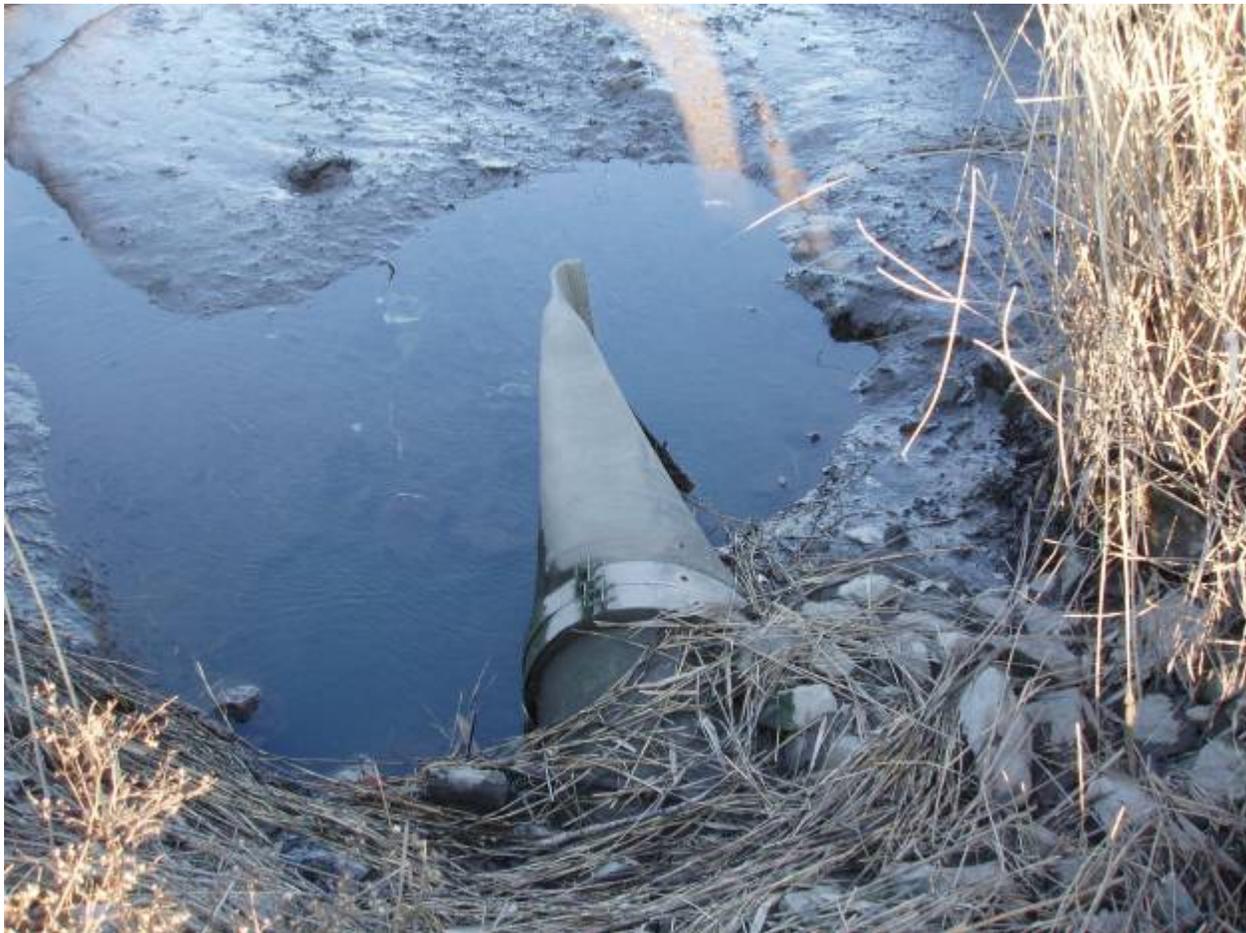
The site contains a Tideflex™ check valve; it appears to be functional during low tide conditions.

**Photo 2 Description: Tideflex™ check valve**
