# Hackensack Meadowlands Tide Gates Inspection Report

**The National Flood Insurance Program  
Community Rating System**

**The New Jersey Meadowlands Commission  
One DeKorte Park Plaza  
Lyndhurst, New Jersey**

**March 27, 2006**

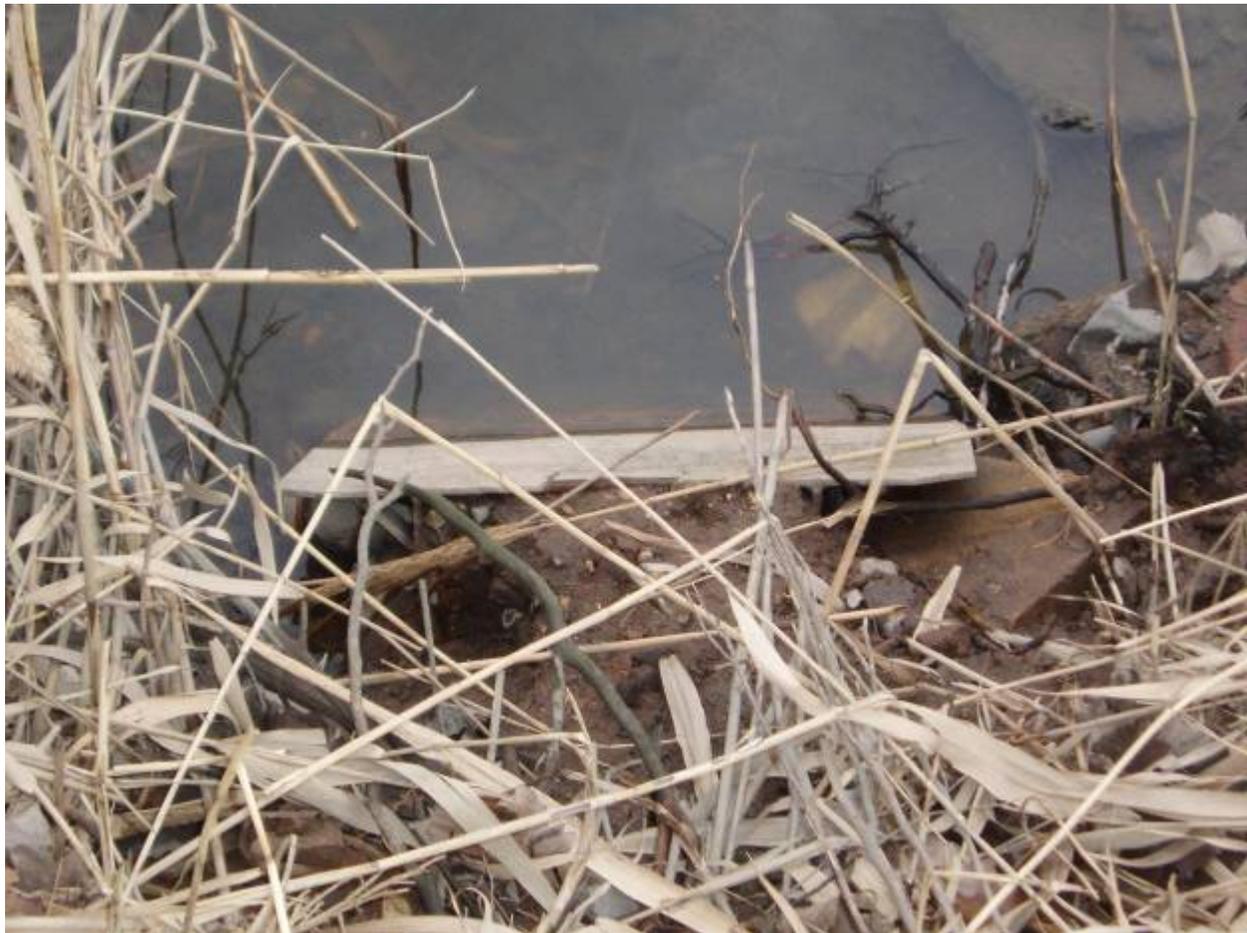
The tide gate appears to seat properly. The gate is attached directly to storm drains located on Mill Ridge Road. In order to know if the gate is functional an inspection needs to be completed during a rain event to see if the gate opens. One of the tide gates found is located behind the property of 17 Mill Ridge Road.

**Photo 1 Description: Metal flap gate shown**

The hinges located on the gate appear to be rusted and need to be cleaned and lubricated.

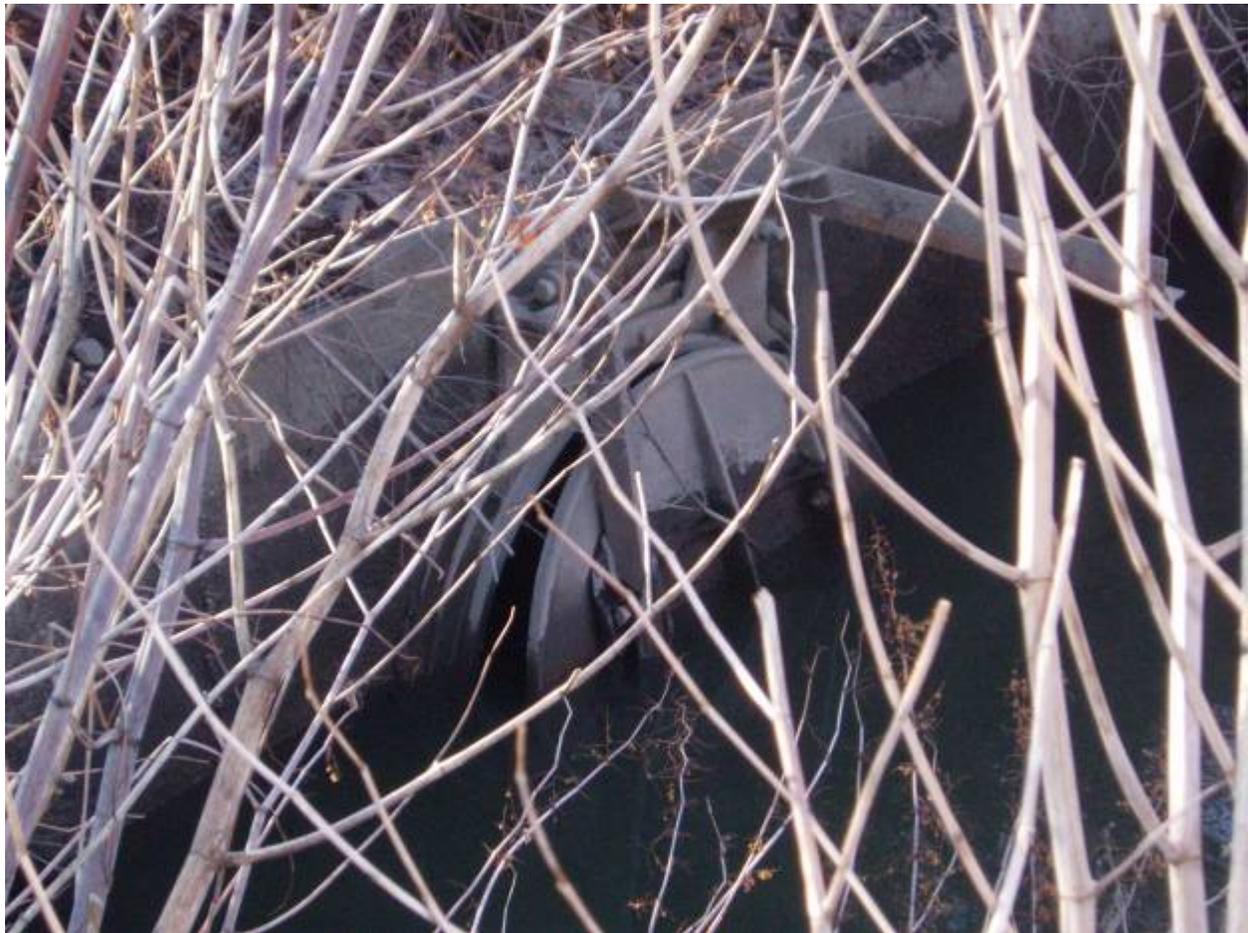
**Photo 1 Description: 1 metal flap gate**

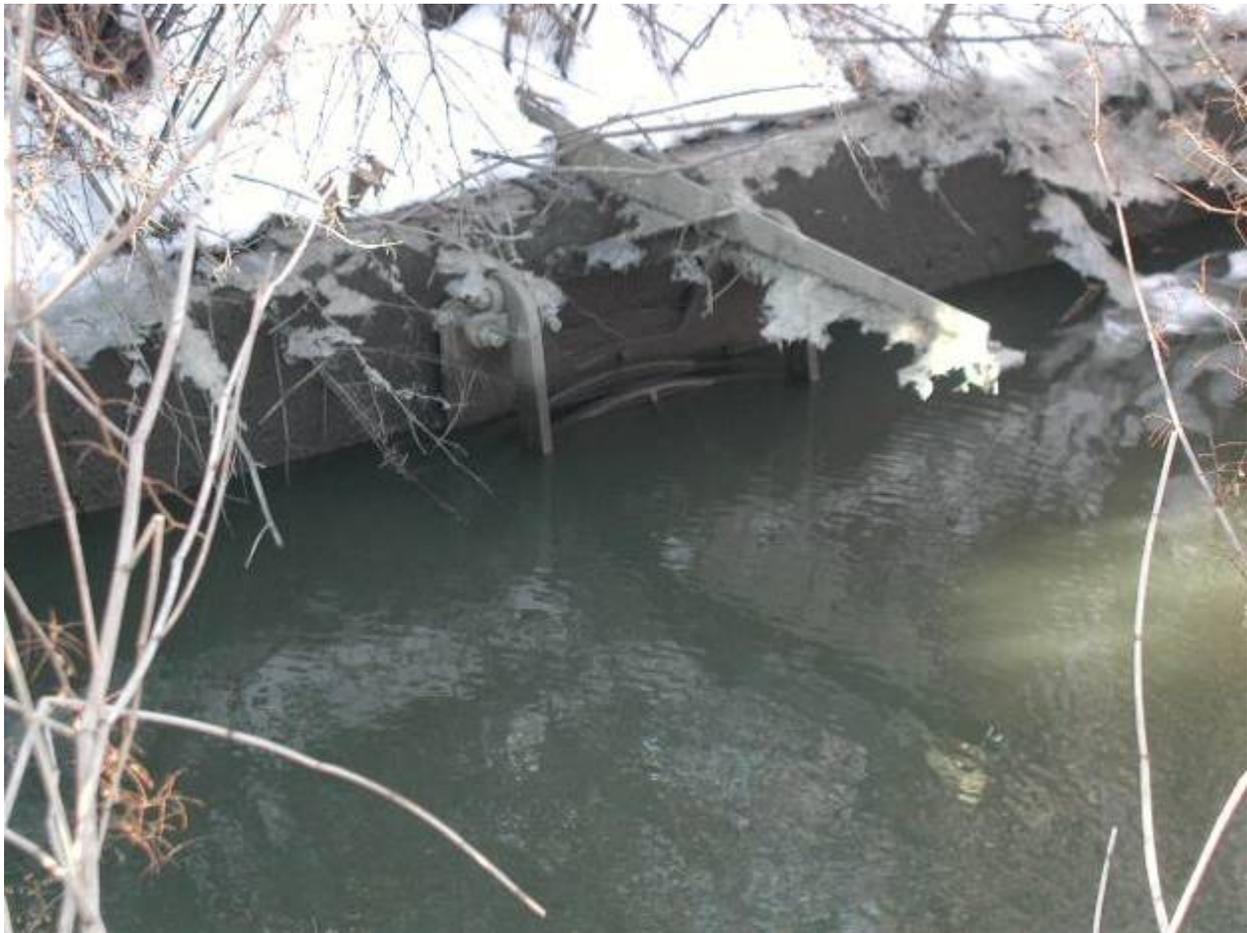
No problems observed.

**Photo 1 Description: 1 metal flap gate**

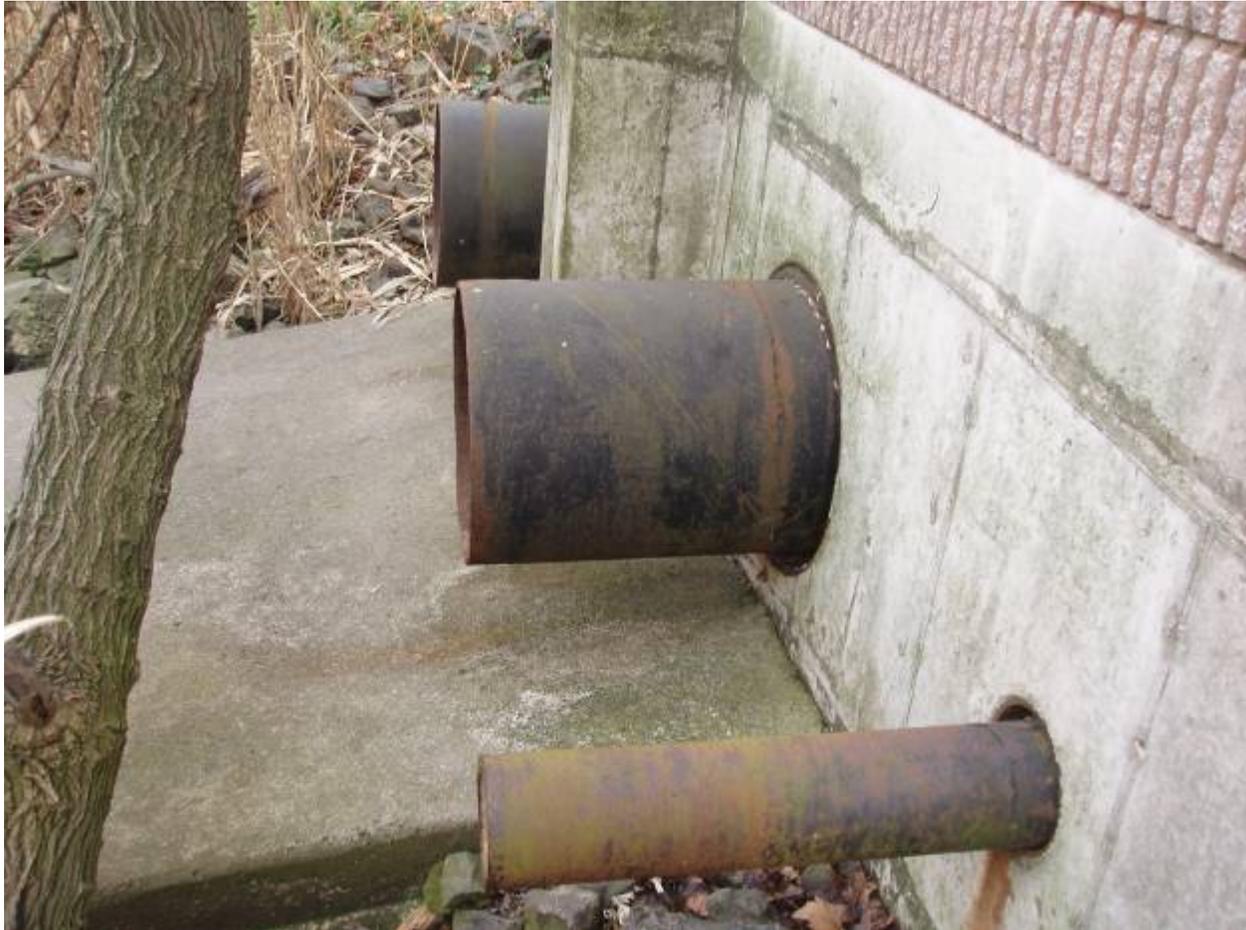
**Photo 1 Description: View of outlet pipes**

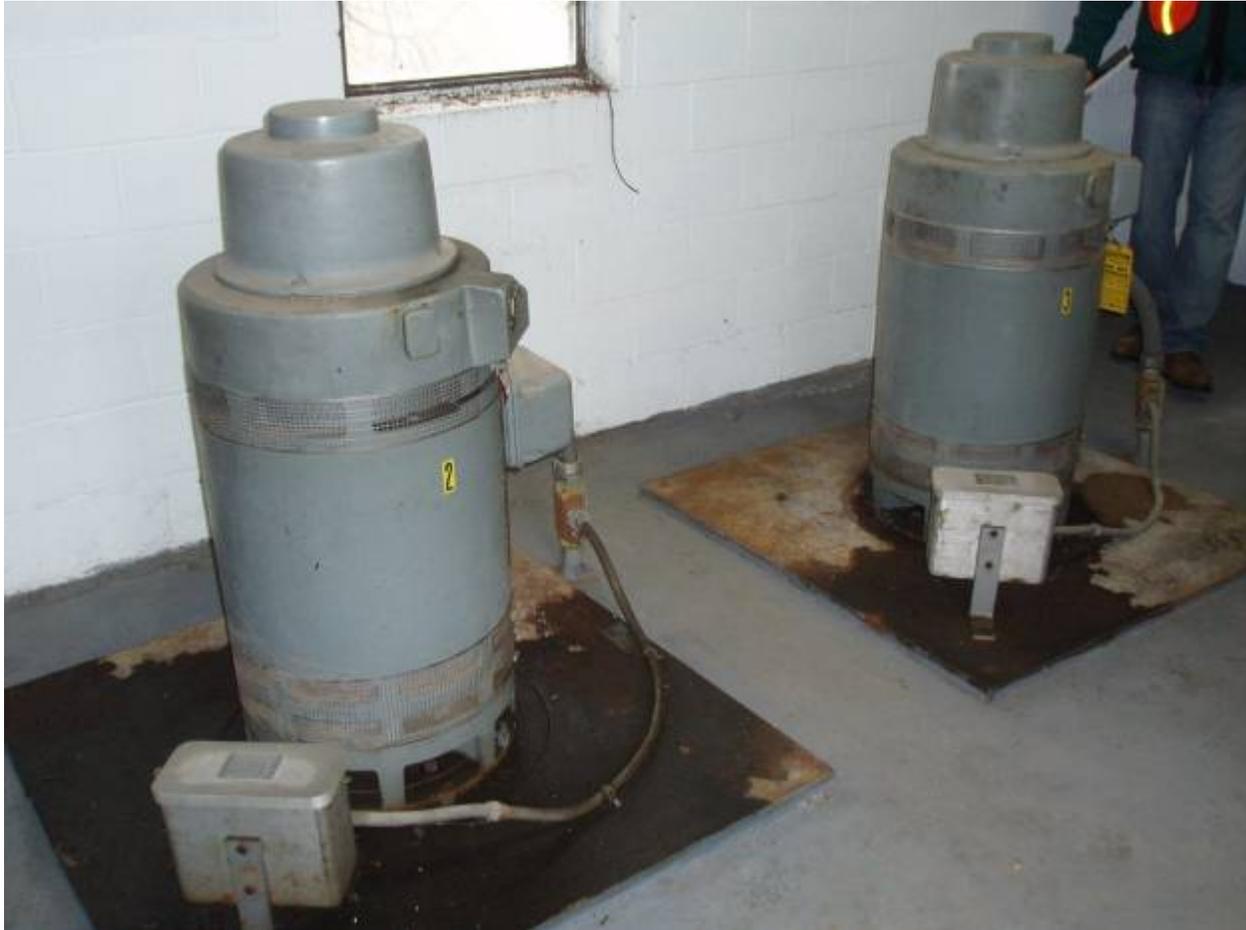
**Photo 2 Description: View of pump systems**

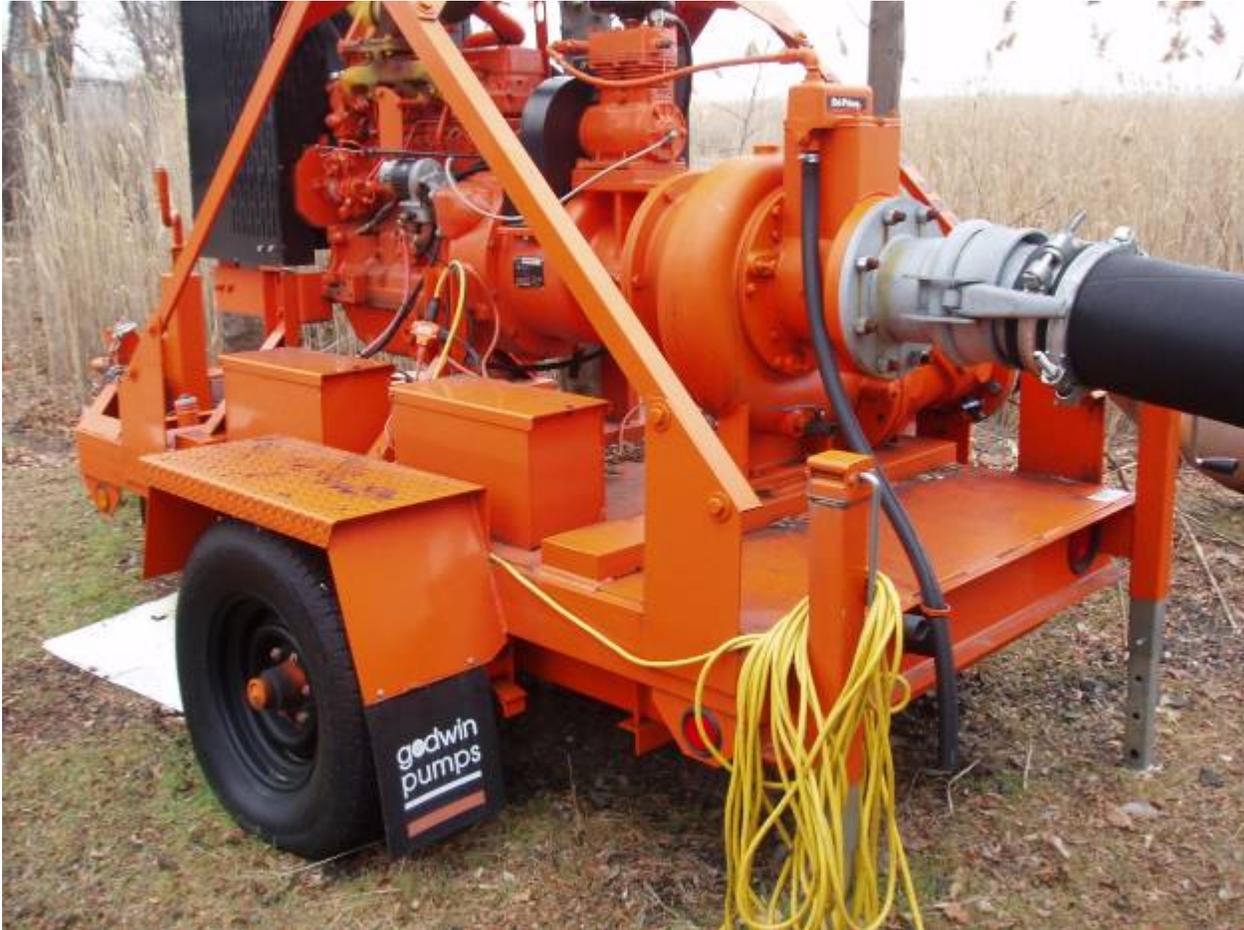
**Photo 3 Description: Godwin diesel back-up pump system**

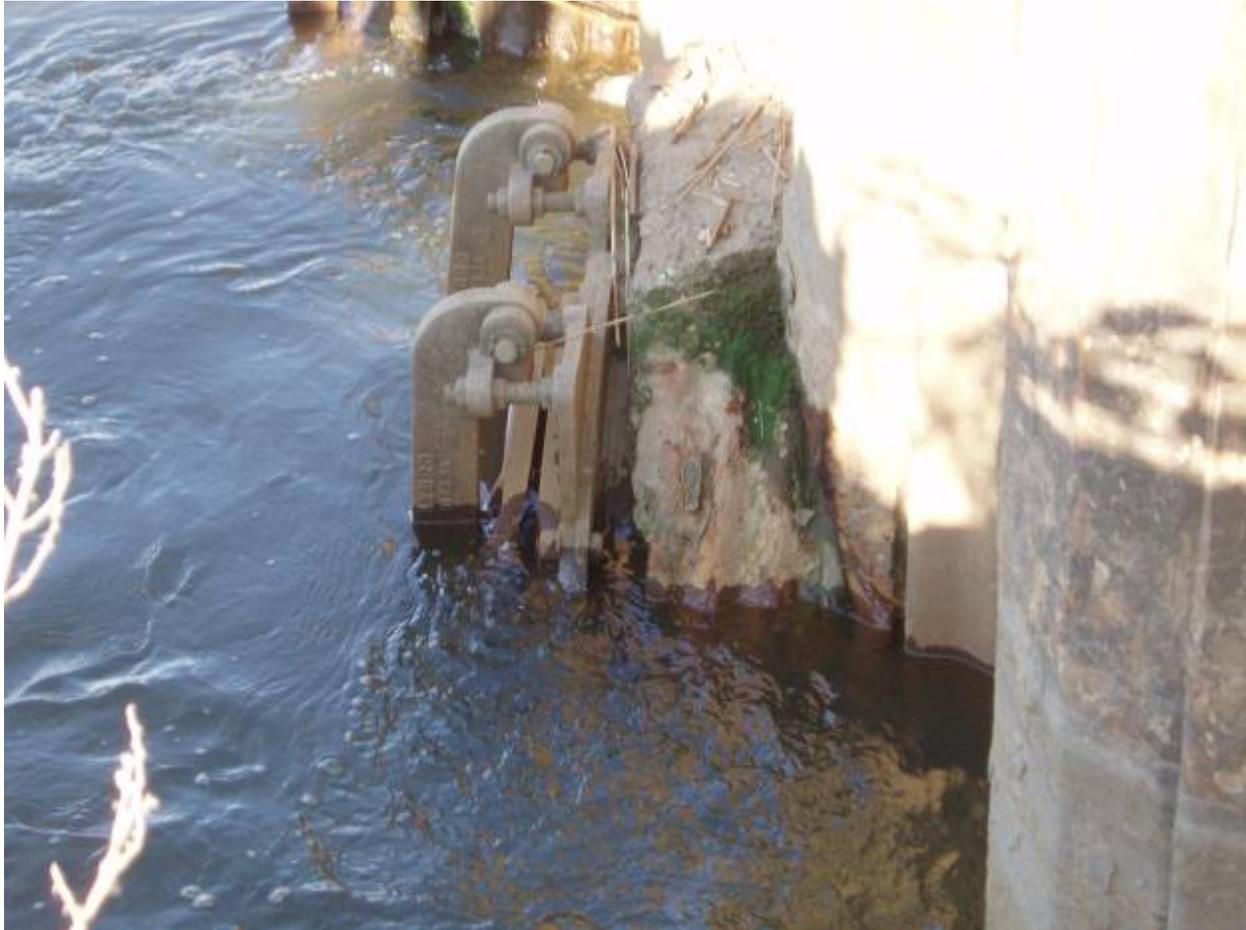
**Photo 1 Description: Metal flap gate shown closed**

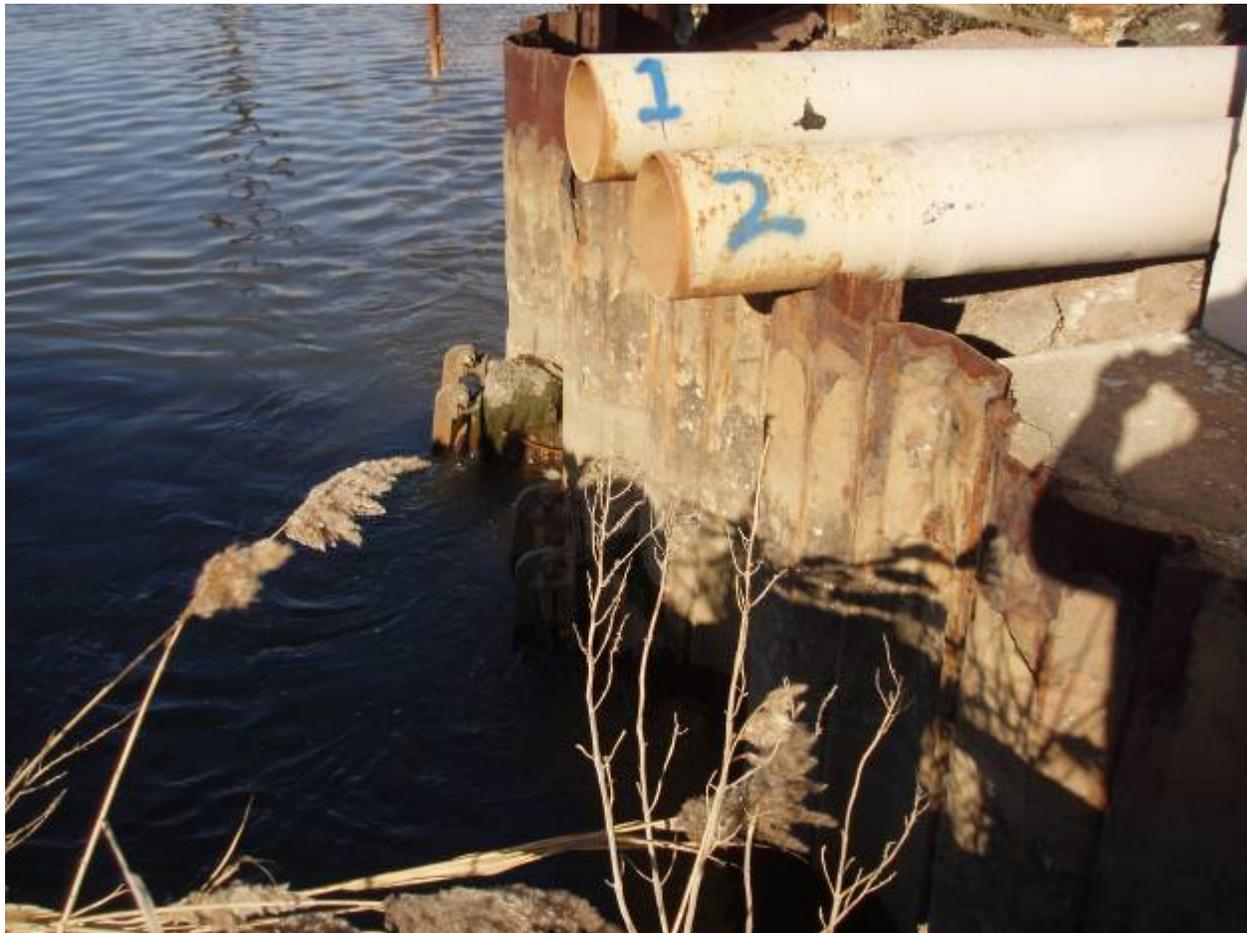
**Photo 2 Description: Pump discharge pipes**

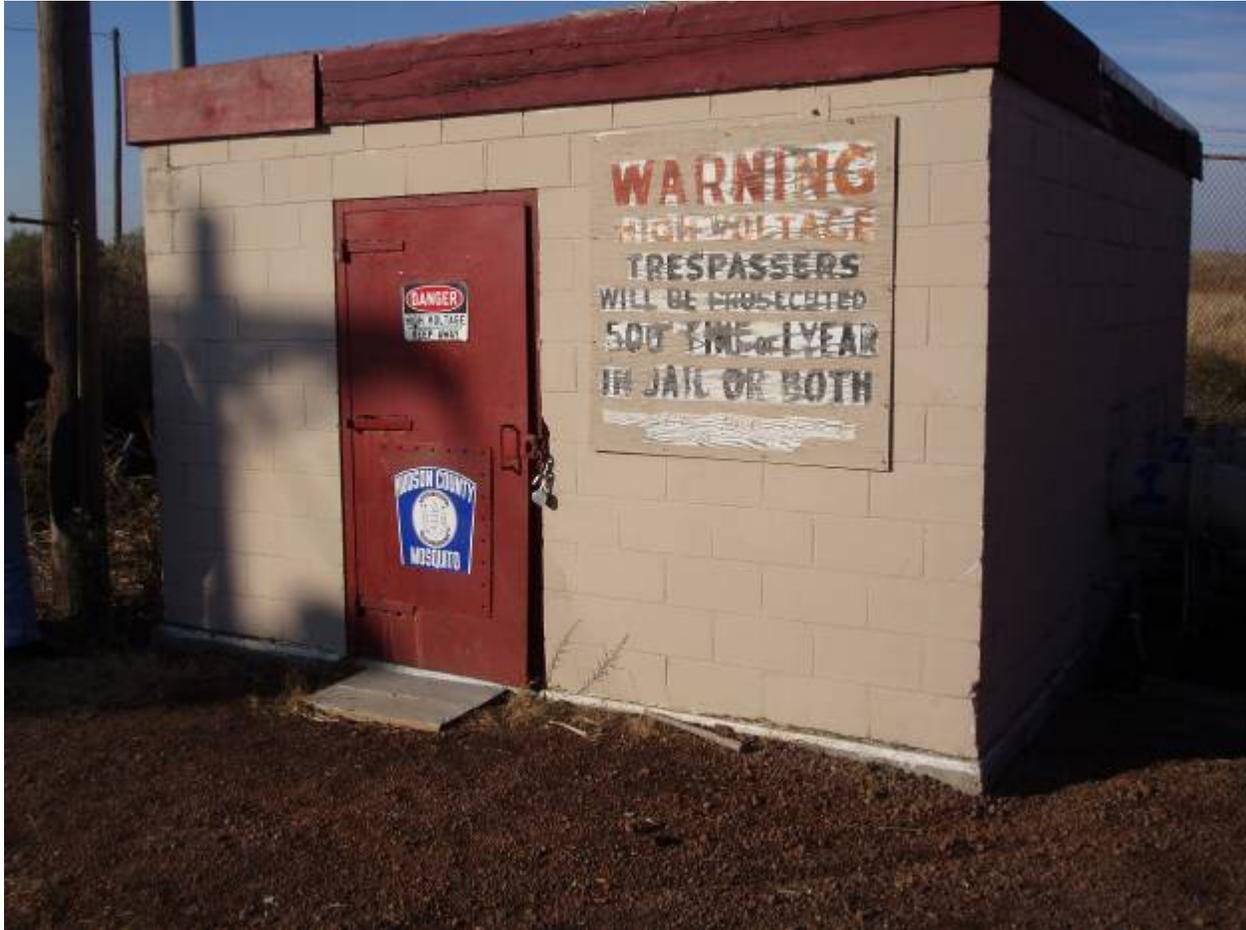
Photo 3 Description: Pump station facility

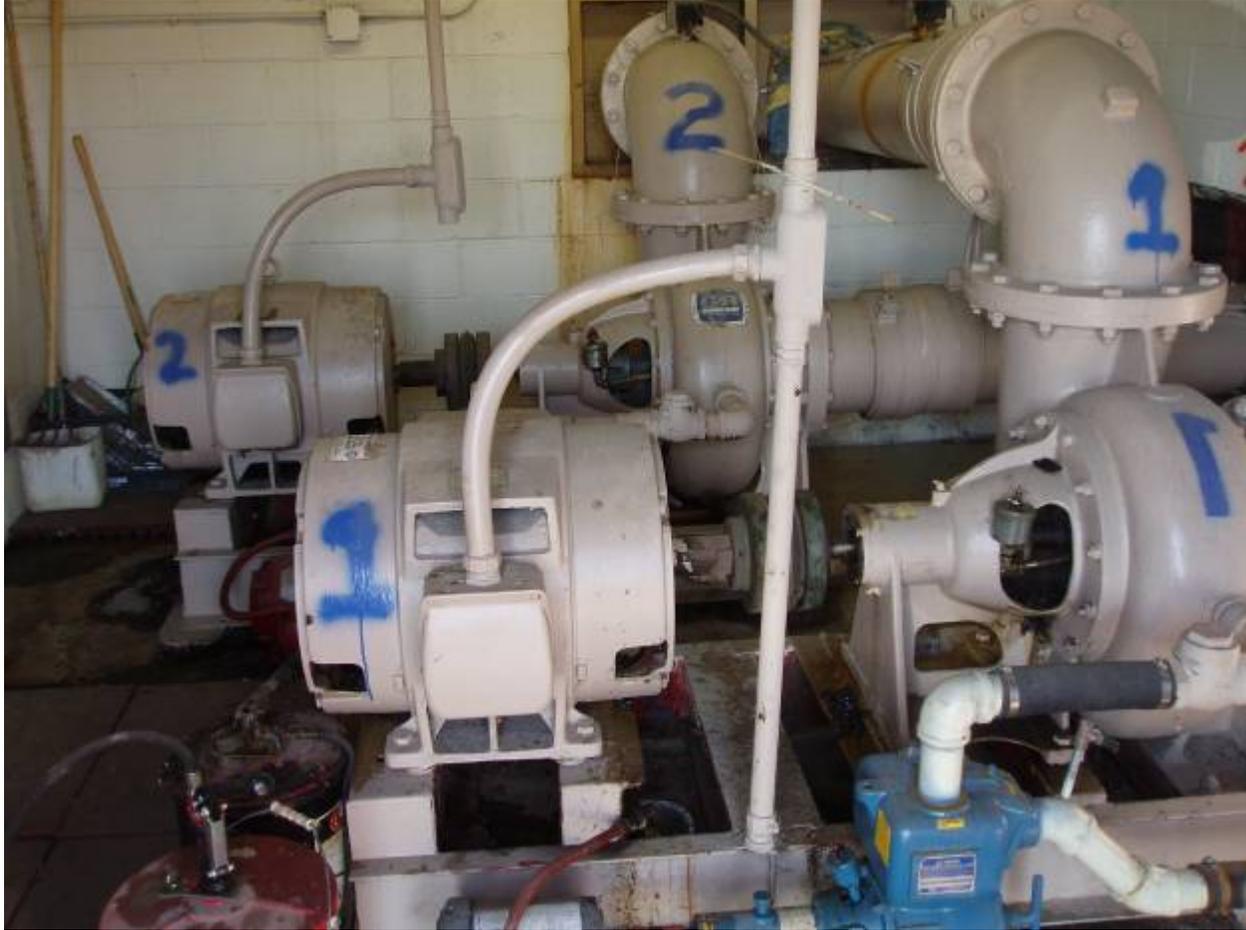
Photo 4 Description: View of pumps

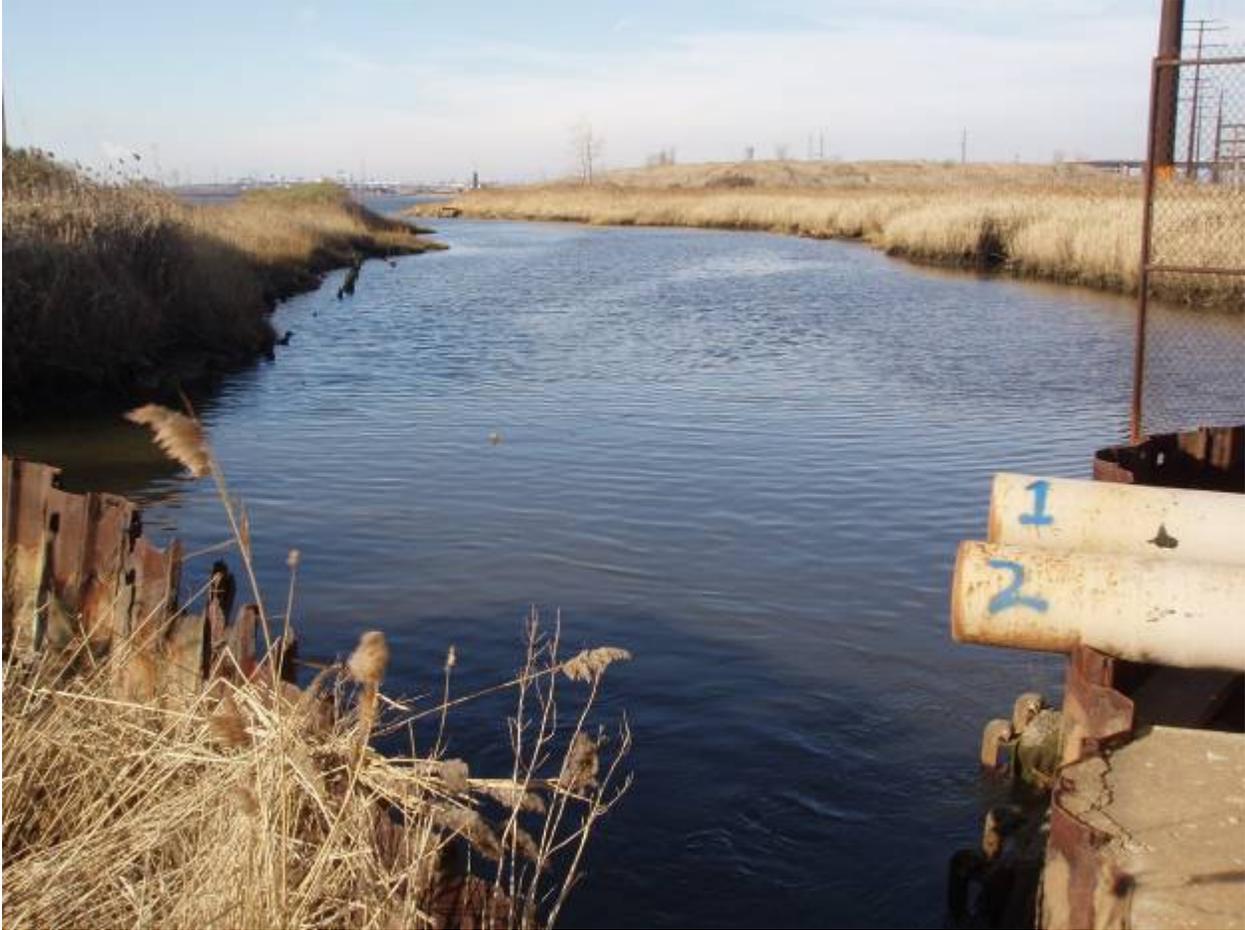
**Photo 5 Description: Downstream view from the pump station facility**

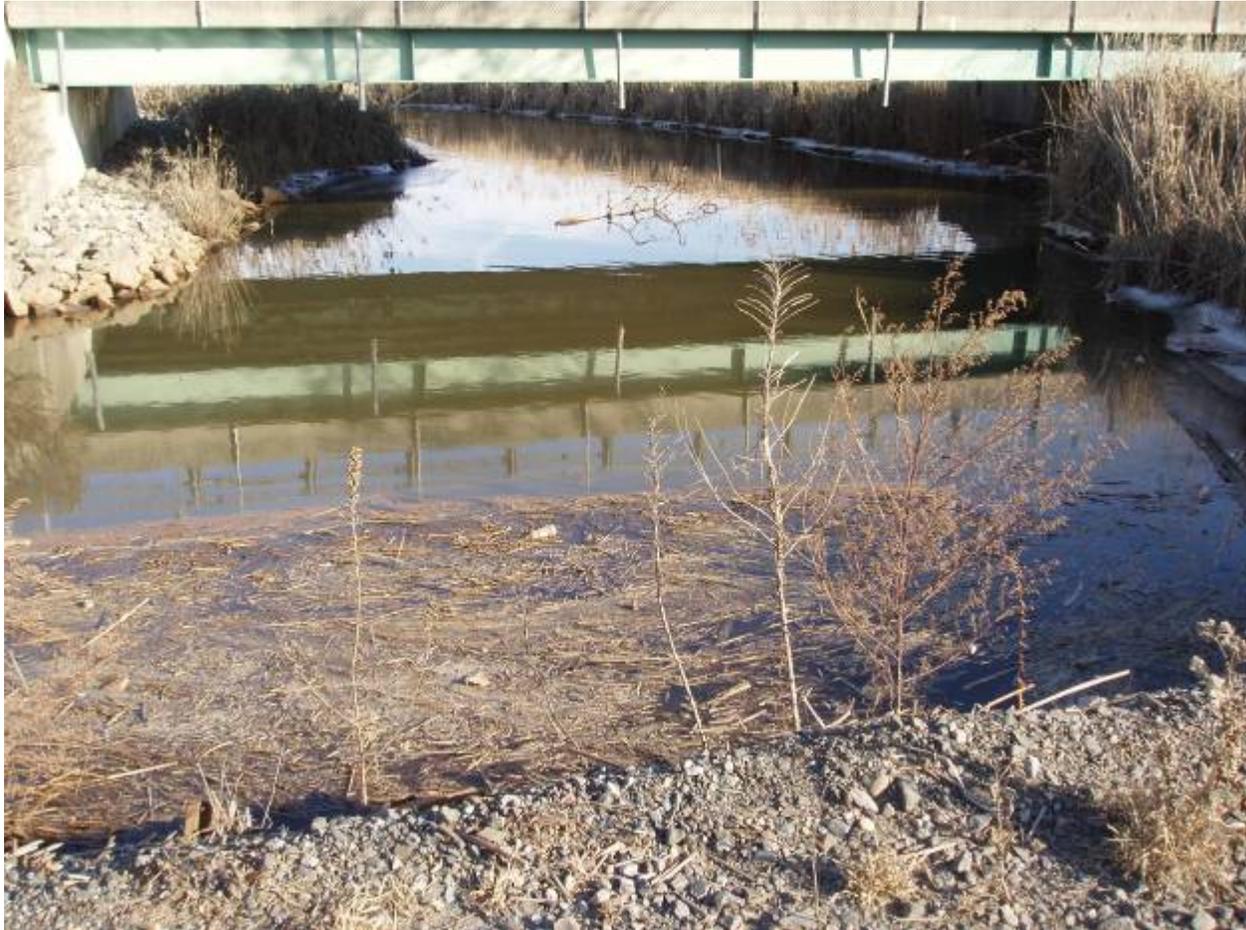
**Photo 6 Description: Upstream view from the pump station facility**

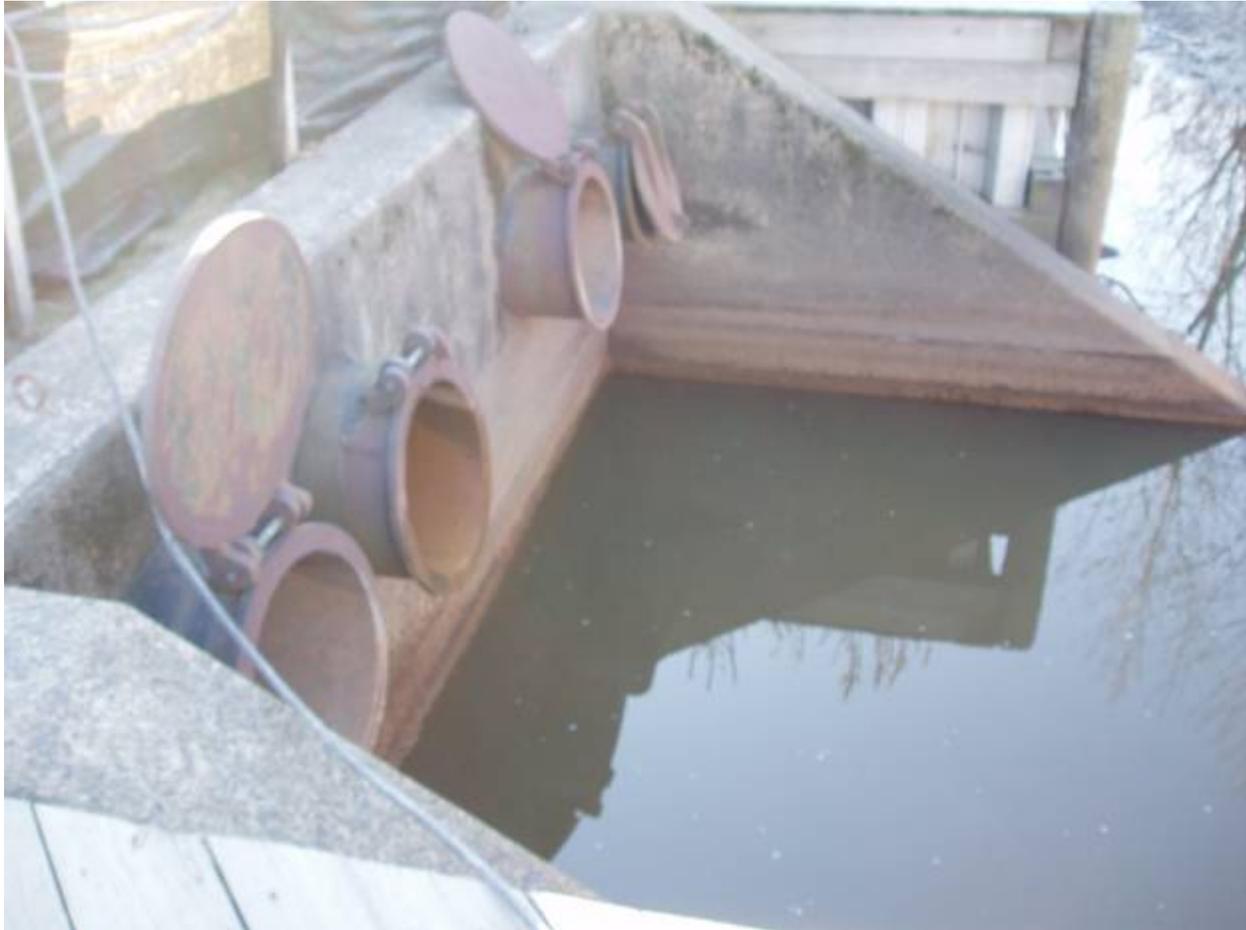
A new pump station is currently being constructed. The current conditions are: 3 out of 4 pumps function, 1 out of 4 tide gates function. The two tide gates that function at discharge are seating properly.

**Photo 1 Description: Flap gates shown on outlet structure**

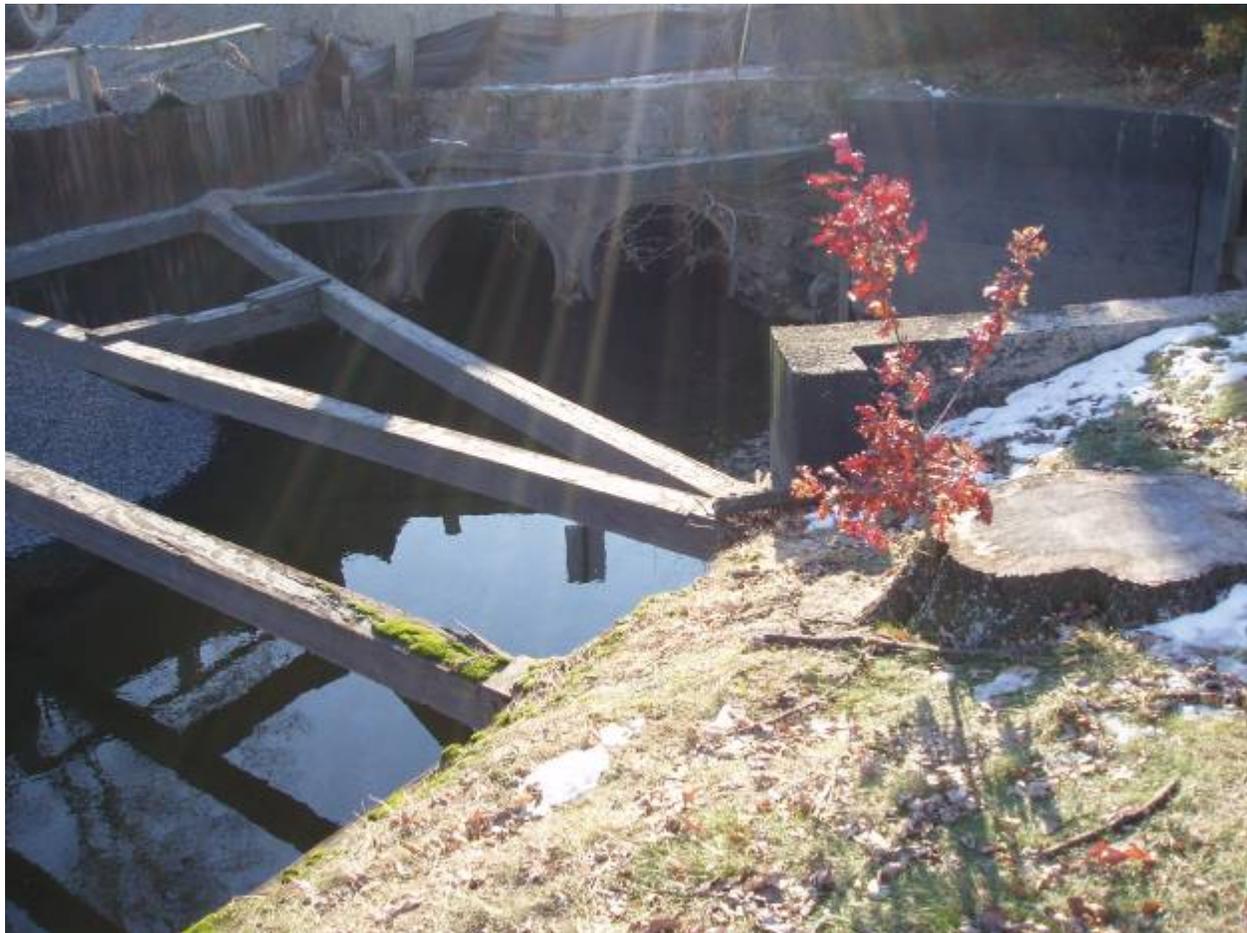
**Photo 2 Description: In-flow at pump station**

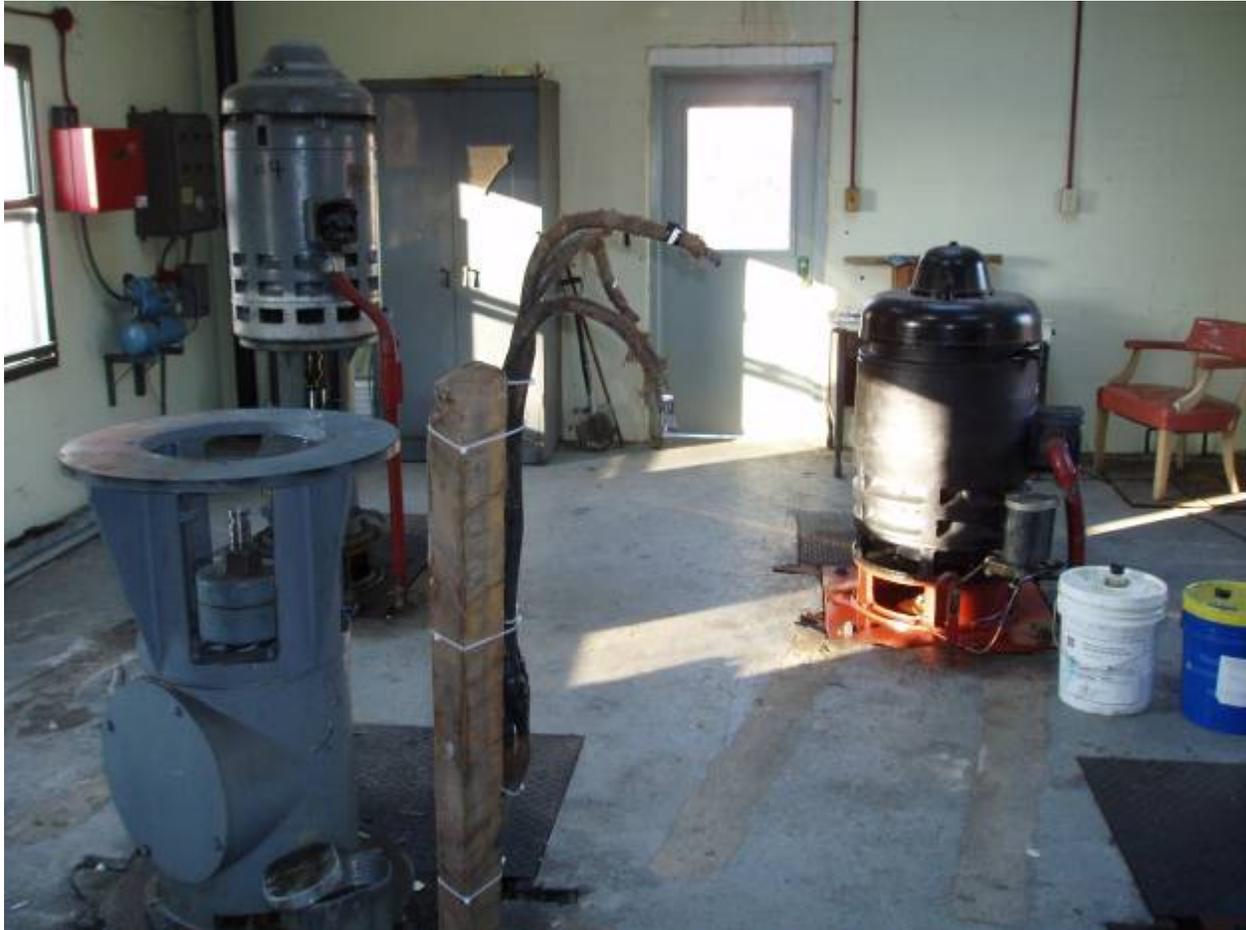
Photo 3 Description: View of pumps

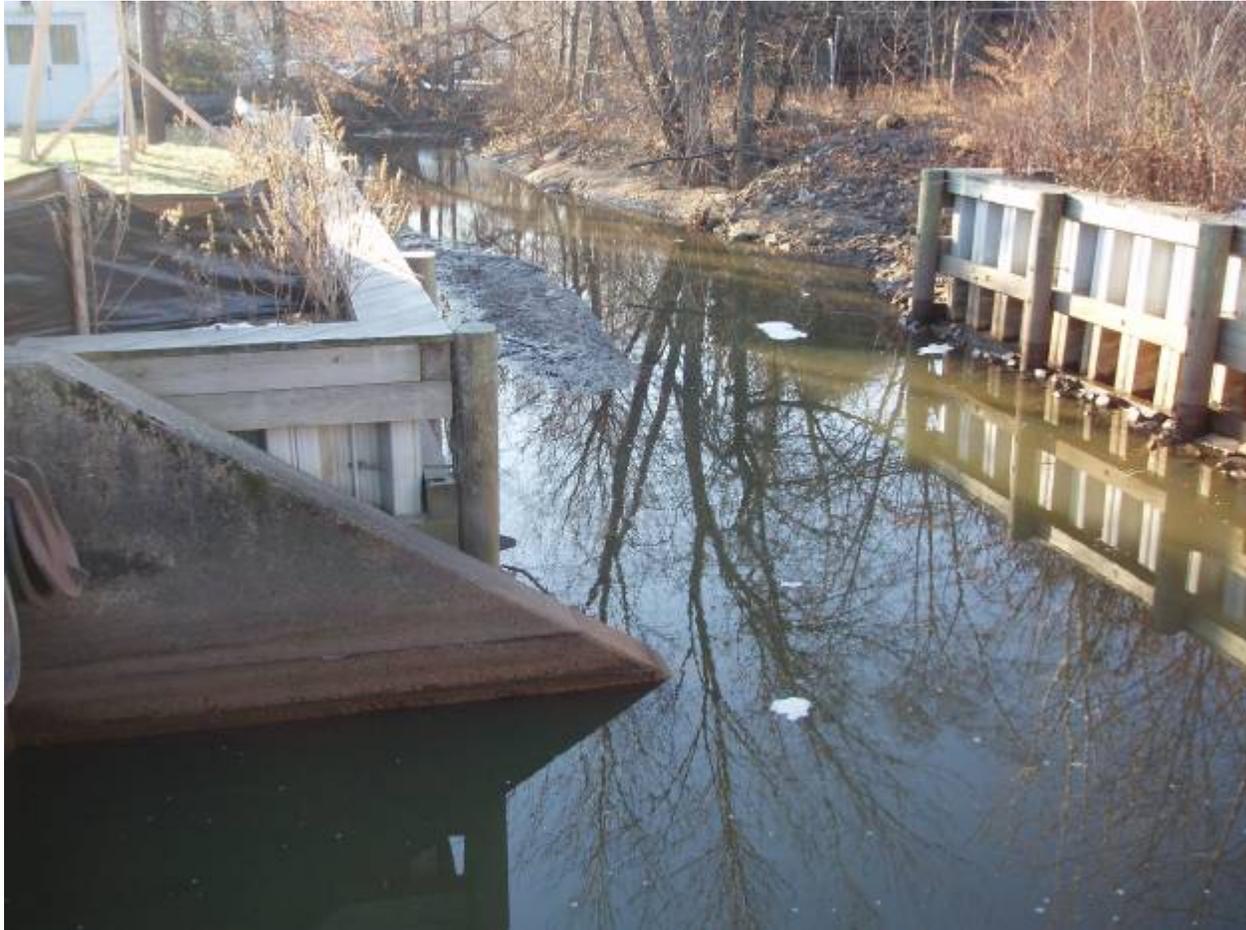
**Photo 4 Description: Downstream view from the pump station**

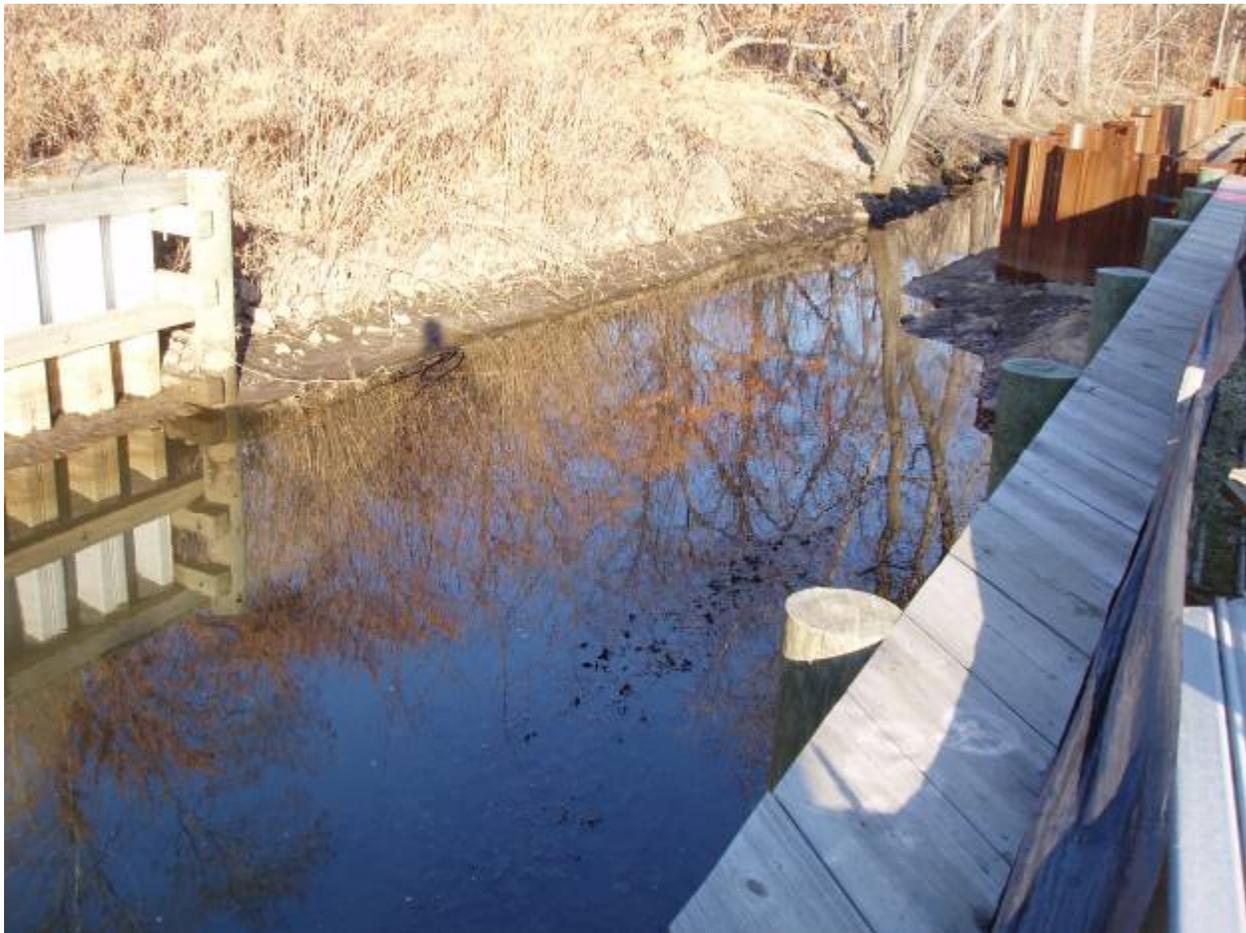
**Photo 5 Description: Upstream view from the pump station**
